GOVERNMENT OF INDIA
MINISTRY OF COMMUNICATIONS
CIVIL AVIATION DEPARTMENT

NOTICES
TO
**AIRCRAFT OWNERS AND
GROUND ENGINEERS**

1930-1948

NOTICES TO AIRCRAFT OWNERS AND GROUND
ENGINEERS, 1930-1948.

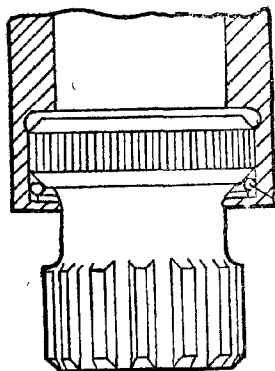
FIG. 2

Comparison of True
Form with Excessive
Wear

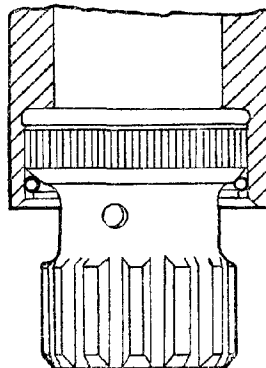
FIG. 3.

CIRCLIP
P 21684

COUPLING
P 23199

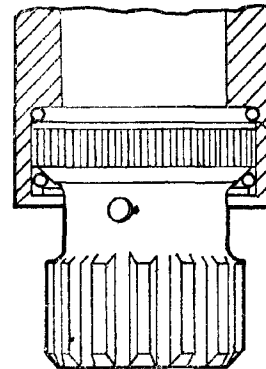
FIG. 4.

COUPLING
P 24519/1

INTRODUCED BY
MOD 146 FOR CAY 5100
MOD 153 FOR PAY 5100
