**Report by the Senior Government
Inspector of Railways, Circle No. 1,
Calcutta, on the derailment of No. 9 Up
Dehra Doon Express between Chichaki
and Hazaribagh Road, E. I. Railway,
on 12th January 1939.**

Derailment of No. 9 Up Dehra Doon Express between Chichaki and Hazaribagh Road, on 12th January 1939.

FROM MR. H. A. JOSCELYNE, M.I.C.E., SENIOR GOVERNMENT INSPECTOR OF RAILWAYS, CIRCLE No. 1, CALCUTTA, LETTER No. 96/XIII/39, DATED CALCUTTA, THE 25TH JANUARY 1939.

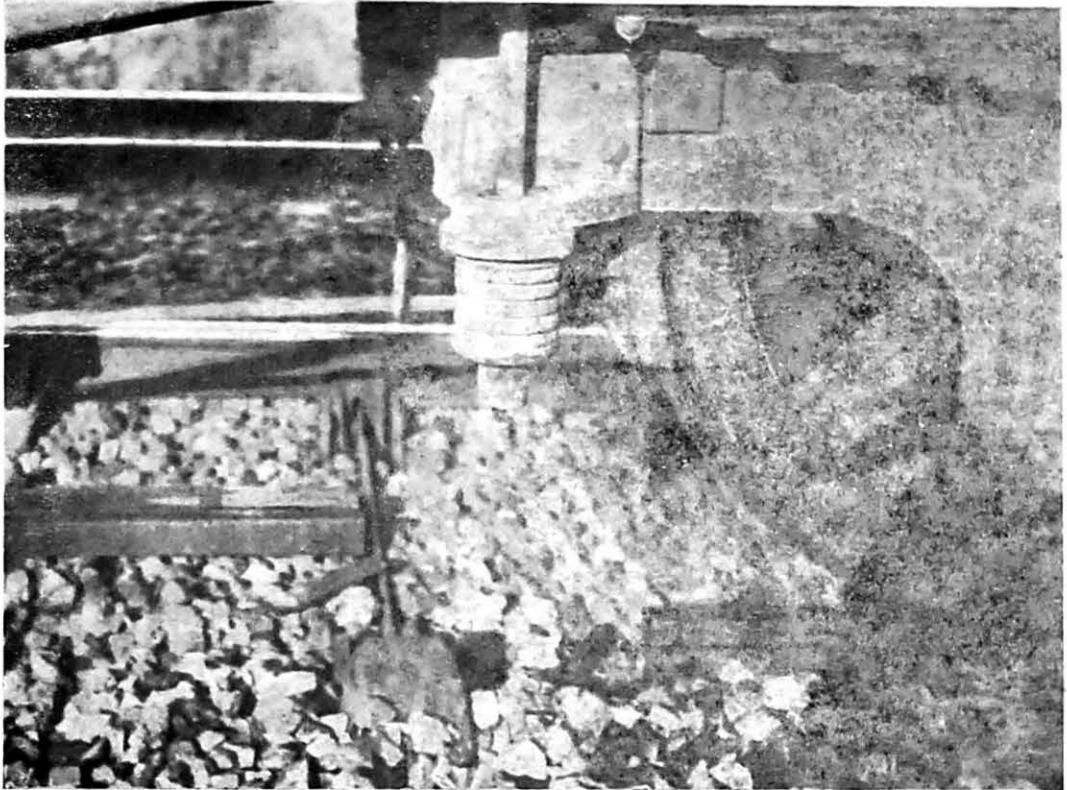
In the description above I have stated that the trailing bogie wheels of the last coach were still on the track when the train stopped. The track where they were standing was sound and unharmed in any way. The leading wheels of the bogie had stopped about 2 feet from a rail joint, this may be seen from a reference to the blue plan attached and to photographs A and B. Had this coach travelled another 6 feet this bogie also would have been derailed as the left hand rail at that very joint was not linked up in line but was lying on its side towards the middle of the track (*vide* photographs A and C).

Free and uninjured rail →

↑
loose nuts and bolts.

Beneath trailing bogie of last coach shewing rail joint opened out, freed rail lying on side and pushed into centre of track, absolutely unharmed. Opened out fish bolts and nuts lying also unmarked.

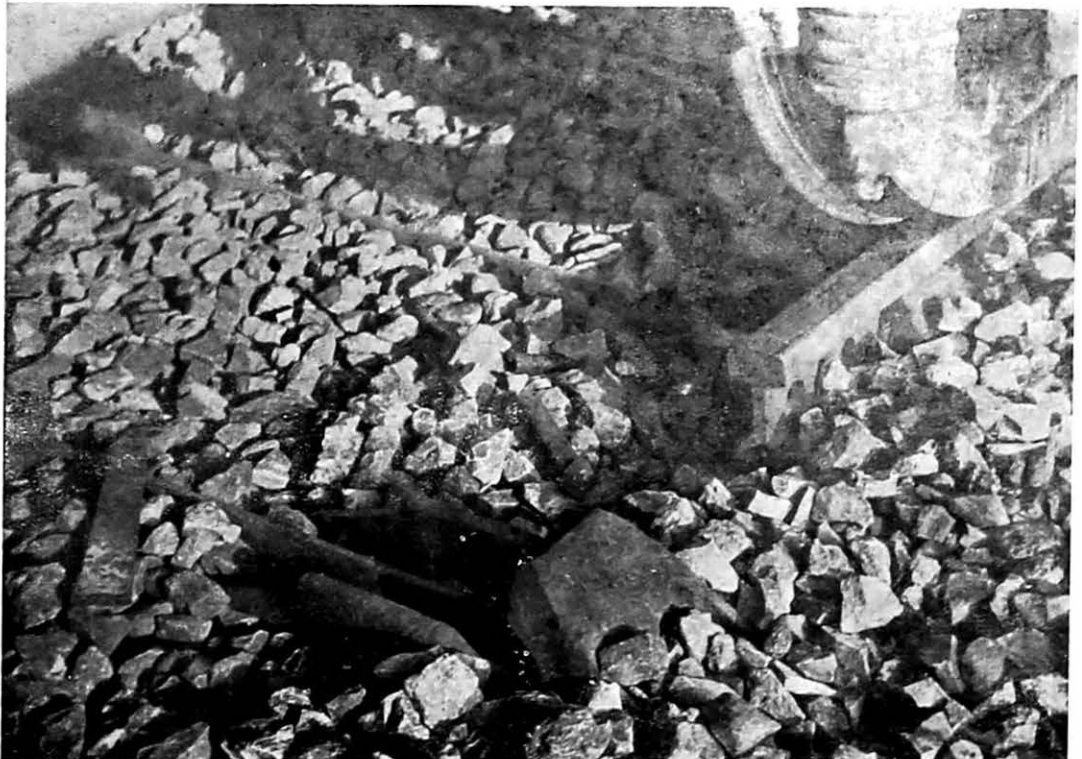
B

34. The fastenings of the D & O plate sleeper lend themselves to easy opening out and removal. The fourteen sleepers to this rail had all had their inner jaws carefully removed, almost every one was to be found undamaged close alongside and the majority of the cotters also undamaged, the outer jaws of the same sleepers being more or less in their original position and smashed by the impact of wheels on them.

End of free rail →

Undamaged cotter →

↑
Outside jaw bearing marks of wheel blows and broken through at face.

↑
Opened out bolts and nuts lying on ballast.

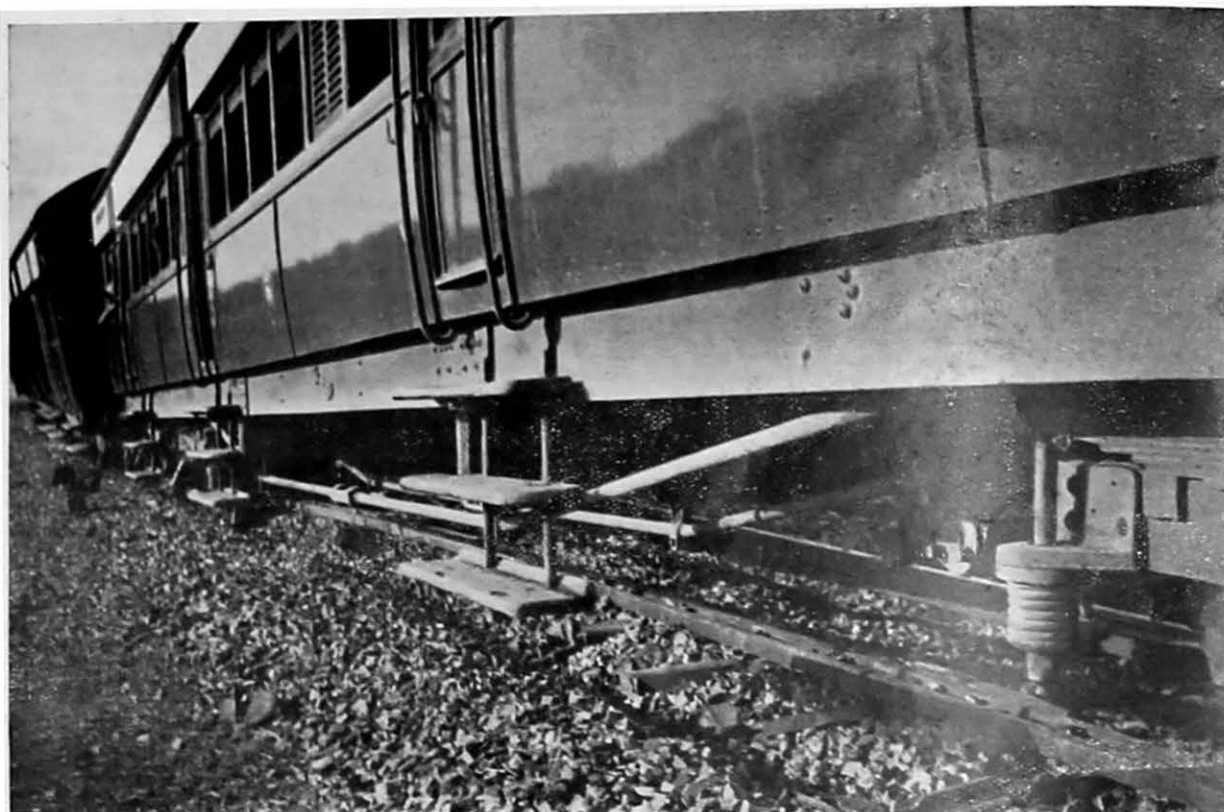
C

Looking forward beneath last coach shewing freed rail turned over and pushed into centre of track, lying across tie bars.

Note churned up pieces of ballast thrown onto web of rail.

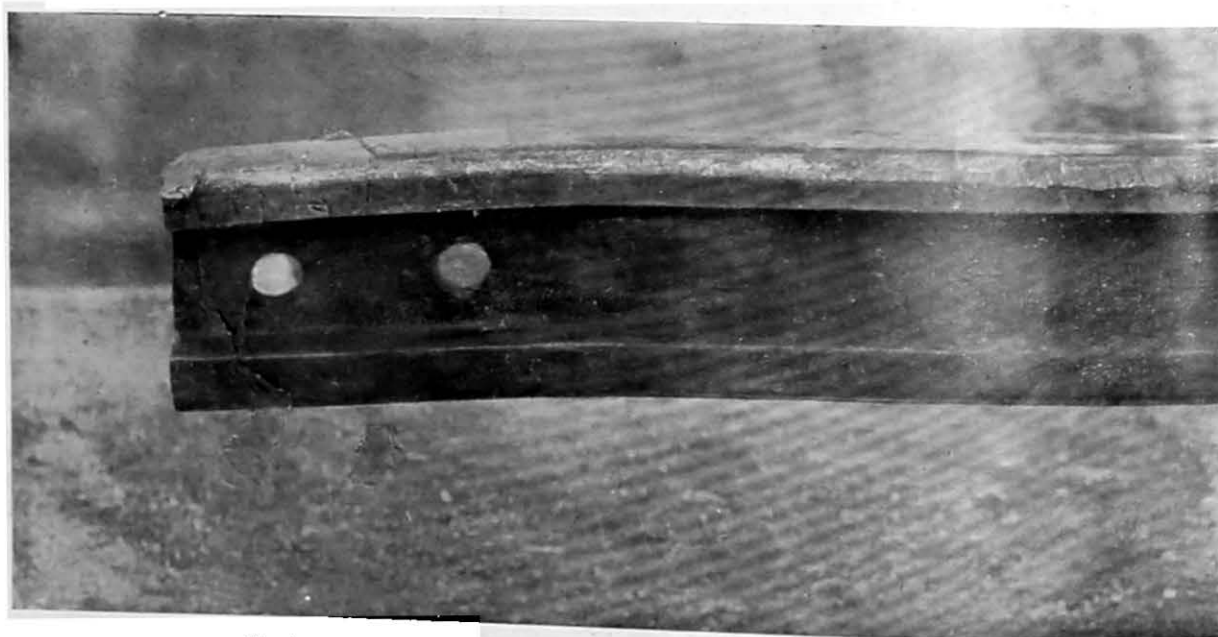
35. The second rail was found lying half way down the bank badly bent and twisted and bearing the mark of a heavy blow at the end where it should have been protected by its adjacent rail had they been coupled up. The force of this blow has even bent the rail downwards. At the opposite end of this 2nd rail the fish bolt holes shew signs of the force with which the fish-plates were stripped off when the bolts were sheared. This evidence makes it clear that the rail lying in the middle of the track had been carefully removed and pushed there before the arrival of the train. It is a physical impossibility that anything else could be the case.

39. This method of derailment by opening out a rail is by no means new, nor is the running of the gap, so made, by the wheels of the train new also. Photographs D and E shew a rail opened out at Bhadaura on October 16th last year. On that occasion after removing the fastenings the rail was merely turned over onto its side but left in alignment by the miscreants who did it. The result was that the whole train, engine and all, ran the gap with the exception of the last vehicle only which was smashed. In that case two wheels of the engine did derail but the *seven* coaches following kept perfectly straight and rerailed themselves on the track after running the gap. They all ran along the flat of the turned down rail and bumped up onto the exposed end of the next rail. The flat rail shews its bend under the repeated blows as the wheels dropped onto it. Photograph E shews the bruised end of the opposite rail as they mounted it. A comparison of this photograph with photograph F shews the exact similarity of the blow that the rail in this Hazaribagh accident received.

Facing end of exposed 2nd rail which received full impact of engine wheels. Note mark of blows bend of rail and distorted fish bolt holes.

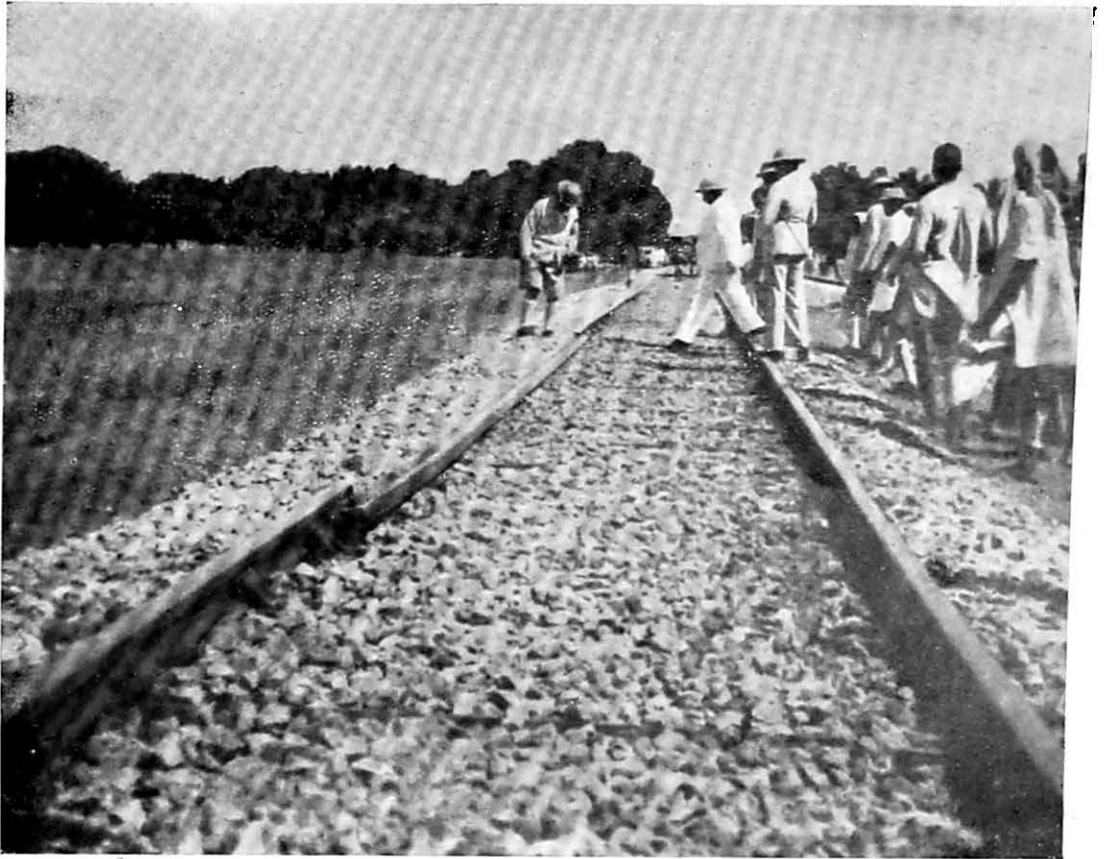
D

Note bend of rail caused by impact of wheels→

View of similar tampering at Bhadaura in October 1938. Rail was turned over in exactly same way but was not pushed into the centre. Hence engine and seven coaches ran the gap after impinging on the 2nd rail thus

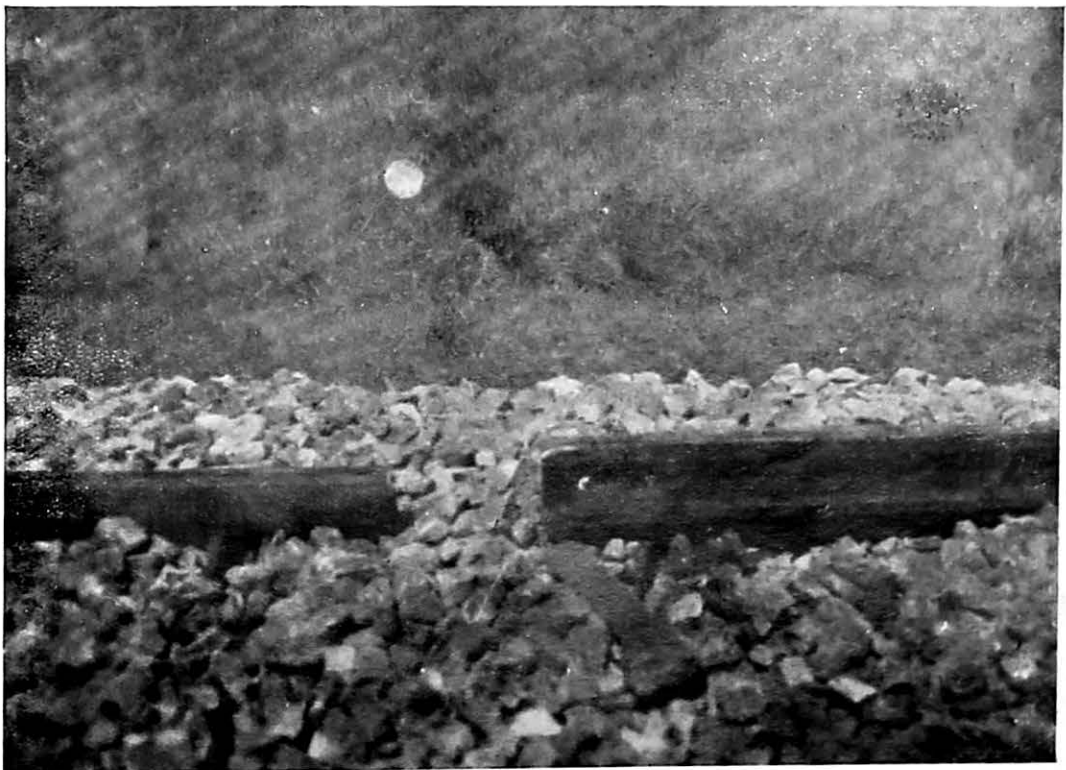
E

Side view of above rails at Bhadaura shewing nature of blow on 2nd rail (compare with photo F.)

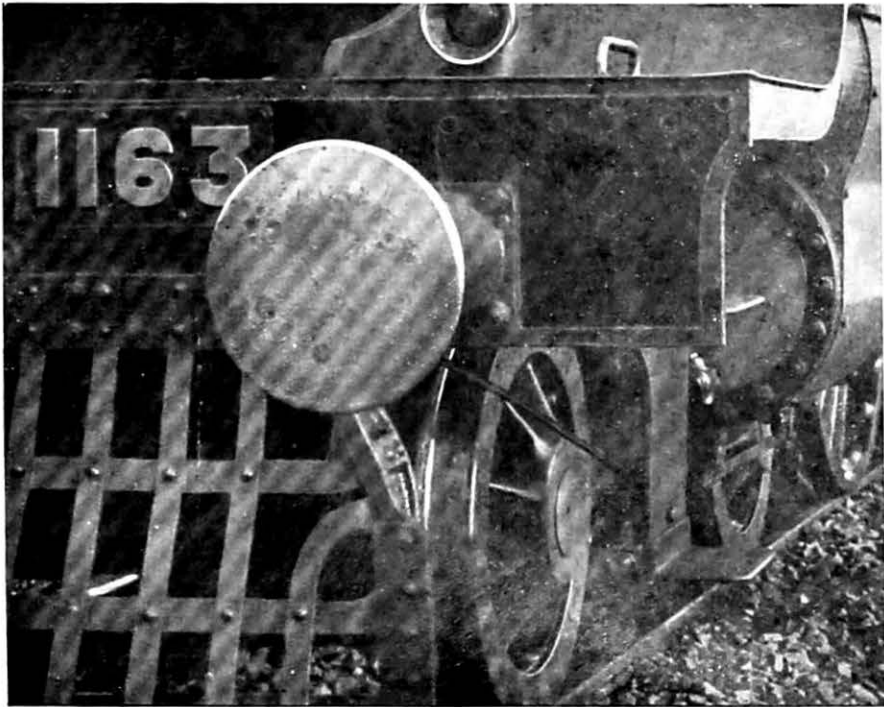
G

↑
Front view of engine leading bogie wheel shewing marks of impact on rail end.
