RAILWAY ACCIDENT INVESTIGATION REPORT

Occurrence of casualties among passengers of 7 up Tinsukia Mail train at Km./77/3-4
between Pathsala and Tihu Stations on the Single Line New
Bongaigaon Gauhati Metre Gauge Section of
Alipurduar Division of Northeast
Frontier Railway at
13-09 hours
on
12 th March, 1981

Date : 12-3-1981.
 Time : 13.09 hours.
 Railway : Northeast Frontier.
 Gauge : Metre Gauge (1000 mm).
 Location : Km. 77/3-4 between Pathsala and Tihu stations on New Bongai-
gaon-Gauhati Section.
 Nature of Accident : Occurrence of casualties to passengers of 7 Up Tinsukia Mail.
 Trains involved : 7 Up Tinsukia Mail consisting of YP class steam locomotive
No. 2074 and 9 coaches.
 Speed : 30 Km/h.
 System of Operation : CTC Section provided with Absolute Permissive Block Signal-
ling.
 Number of track : One.
 Gradient : 1. in 1000 rising.
 Alignment : Straight.
 Weather : Clear.
 Visibility : Good.
 Cost of damage : Nil.
 Casualty : Killed — 1
 Grievous — 3
 Simple — 10

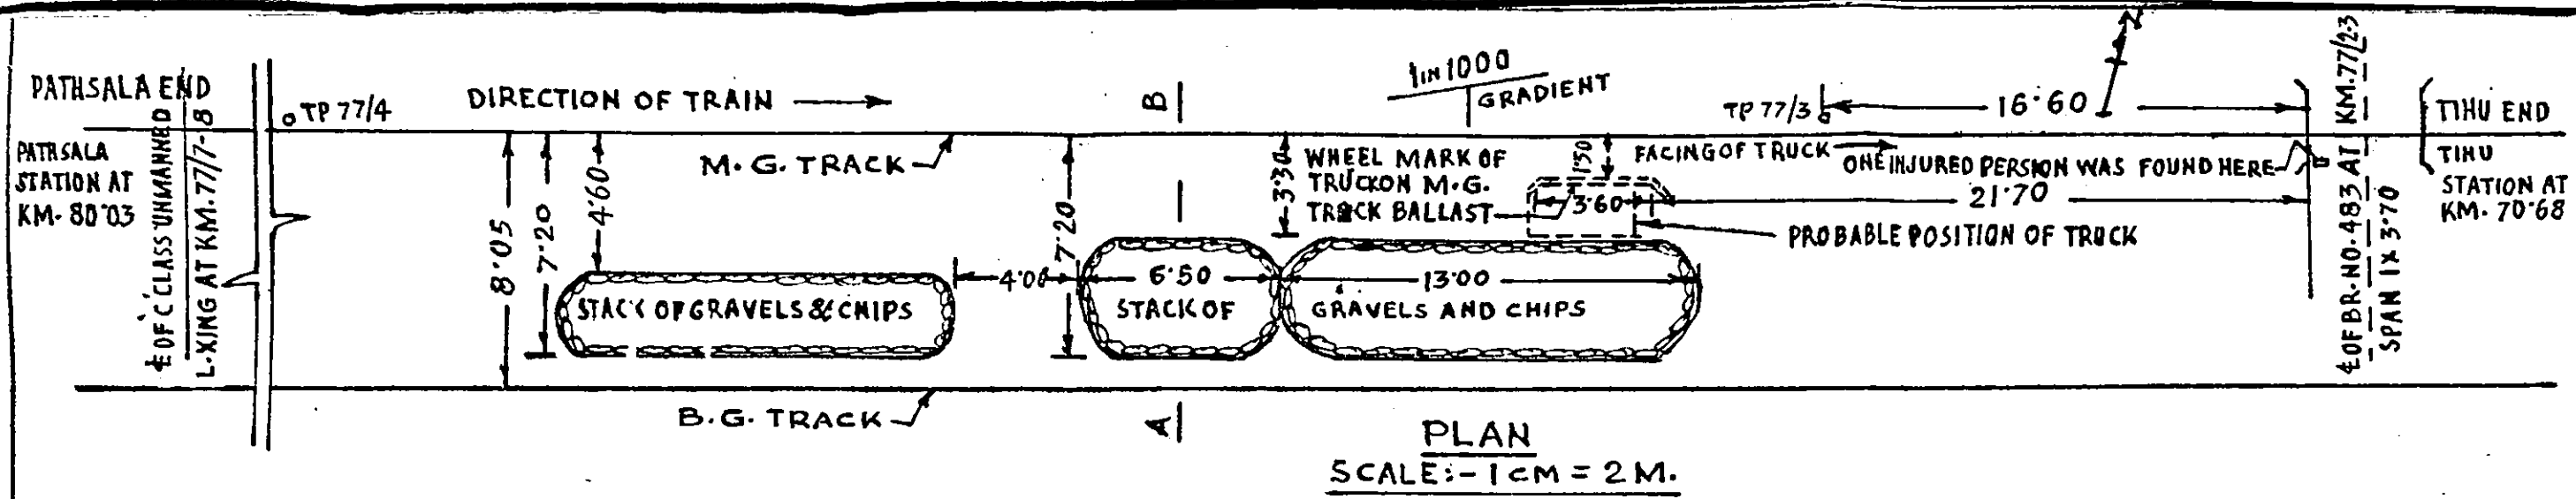
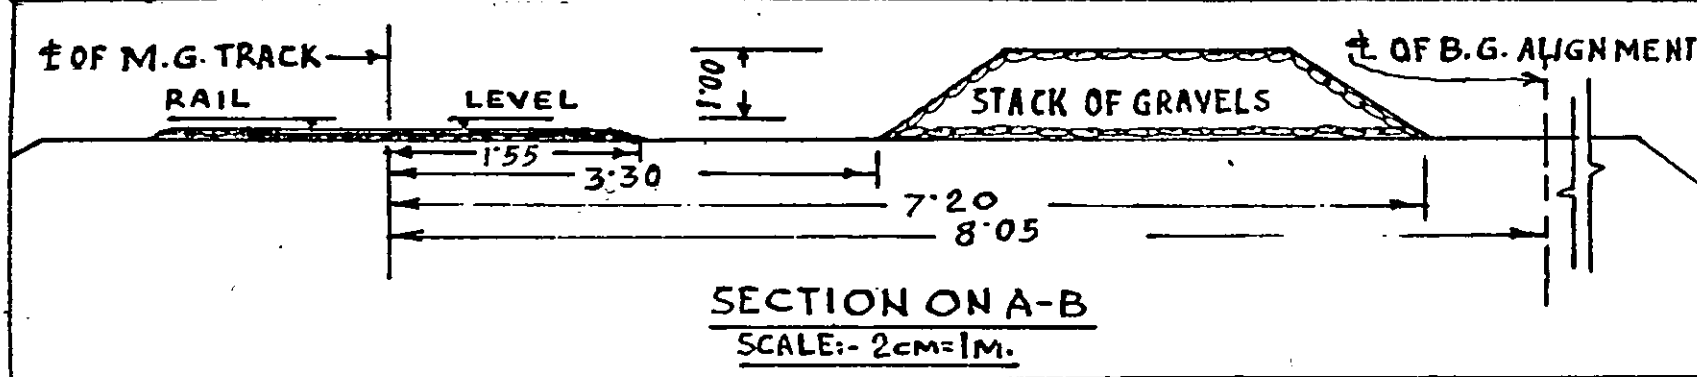
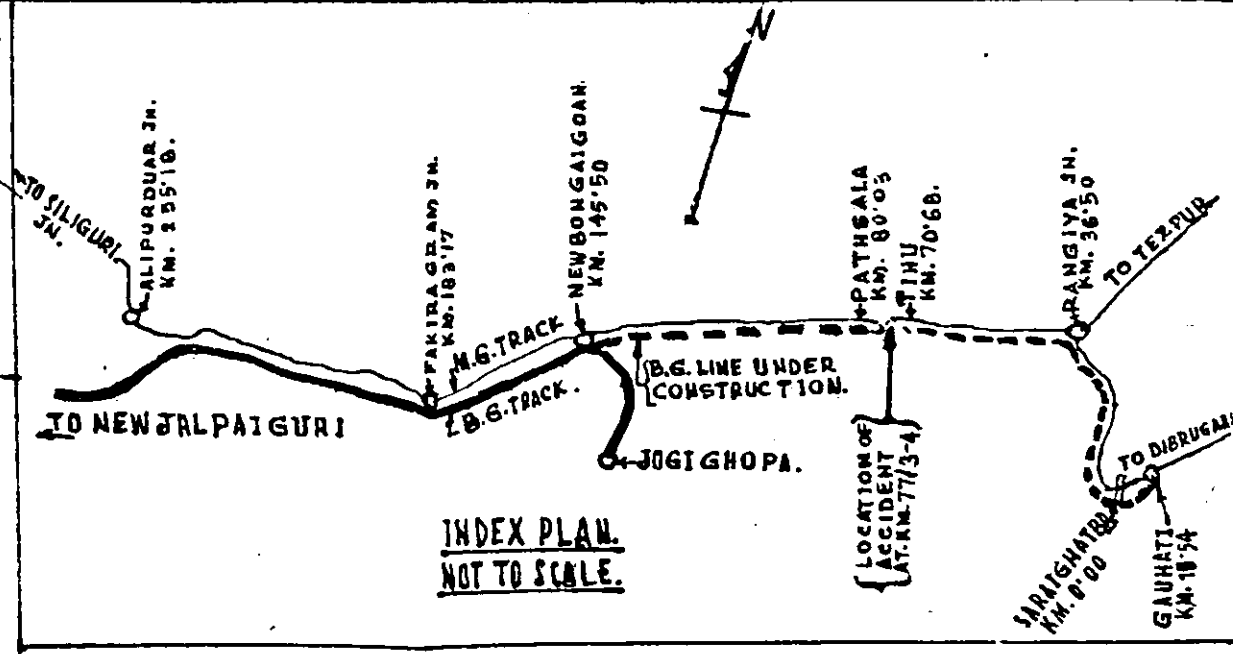
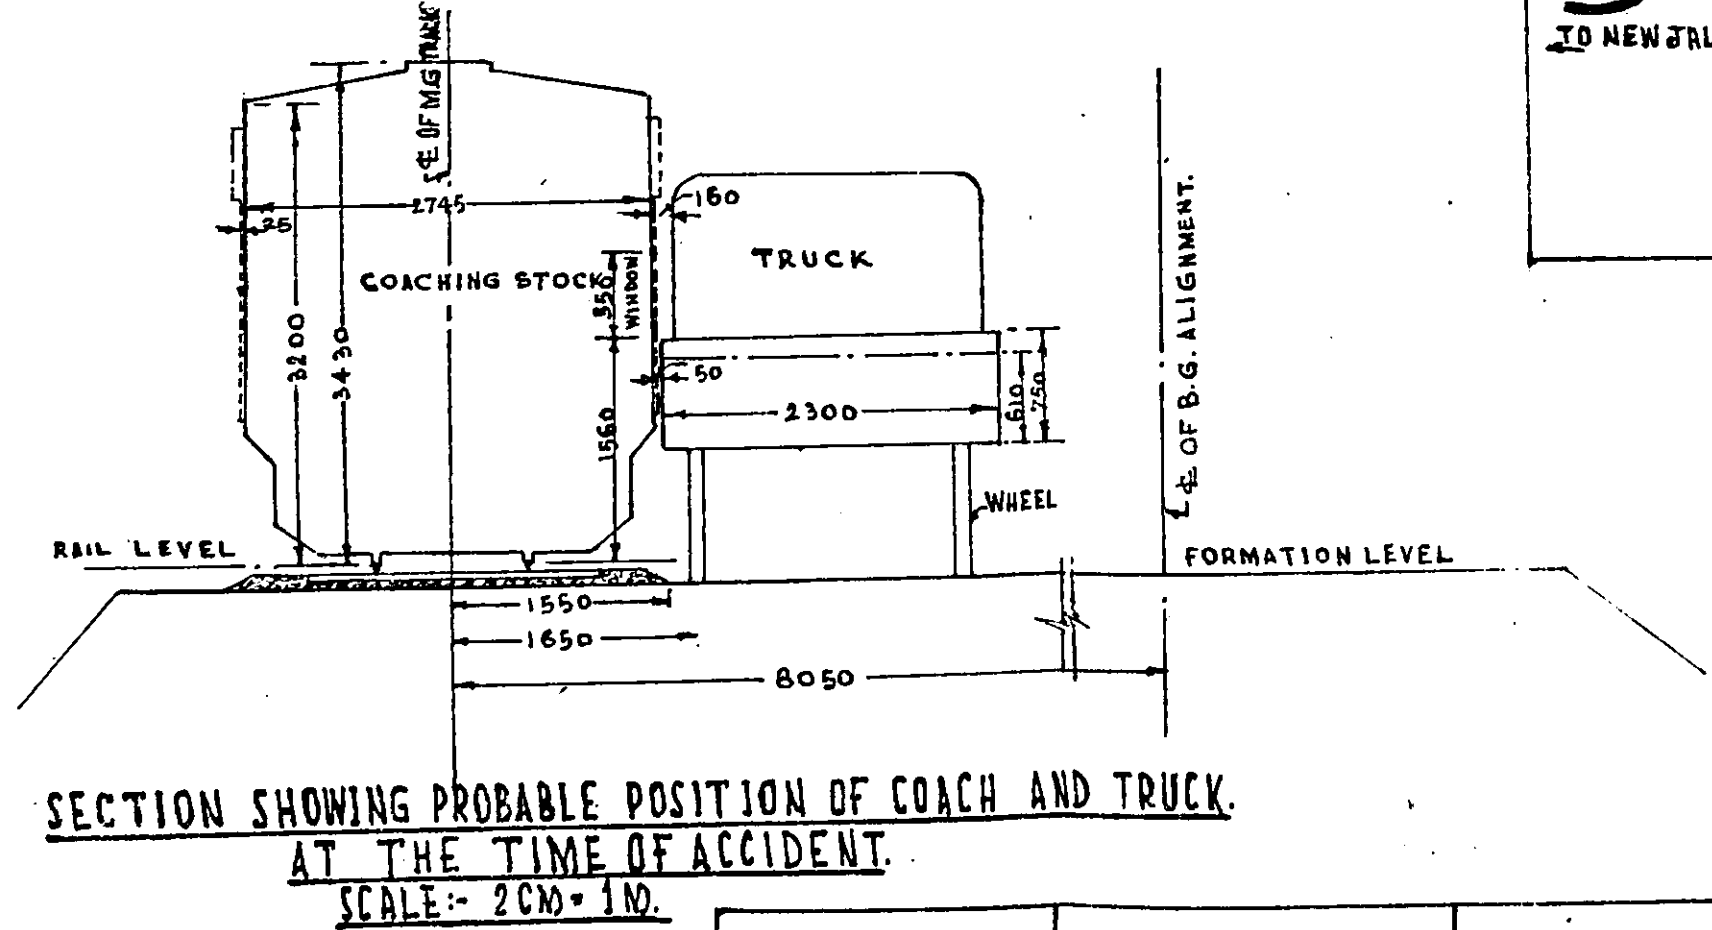
| CHD. | | AT KM. 77/3-4. BETWEEN TIHU AND PATHSALA. SKETCH IN CONNECTION WITH ACCIDENT OF 7UP ON 12-3-81. |

6.1.2 It was explained by the Executive Engineer (Con) that when the earlier trips were unloaded in the presence of the IOW, the trucks were unloaded by stopping them about 60 metres short of the Bridge No. 483 and well clear of the line demarcated at 2.5 m. from the centre line of M.G. track. The unloaded material was then carried forward by manual labour and stacked. However the particular truck which caused the accident, having come there for a first time, seemed to have stopped in the 3.3 m. distance between the metre gauge track and the stacks already made.

In this position it was observed that the truck would be fouling the moving dimensions of the metre gauge track.

6.1.3 It was stated by the Divisional Engineer that soon after the accident some wheel marks were found on the ballast shoulder of the metre gauge track at a distance of 1.5 metres from the centre line of the track. The truck standing in this position would have fouled the metre gauge track sufficiently to have been hit by the locomotive and to be smashed up. Therefore these marks should have been made while the truck came in before and went back soon after the accident.
