Railway Accidents

Reports by the Government
Inspectors of Railways of
Inquiries into Accidents

Half-year ending the 31st March 1927

**ACCIDENT TO 86 DOWN MAIL TRAIN AT AMRITSAR ON THE
9TH OCTOBER 1926.**

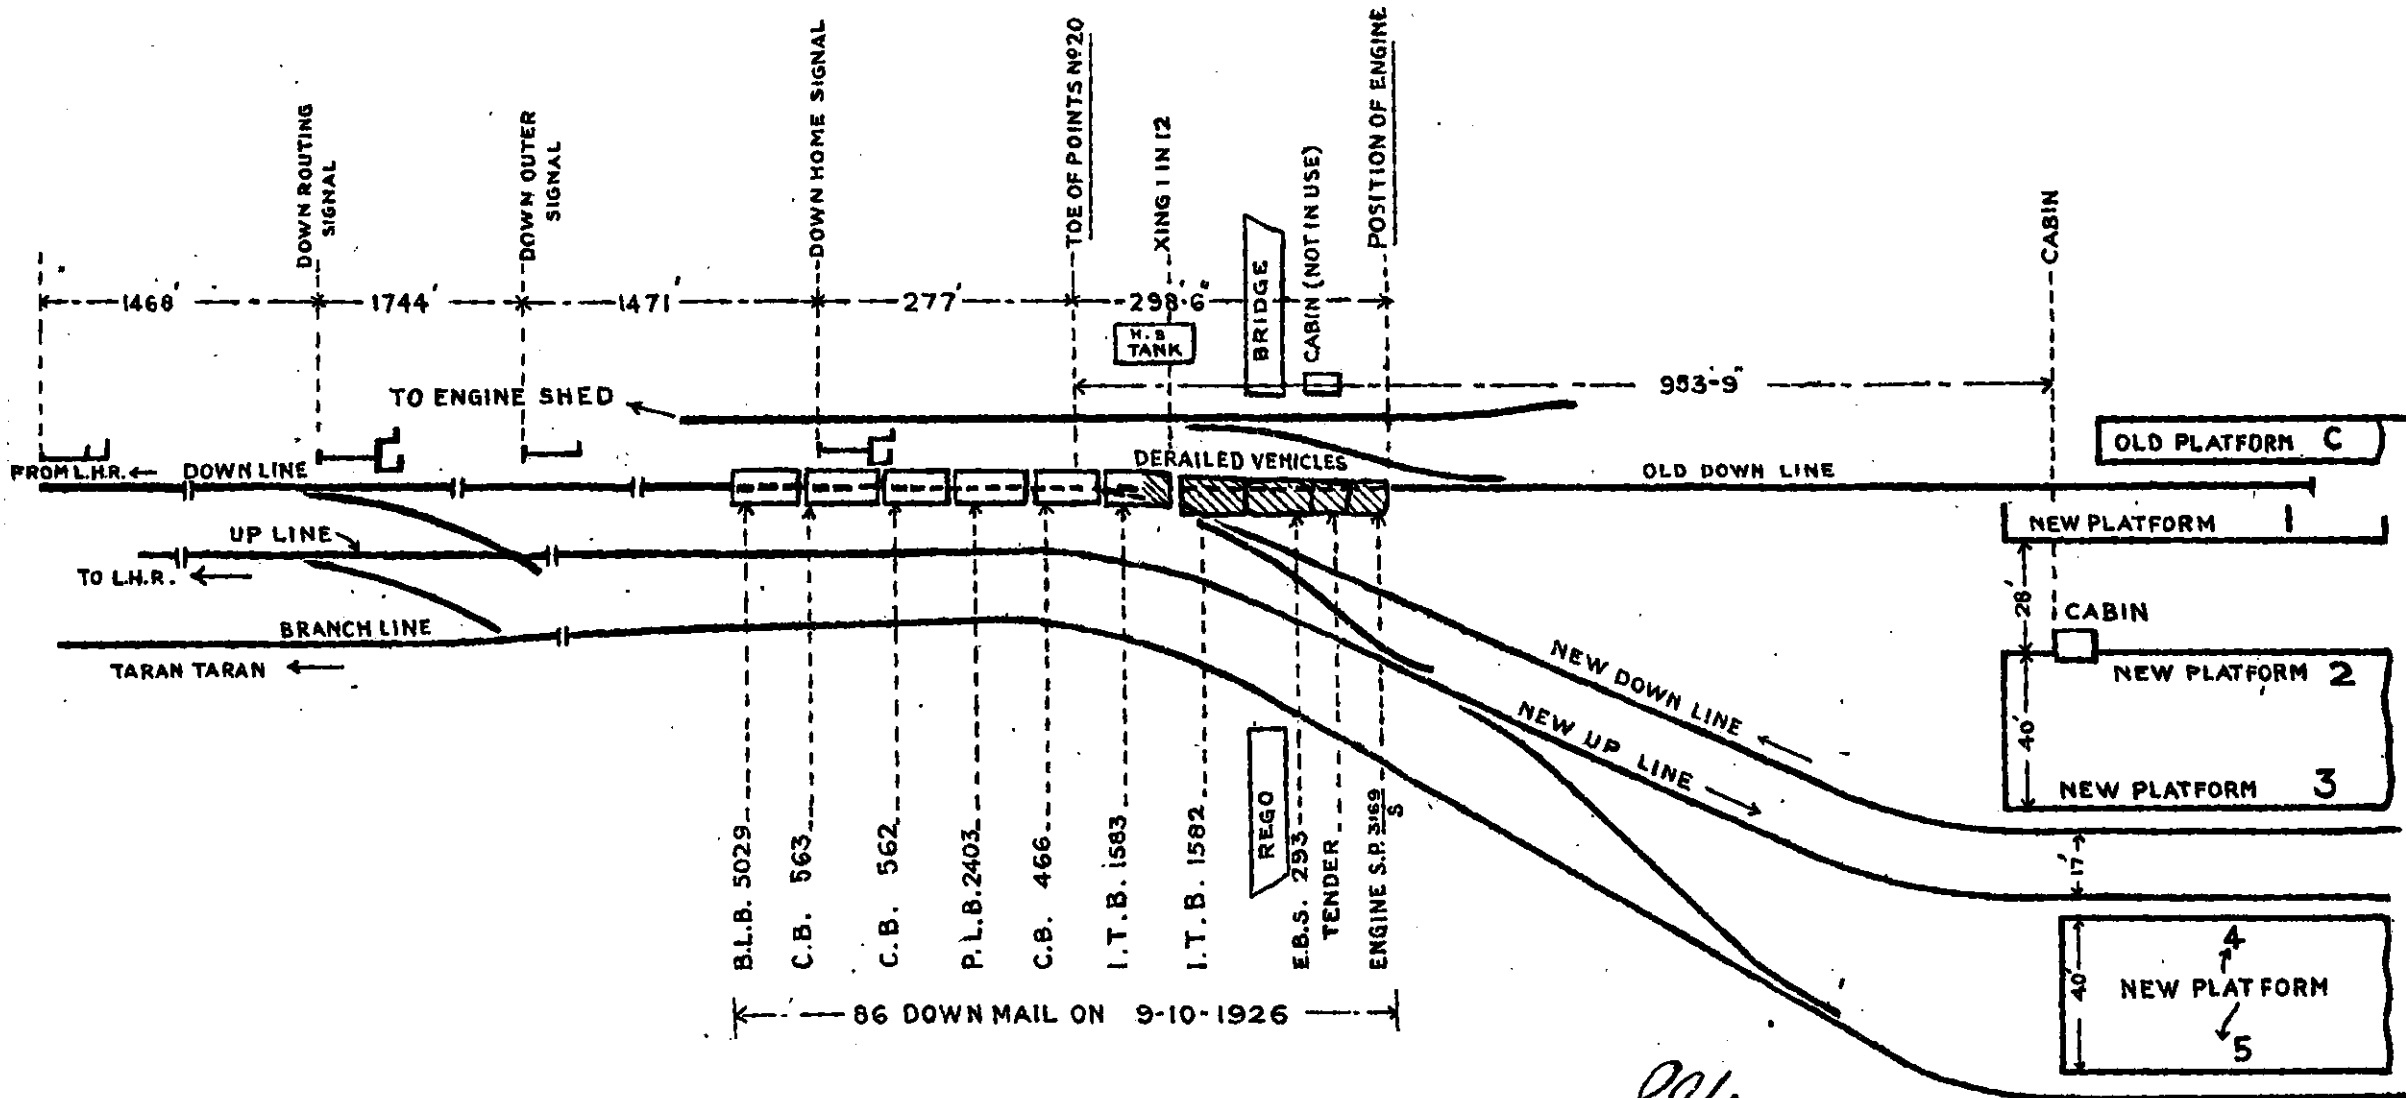
ROUGH SKETCH SHOWING POSITION OF DERAILMENT OF 86 DOWN MAIL OCCURRED ON 9TH OCTOBER 1926 @ 22.55 AT AMRITSAR

4. When entering Amritsar yard the engine left the track at facing points No. 20 which were correctly set and locked for the turnout to No. 3 platform. The engine and two leading bogie coaches were completely derailed, and the leading wheels of the third bogie coach were also derailed. The second bogie on the train which was an intermediate and third class coach telescoped partly into the leading bogie coach which was a 1st and 2nd class composite.

9. The derailment took place at facing points No. 20 in the Down main line at the Lahore end of Amritsar. These points are 1,575 ft. from the centre of the present Down main line platform, No. 3.

11. All the evidence shows that the signals were correctly lowered and that Points No. 20 interlocked with them were also correctly set and locked. An examination of points No. 20, and the west cabin after the accident showed that if the switch were gaping even $1/16$ of an inch the locking bar could not be worked and the home signal could not be lowered. The points could not therefore have been gaping and there was nothing to show that any wheel could or did pass between the switch and stock rail. The points however were packed with a mixture of ballast and cinders and had not been sufficiently long in the line to be firmly bedded and it was also noticed that at the toe of the switch the track was about $3/16$ inch lower than the track 5 ft. in advance. I am therefore of opinion that the derailment occurred by the leading wheels of the engine mounting the switch and stock rail, particularly as the wheels of the coaches took the correct road.

20. Finally as regards the cause of the accident I am of opinion that it was due to the Driver travelling at excessive speed when taking the turnout at points No. 20, which were not truly level and had not been sufficiently long in the line to be firmly packed and bedded.

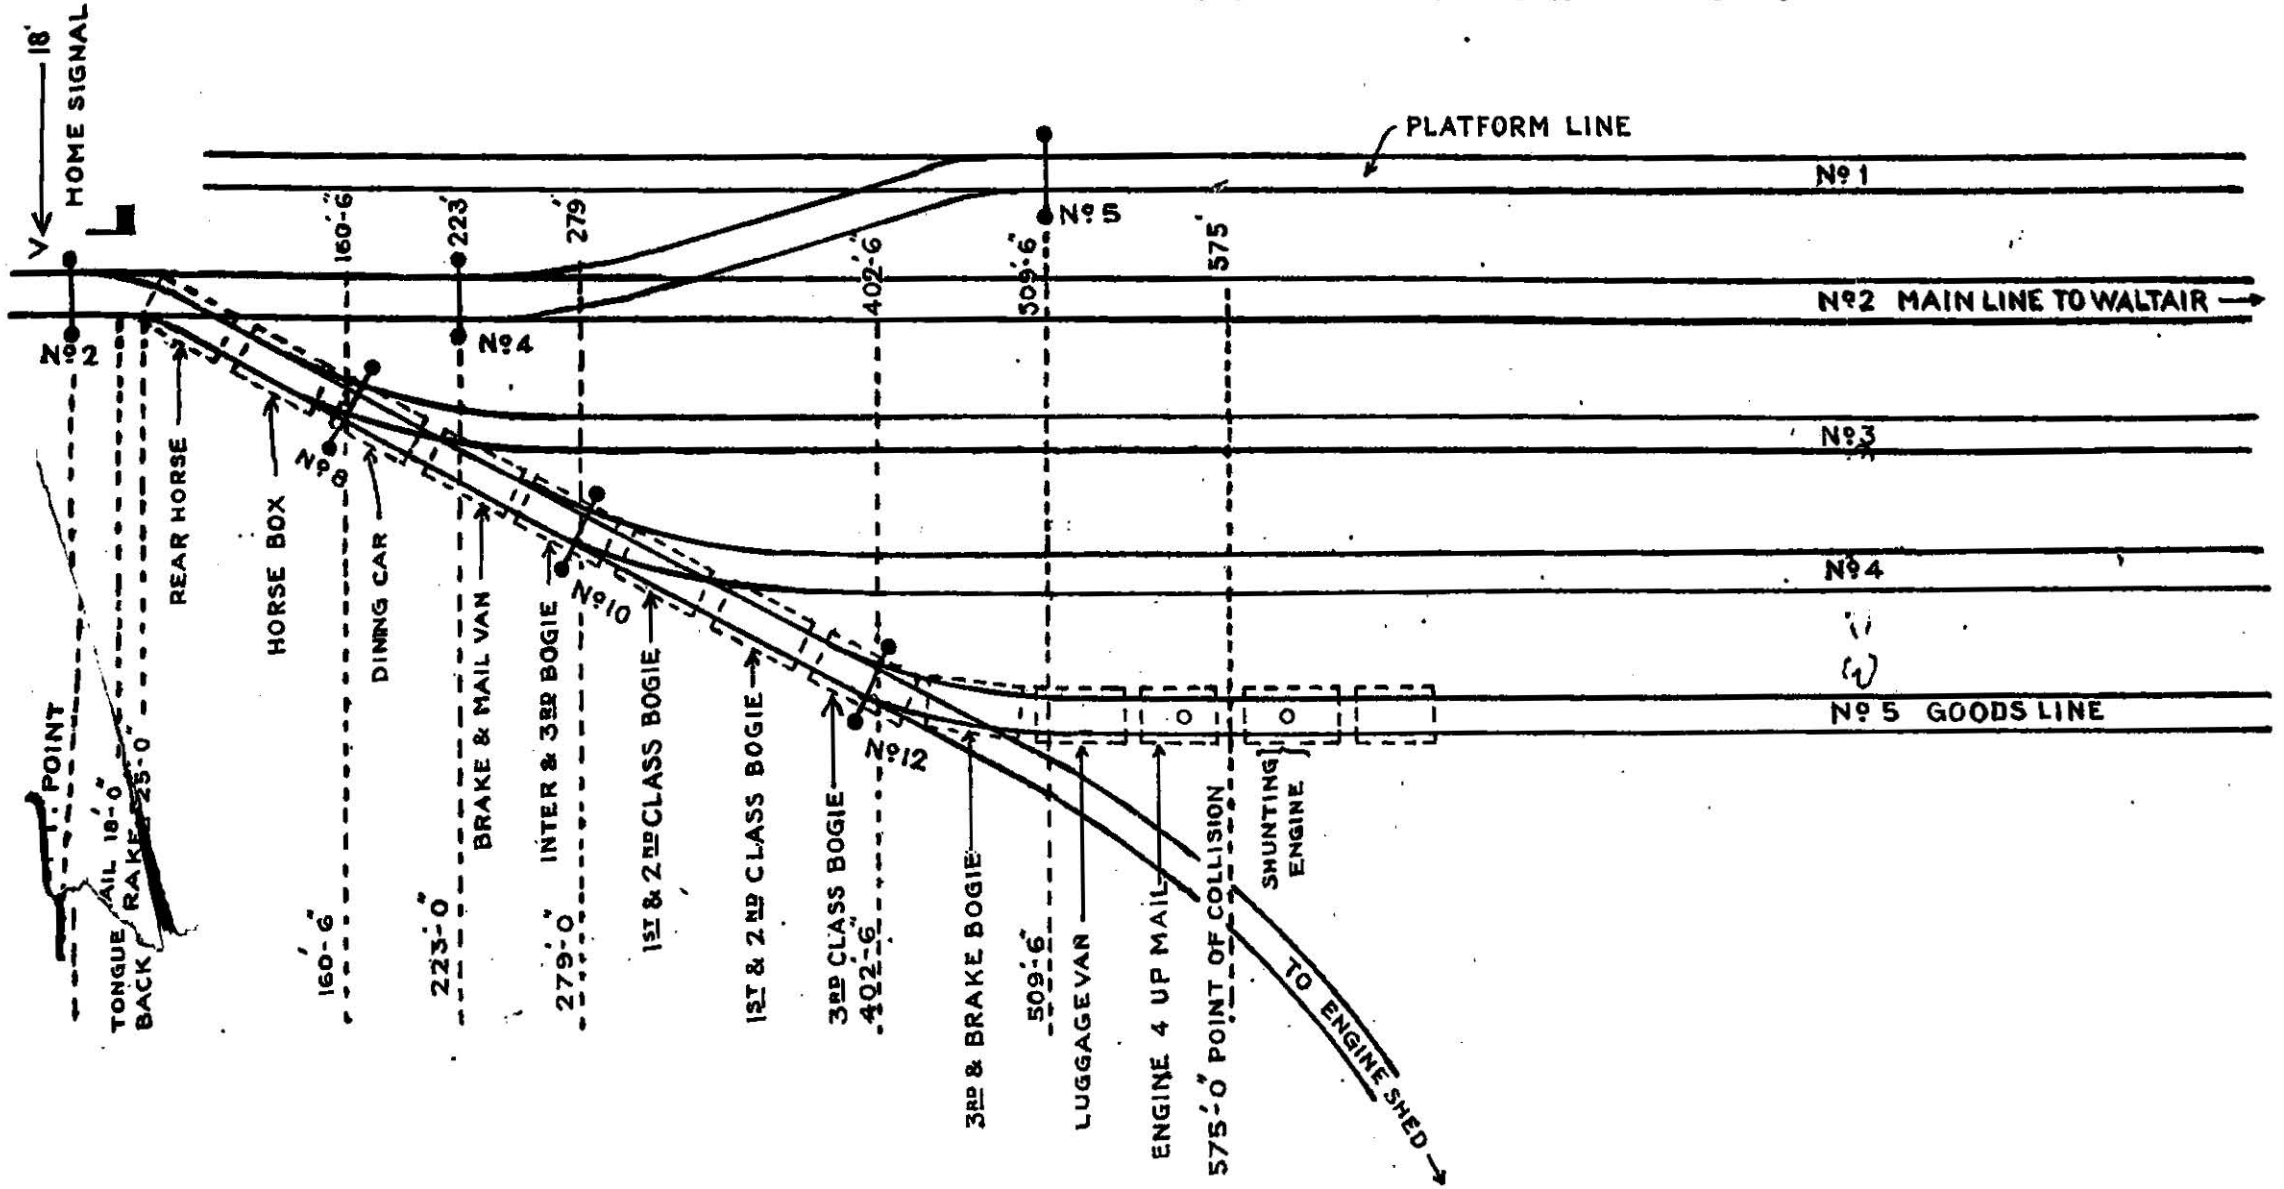
PLAN SHOWING SITE OF ACCIDENT AT BHADRAK STN ON 13-3-27

5. *Description of the Accident.*—On the night of the 13th March 1927, 6 Up Puri Passenger was received at Bhadrak on the platform line (No. 1) at 21-54 and the train left at 22-7. Markona asked Line Clear from Bhadrak for 4 Up Madras Mail at 21-58 and Line Clear was given at 22 hours. The train ran through Markona at 22-18, and at 22-30 at Bhadrak collided with a shunting engine (tender foremost attached to wagons on Goods Line No. 5 at a point 575 feet from the facing points. The composition of the 4 Up was one luggage van, 7 bogie vehicles, and two horse boxes. The luggage van, the whole of the body of the second vehicle, and half the body of the third both 3rd class carriages, were smashed to pieces in the telescoping that followed the collision and one Upper Class Composite carriage was derailed. 14 passengers were killed and 66 injured. One Pointsman, standing near the shunting engine was killed, the Drivers of both engines and one fireman were injured. The damage done to rolling stock is estimated at Rs. 75,000 approximately. Shortly after the accident the points were found set and locked for the correct line.

10. I am of opinion that the wrong setting of facing points No. 2 was the cause of the accident, and for this, Points Locker Surya Narayana was responsible.

12. (a) The remodelling of Bhadrak Station, which has been under consideration for some time, should be expedited and should include the isolation of the Passenger Lines from the Goods.

(b) The observance of the 10-mile restriction, which is the principal safeguard at un-interlocked stations, should be more rigidly enforced at all such stations.
