Report of the  
commission of inquiry for enquiring  
into the failure of the Panohet and  
Khadakwasla dams.

**REPORT**  
OF THE  
**COMMISSION OF INQUIRY FOR ENQUIRING**  
**INTO THE FAILURE OF THE PANSHET**  
**AND KHADAKWASLA DAMS.**

1963

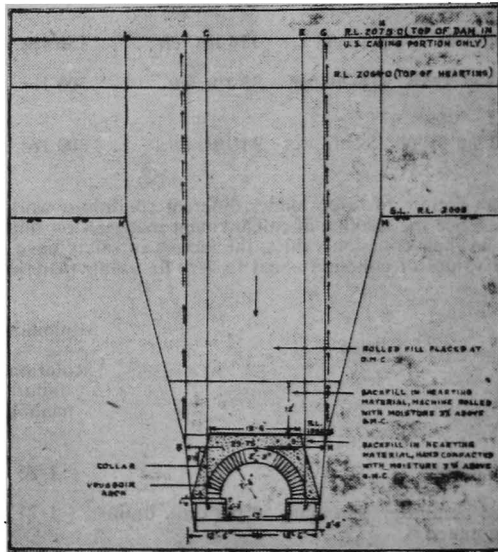
2. The following figure shows a vertical cross section through the conduit at the centre of hearing portion as constructed i.e. at the point from which the downstream portion of the arch has been washed away :—

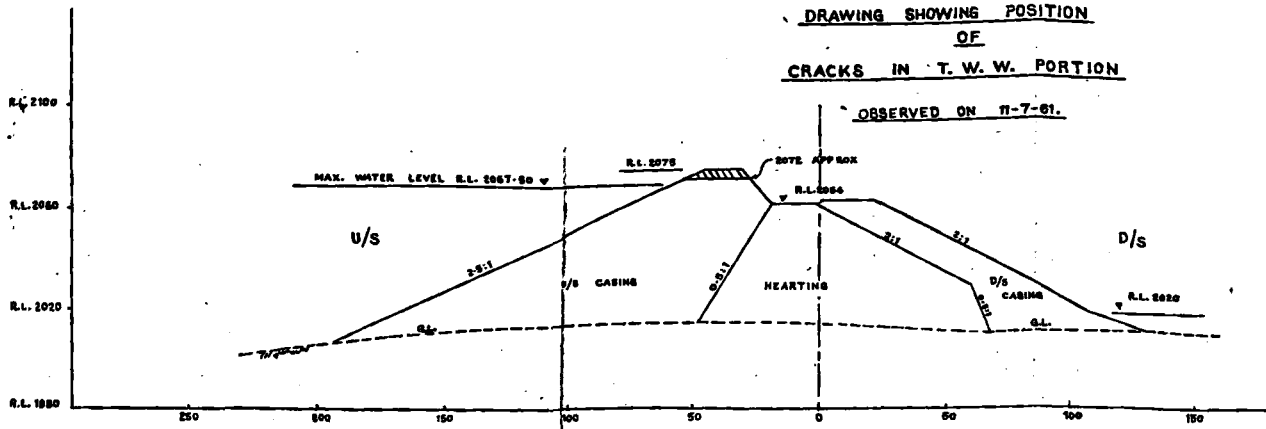
**DRAWING SHOWING POSITION  
OF  
CRACKS IN T. W. W. PORTION**

OBSERVED ON 11-7-61.

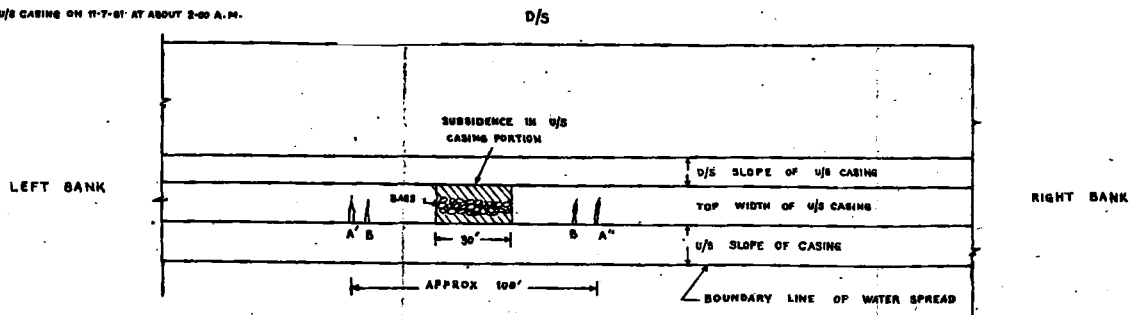
**CROSS SECTION OF PANSHET DAM IN THE T.W.W. PORTION  
(PORTION BELOW G.L. NOT SHOWN)**

NOTE:-  
THE SUBSIDENCE WAS FIRST  
OBSERVED IN THE HATCHED PORTION  
OF THE U/S CASING ON 11-7-61 AT ABOUT 2-00 A.M.

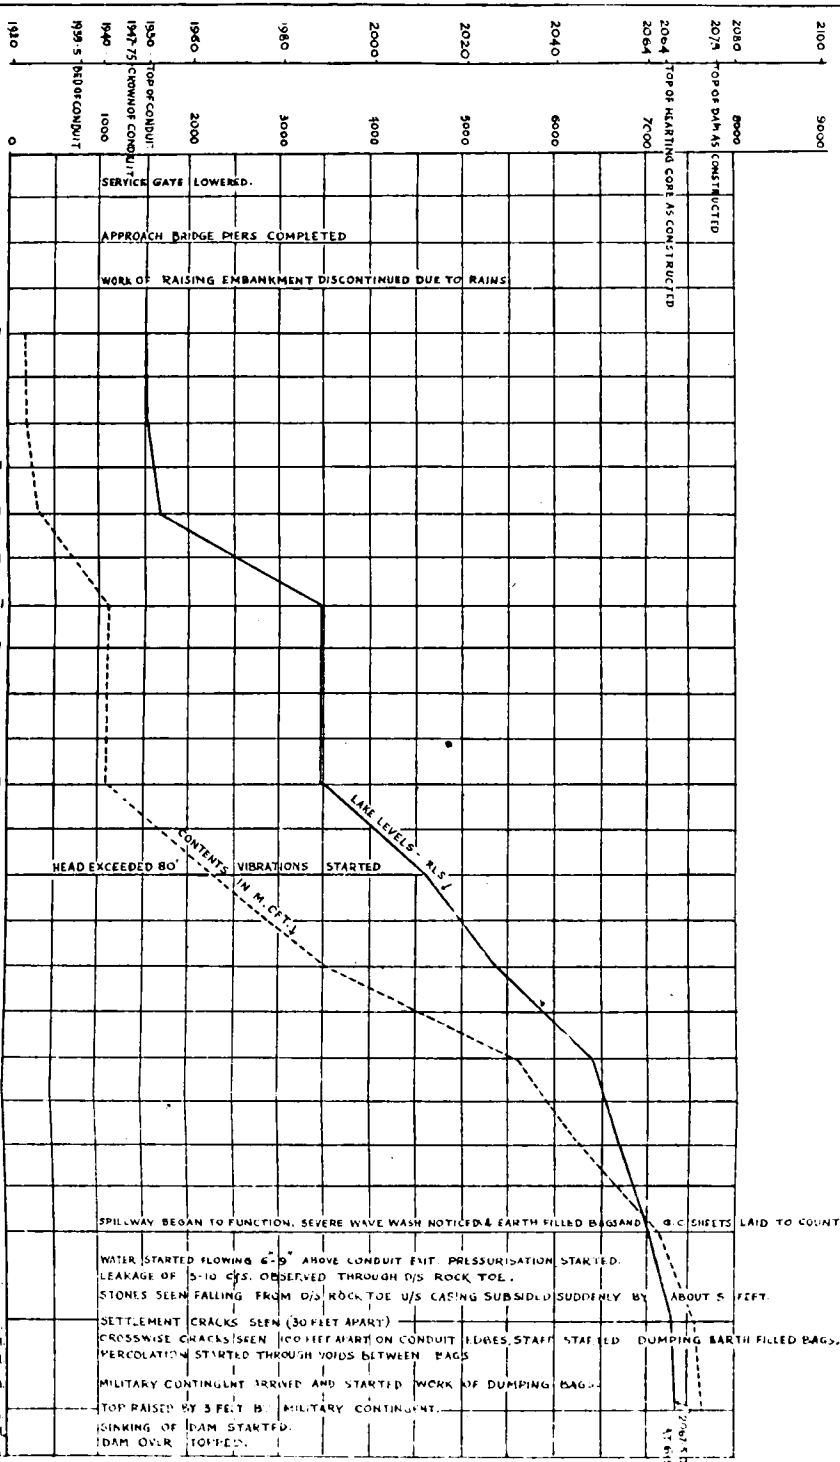
GRAPH FOR THE PERIOD FROM 10-6-61 TO 12-7-61  
 SHOWING

WATER STARTED FLOWING 4'-5" ABOVE CONDUIT ENT. PRESSURISATION STARTED. LEAKAGE OF 5-10 CFS. OBSERVED THROUGH D/S ROCK TOE. STONES SEEN FALLING FROM D/S ROCK TOE U/S CASING SUBSIDED SUDDENLY BY ABOUT 5 FEET.

SETTLEMENT CRACKS SEEN (30 FEET APART) CROSSWISE CRACKS SEEN (100 FEET APART) ON CONDUIT EDGES STAFF STAFFED DUMPING EARTH FILLED BAGS. PERCOLATION STARTED THROUGH VOIDS BETWEEN BAGS

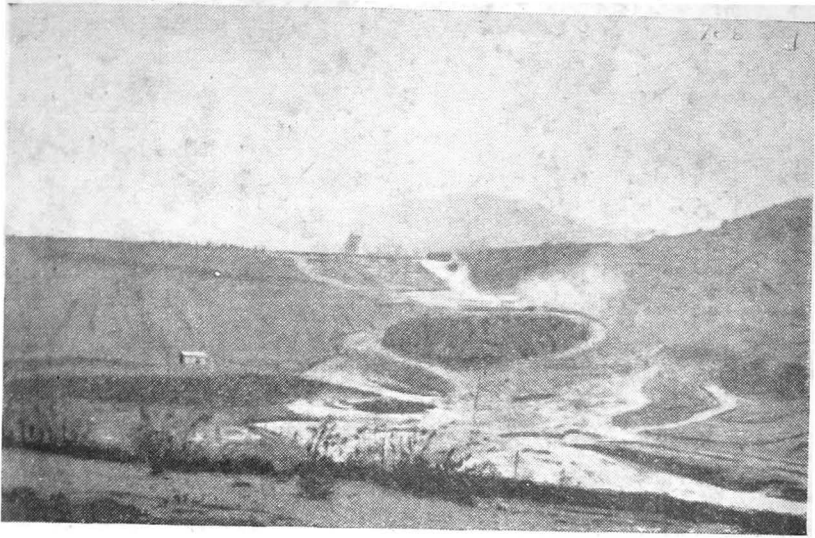
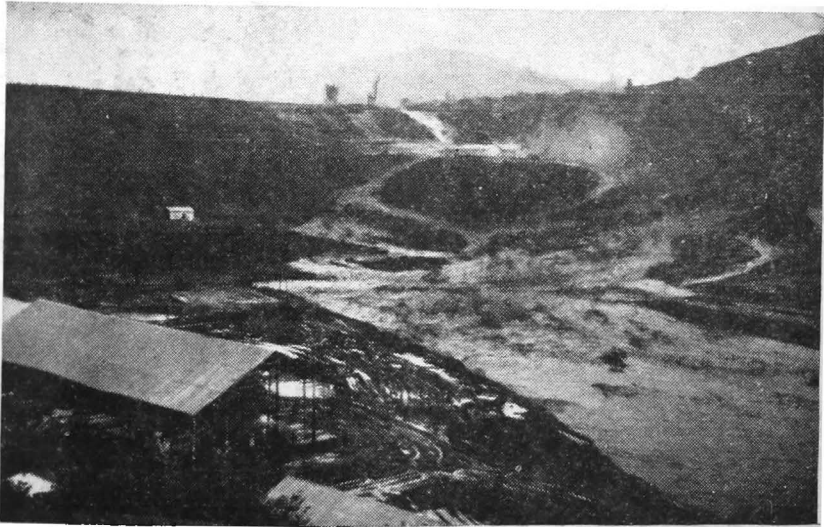
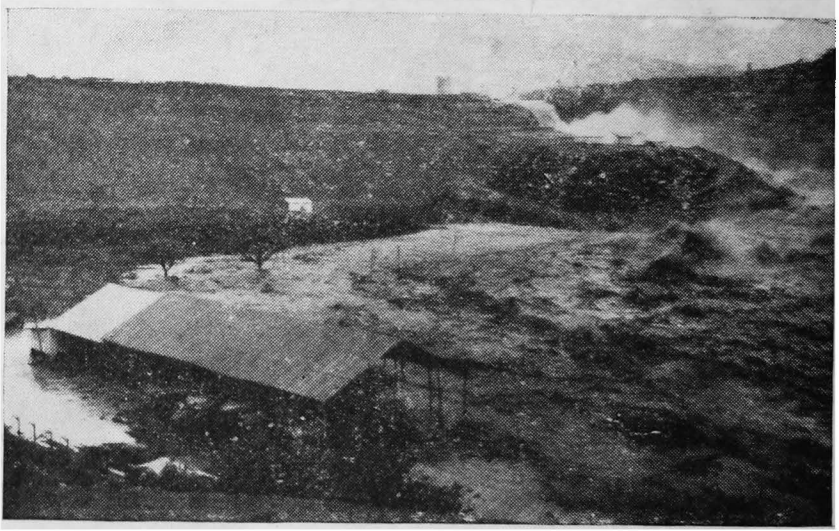
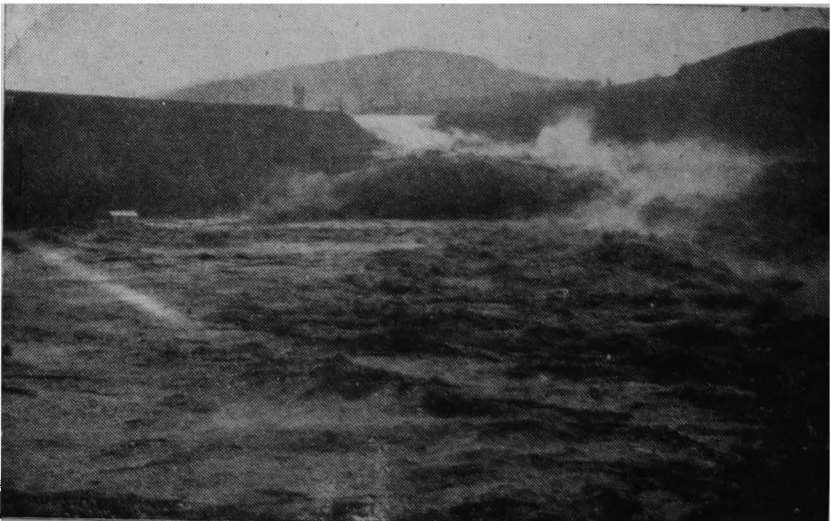
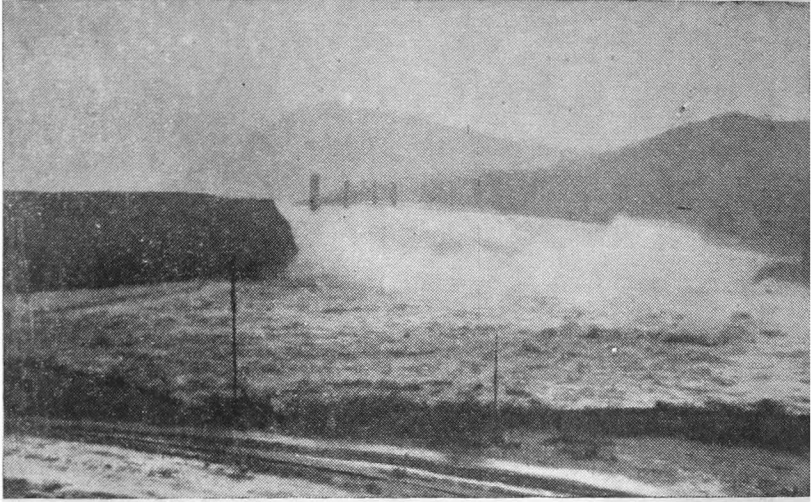
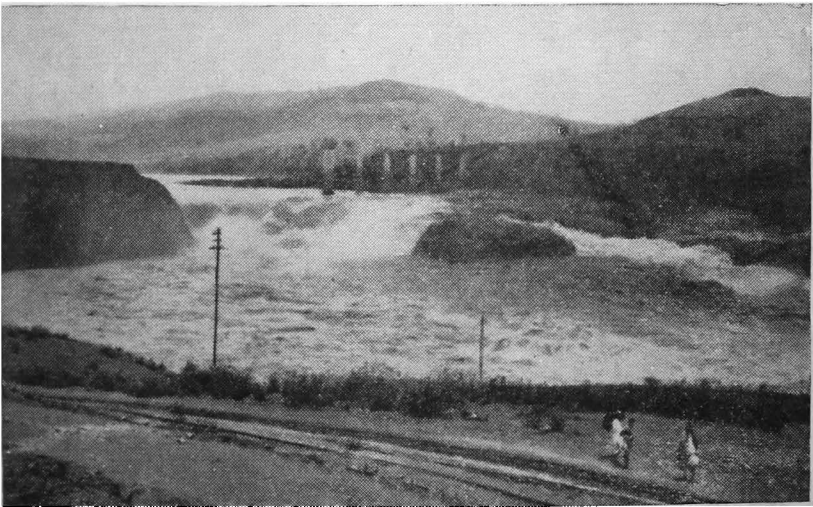
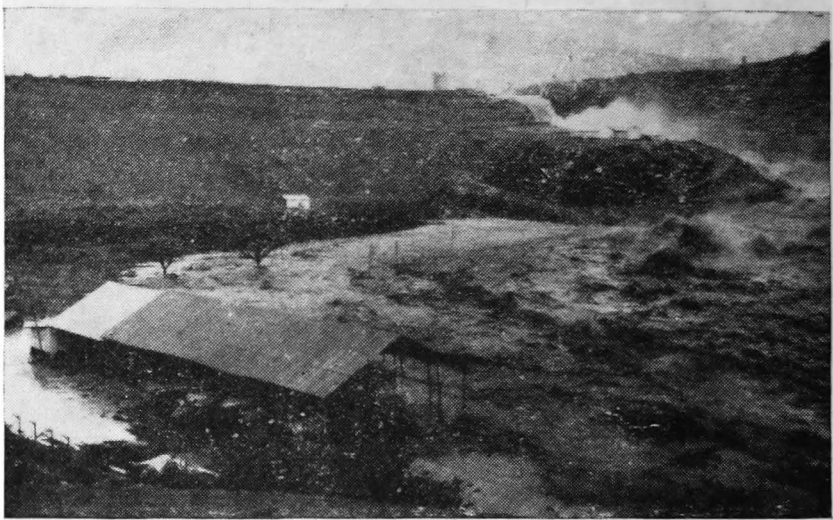
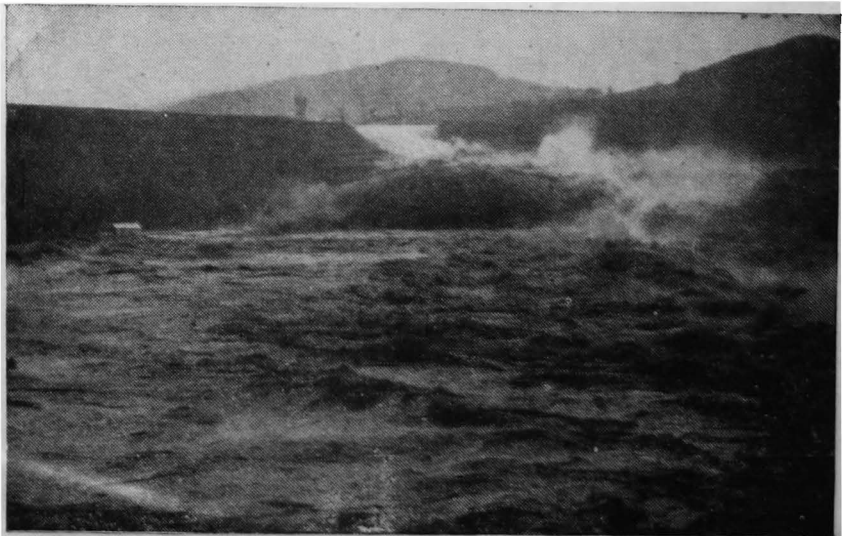
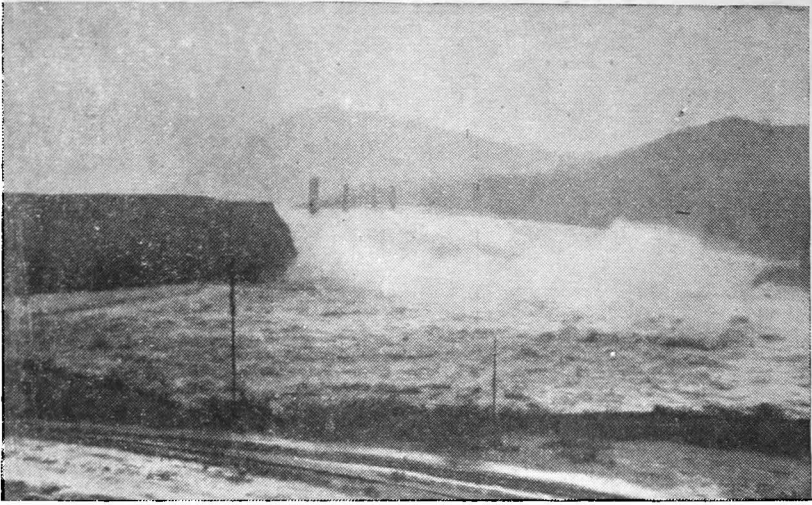
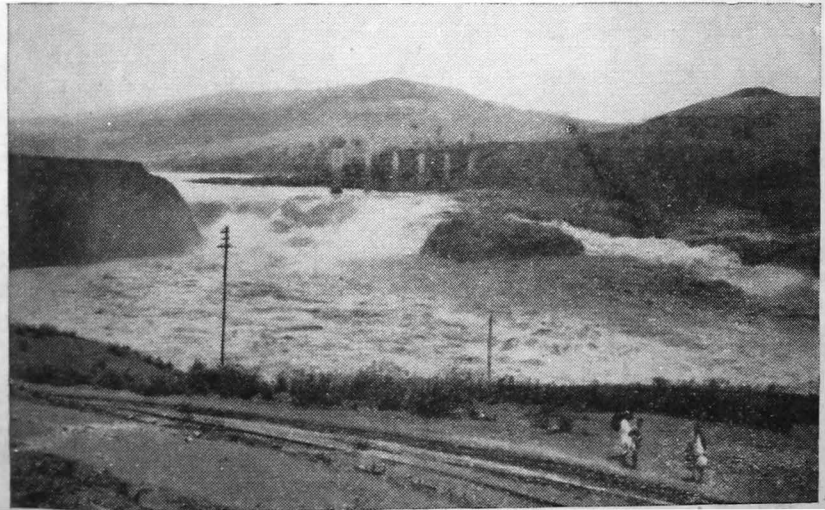
PLATE No. V (a)

**Photographs showing programme undermining of the dam in Temporary Waste Weir portion after overtopping**

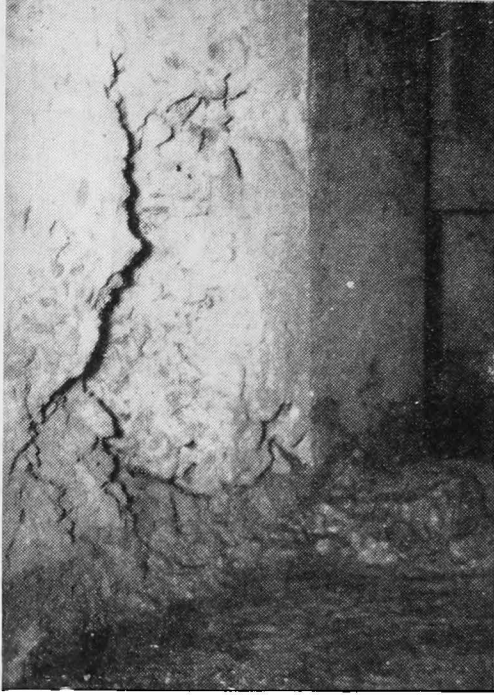
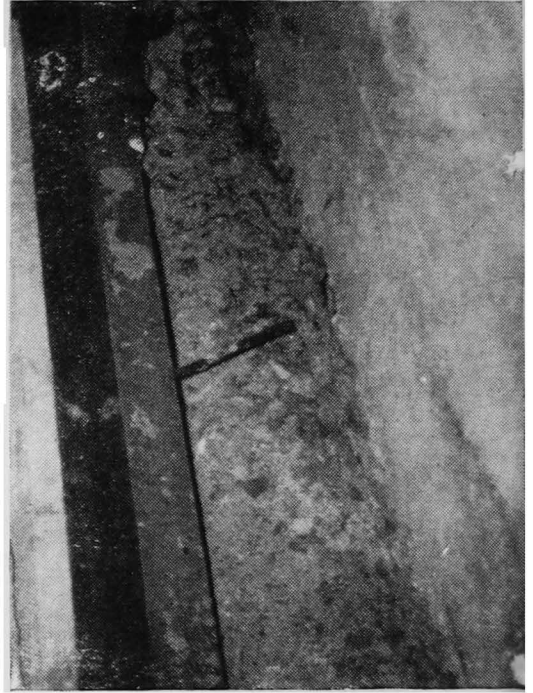
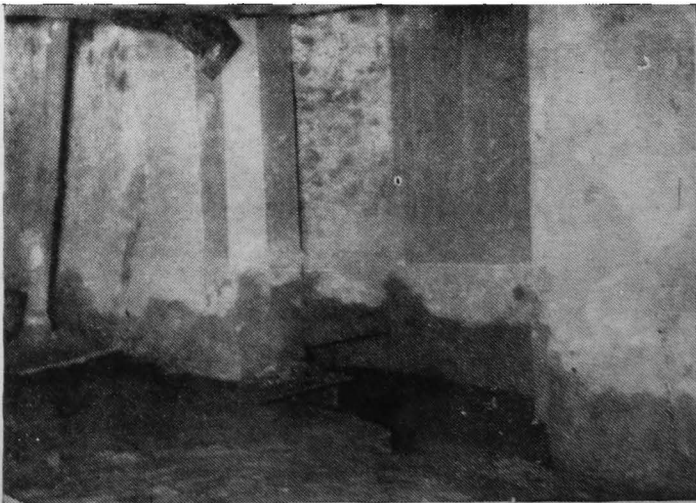
PLATE No. VI

Photographs showing cavitation damage in control tower and conduit

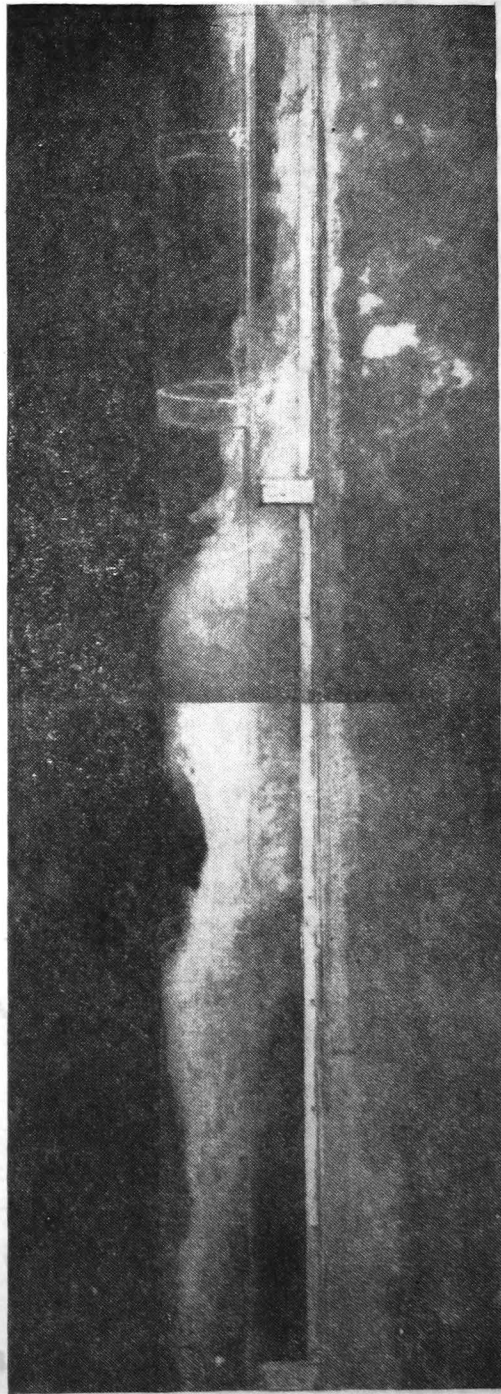
PLATE No. VIII

Photograph showing typical profile for hydraulic jump  
in hydraulic model

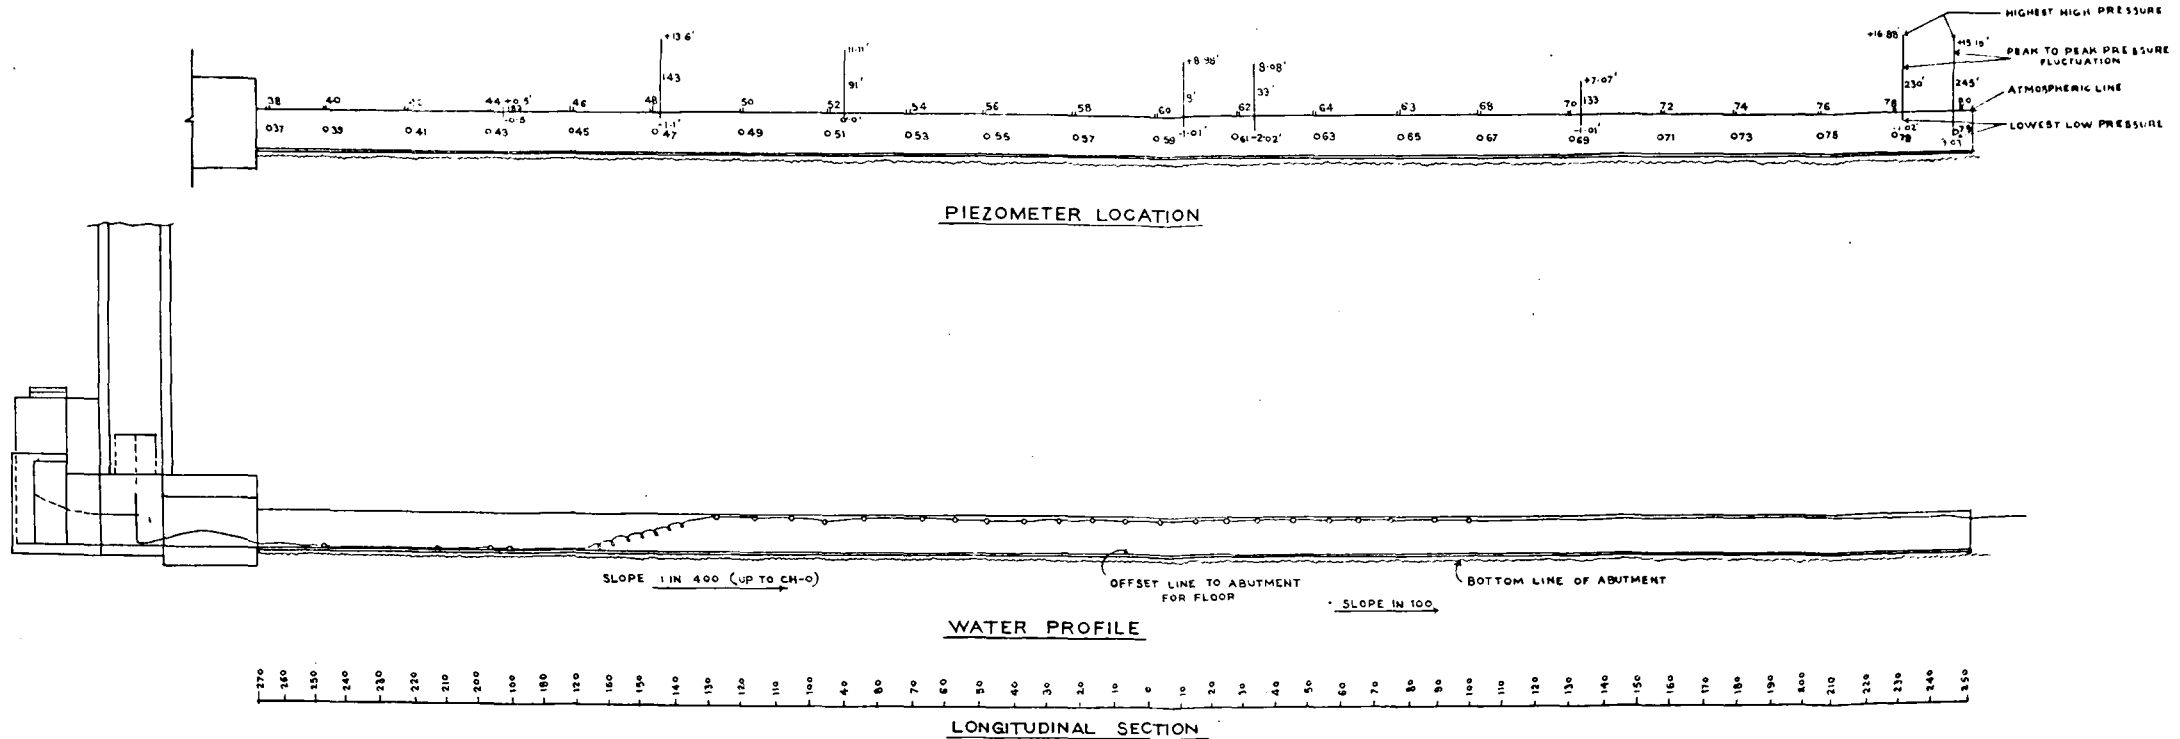
COMMISSION OF INQUIRY  
PANSHET AND KHADAKWASLA DAMS  
PANSHET DAM SLUICE OUTLET  
SHOWING  
WATER PROFILE FOR RESERVOIR R.L.2067.50  
AND PIEZOMETER LOCATION ON THE CONDUIT ARCH

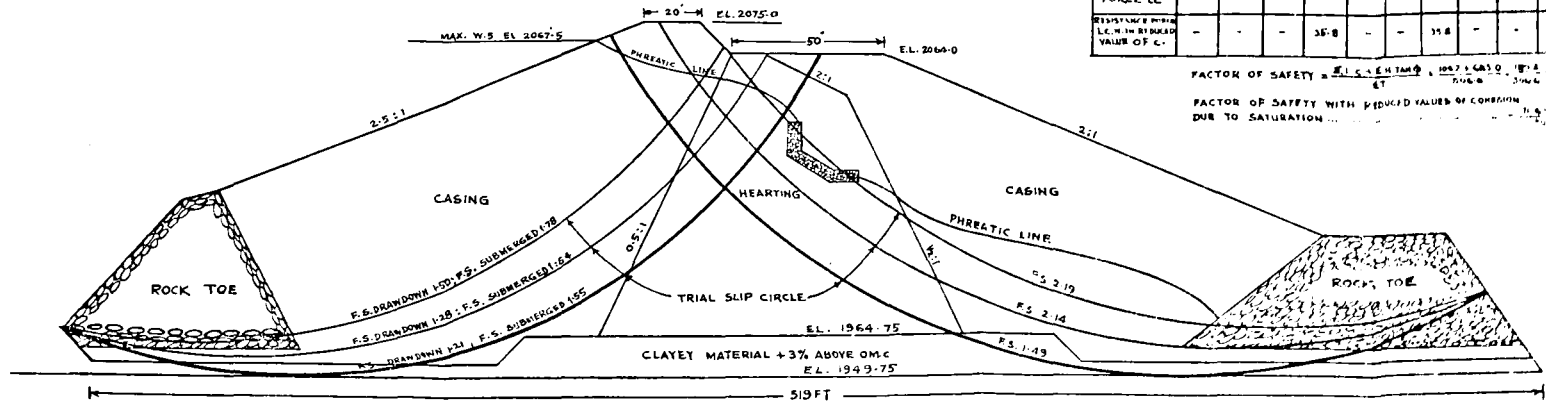
STABILITY ANALYSIS OF PANSHET DAM BY SWEDISH  
SLIP CIRCLE METHOD (ROTATIONAL FAILURE)

FACTOR OF SAFETY =  $\frac{ELc + EN \tan \phi}{ET} = \frac{168.2 + 908.6}{908.6} = 1.18$  [C HEARTING = 500 LBS./SFT]  
 C CASING = 150 LBS./SFT  
 FACTOR OF SAFETY WITH REDUCED VALUES OF COHESION DUE TO SATURATION ... =  $\frac{71.6 + 908.6}{908.6} = 1.08$  [C HEARTING = 300 LBS./SFT]  
 C CASING = 0 LBS./SFT
