What Determines the Length
of Life of Prepared Roll
Roofings ?

Bulletin No. 304

BY HENRY GIESE, H. J. BARRE AND J. BROWNLEE DAVIDSON

AGRICULTURAL EXPERIMENT STATION
IOWA STATE COLLEGE OF AGRICULTURE AND
MECHANIC ARTS

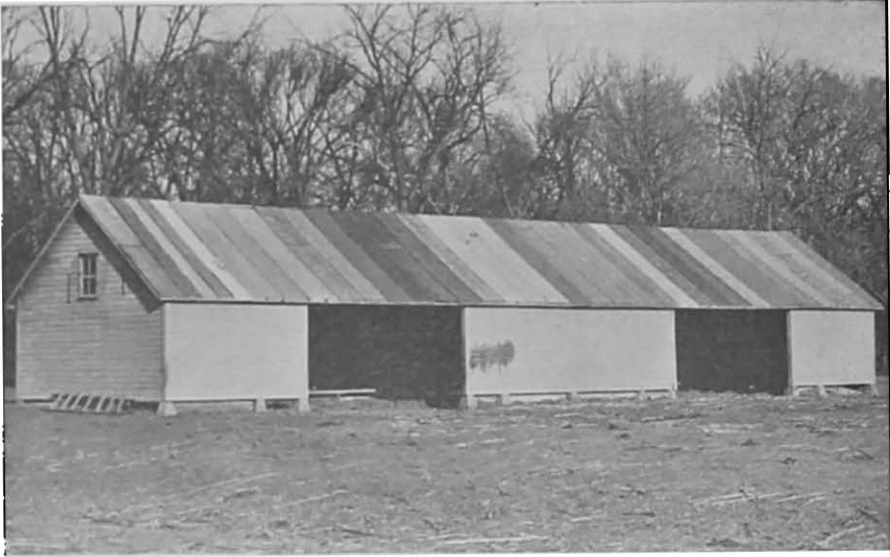
Fig. 1. Roofing samples in place for weathering tests.

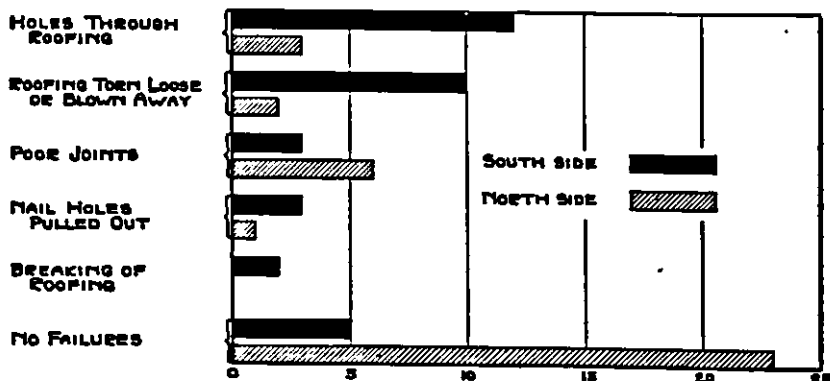
Figure 2 presents the observations concerning the number of kinds of failure which occurred on each slope of the roof after 14 years of weathering. It should be noted that the failures of the samples on the south slope were two and one-half times as numerous as those on the north slope. There were 30 failures on the south slope as compared with 12 on the north. The samples on the south slope were exposed more directly to

Fig. 2. Kind and number of failures observed in the weathering tests.

“Holes through roofing” was the most common type of failure, caused principally by pitch in the knots in the sheathing. The excessive amount of pitch in the knots in two boards of the sheathing caused a very rapid deterioration in samples Nos. 25, 26, 27, 28 and 29 which were placed over these boards. Other holes were caused by loosened nails and unevenness in the sheathing.

The action of the wind, on account of the character of the building, was unusually severe, and was perhaps the next most important factor in the failures. After the roofing stretched and loosened, the wind caused much flapping. The wind eventually tore several of the roofing samples and removed a portion altogether. Poor joints and cracks in roofing were common types of failures.

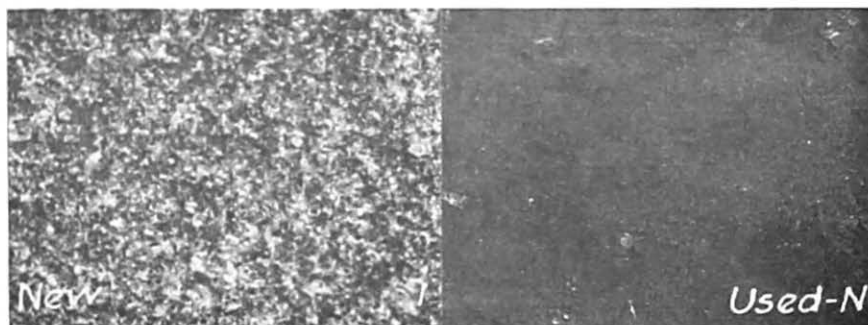
Fig. 3. On the left is new "mica" roofing and on the right the same roofing after it had been used on the north side of the building. The observations of the condition of the roofing on the north and south sides are recorded below for the various years.

SOUTH SIDE		NORTH SIDE	
1915	Condition good. Gray color. Some mica gone.	1918	Condition good. Gray color. Mica partly gone.
1916	Few bulges.	1924	Surface in fair condition. About 30 percent of mica gone.
1918	Condition fair. Dark gray color. Mica two-thirds gone in many places.	1925	About 50 percent of mica gone.
1921	Gray color. About one-half of mica gone.	1926	About 80 percent of mica gone.
1923	Mica surfacing badly weatherworn.	1927	Mica practically all gone.
1924	Surface in fair condition.	1931	Condition fair.
1925	One hole 4 inches in length. About 75 percent of mica gone.		
1926	About 80 percent of mica gone.		
1927	Mica practically all gone.

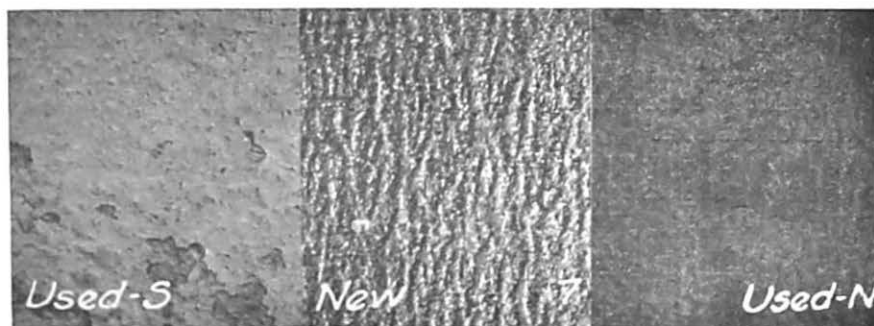
Fig. 4. Alligator roofing—new sample is shown in the center, that used on the south side of the building at the left and the sample from the north side at the right. Below are the observations of the condition on each side of the building.

SOUTH SIDE		NORTH SIDE	
1915	Condition good. Brown color. Surface bitumen partly gone. Surface appeared smooth.	1918	Condition good. Gray color. Mica mostly gone.
1916	Condition good. Black color. Surface pliable.	1921	Mica practically all gone.
1918	Dark gray color. Most of mica gone.	1927	No apparent change in condition.
1919	Condition fair. Slightly weatherworn.	1931	In fairly good condition.
1921	Mica entirely gone.		
1922	Dusty brown color. Appearance fair.		
1923	Surface appearance dusty.		
1924	Top ply gone in spots. Dirty brown color.		
1927	About 25 percent of top ply gone.

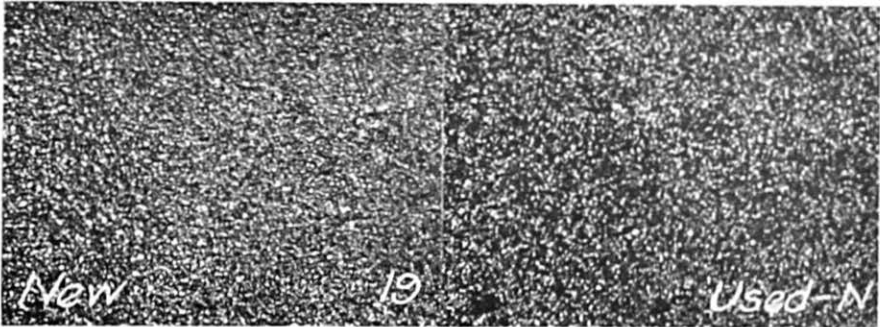
Fig. 5. New and used roofing with fine sand finish. The condition on the north and south sides of the building for the various years are recorded below.

SOUTH SIDE		NORTH SIDE	
1915	Condition fair. Dark gray color. Some surface bitumen gone.	1918	Condition good. Gray color. Some sand gone. Surface ply broken in one place.
1916	Black color, with fine white sand. Surface dry and stiff and covered with smooth coarse sand.	1921	Light gray color.
1918	Light color. Surface bitumen hard and brittle, and gone in spots.	1927	Surface appeared weatherworn.
1919	Gray color. Nearly one-half of sand gone.	1931	Condition poor.
1922	Surface badly weatherworn.		
1923	Sand 85 percent gone. Paint no apparent value.		
1925	Surface ply broken badly except where painted.		
1926	About one-half of roofing gone.

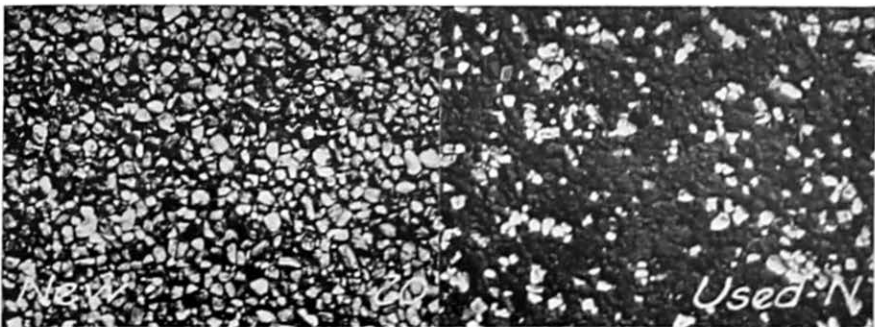
Fig. 6. Roofing surfaced with pebbles—new on the left, used right. Observations for the various years are recorded below.

SOUTH SIDE		NORTH SIDE	
1915	Condition good. Pebble color. About one-third of pebbles gone. Bitumen brittle.	1918	Condition good. Gray color. Some pebbles gone.
1916	Black color with white pebbles. About one-half of pebbles gone.	1919	About 40 percent of pebbles gone.
1918	Light color. Two-thirds of pebbles and much bitumen gone.	1921	About 70 percent of pebbles gone.
1919	Gray color. Remaining bitumen lifeless.	1922	About 75 percent of pebbles gone.
1921	Pebbles 90 percent gone.	1923	About 80 percent of pebbles gone.
1922	Surface badly weatherworn. Paint of no apparent value.	1924	About 90 percent of pebbles gone.
1923	Pebbles 95 percent gone with slightly less removed on the painted area.	1925	Condition fair.
1925	Surface ply broken in places.	1927	Pebbles 95 percent removed.
1926	About one-half of roofing gone.	1931	Condition poor.

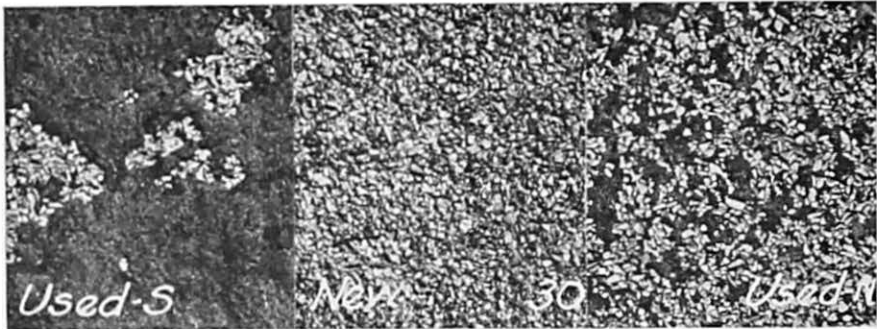
Fig. 7. Slate covered roofing. New sample is shown in the center, that used on the south side of the building at the left and on north side at the right. Observations for each side at different years are recorded below.

- 1916 Condition very good. Slate color.
 1916 Condition good. Pliable. Some slate gone.
 1918 Remaining slate firmly in place.
 1921 Edge curled slightly.
 1922 Some slate removed near edge. Paint retained slate.
 1923 Paint of little apparent value.
 1924 About 20 percent of surfacing gone except where painted.
 1925 About 30 percent of surfacing gone except where painted. Surface good except near east joint.
 1927 Holes near ridge.

- 1918 Condition good. Slate color.
 1922 Slate surfacing firmly in place but appeared somewhat weatherworn. Joint fair.
 1924 About 5 percent of slate surfacing gone.
 1925 About 10 percent of slate gone. Surface in poor condition near edge.
 1927 No apparent change in condition.
 1931 Condition fair.

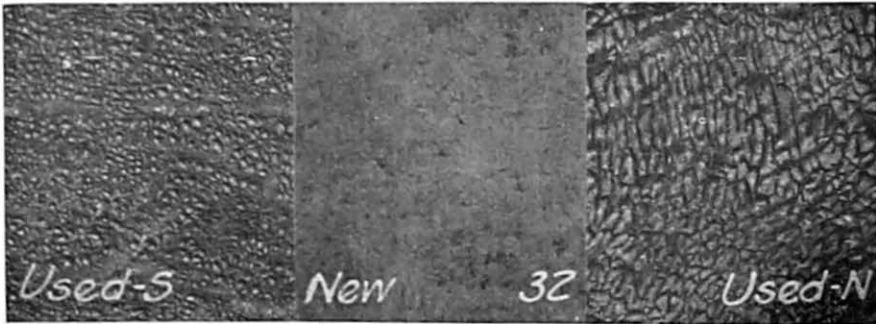
Fig. 8. "Asbestos" roofing is shown above—new sample in the center, that used on the south and north sides of the building are shown, respectively, on the left and right. Observations on the condition are recorded below.

- 1915 Condition good. White color. Top ply badly scuffed.
 1918 Light color.
 1919 Light gray color. Asbestos top ply checked and weatherworn.
 1921 Condition fair. Some breaks in top asbestos ply. Joint poor.
 1922 Asbestos top ply badly broken and weatherworn. Paint renewed slightly.
 1927 No apparent change in condition.

- 1918 Condition good. Light color. Asbestos nearly gone.
 1919 Gray color. Some breaks in asbestos ply.
 1921 Light gray color.
 1923 Asbestos surface scarred.
 1924 Asbestos top ply badly broken and weatherworn. Joint poor.
 1927 No apparent change in condition.
 1931 Replaced.

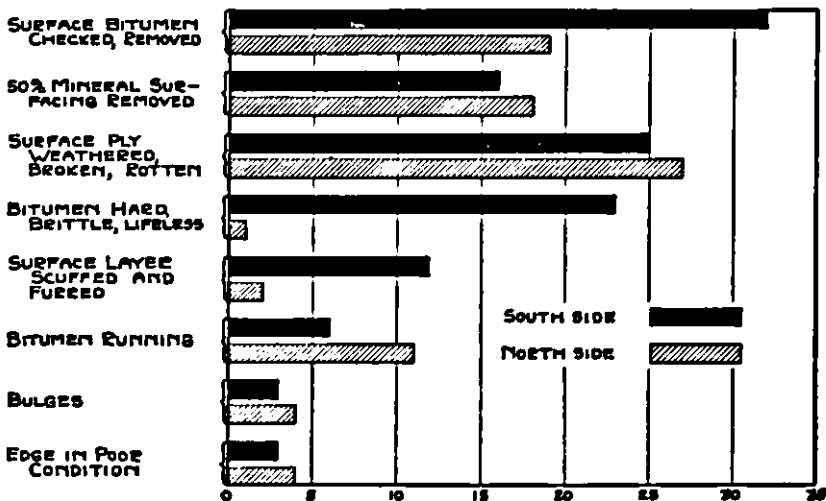
Other minor weathering effects, together with those mentioned above, are summarized in fig. 9. Reports on "bitumen running" caused by the heat of the sun, were more frequent for the samples on the north slope. The effect of the heat on the south slope was apparently sufficient to dry the bitumen.

Fig. 9. Kind and number of minor effects observed in the weathering tests.
