State Soil Conservation Committee in Cooperation With the Soil Conservation Service, United States Department of Agriculture, and the Agricultural Experiment Station, the University of Wisconsin, Madison

(June, 1951)

Erosion controlled by **Terraces**

H. B. Atkinson¹ and Orville E. Hays²

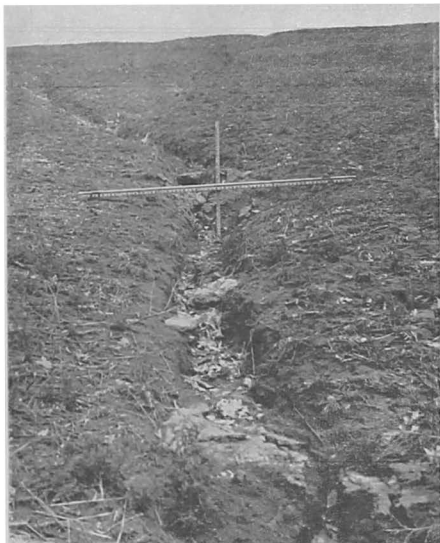
Terraces and strip cropping stopped gullies. The picture shows gully erosion in Area UCW. (Table 1.)

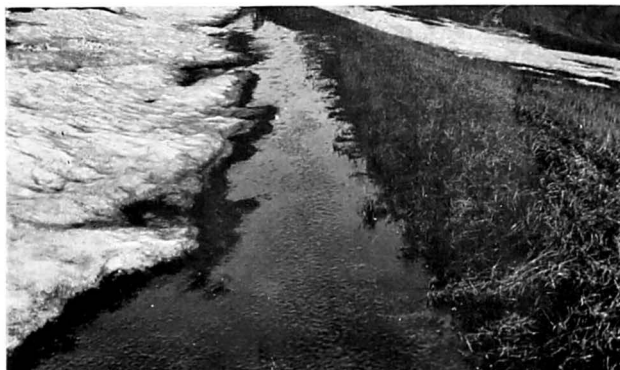
A terrace collecting runoff water which is flowing slowly to outlet.

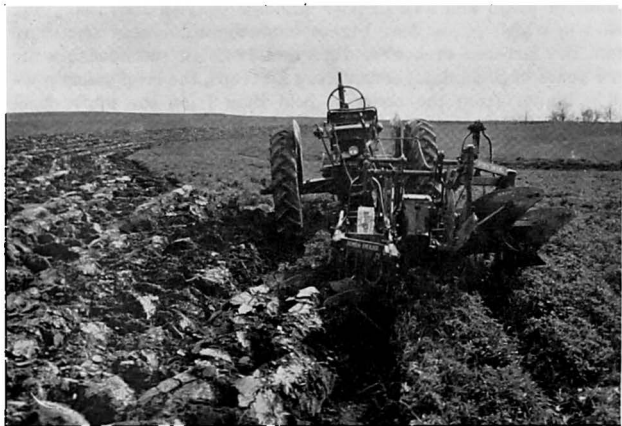
The two-way plow being used to plow terraces. No dead furrows or back furrows are left between terraces to concentrate water.

6. The two-way plow is well adapted for plowing terraced fields. Use of this type of plow allows one to control the location of dead furrows and back furrows.

The use of a two-way plow produces a uniform slope between terraces as plowing is started on the terrace ridge and all of the soil is turned up hill. This eliminates the necessity of any back furrows or dead furrows in the interval between the terraces. When back furrows or dead furrows are left in the interval between terraces, they collect runoff water. This concentration of water causes rilling on the lower half of the terrace interval. The use of a two-way plow is well adapted for plowing terraced fields. One can easily control the location of dead and back furrows by using a two-way plow.
