**United States Department of the Interior
BUREAU OF RECLAMATION**

LOWER COST CANAL LININGS

**A progress report on the development of
lower-cost linings for irrigation canals**

Denver, Colorado, June 1948

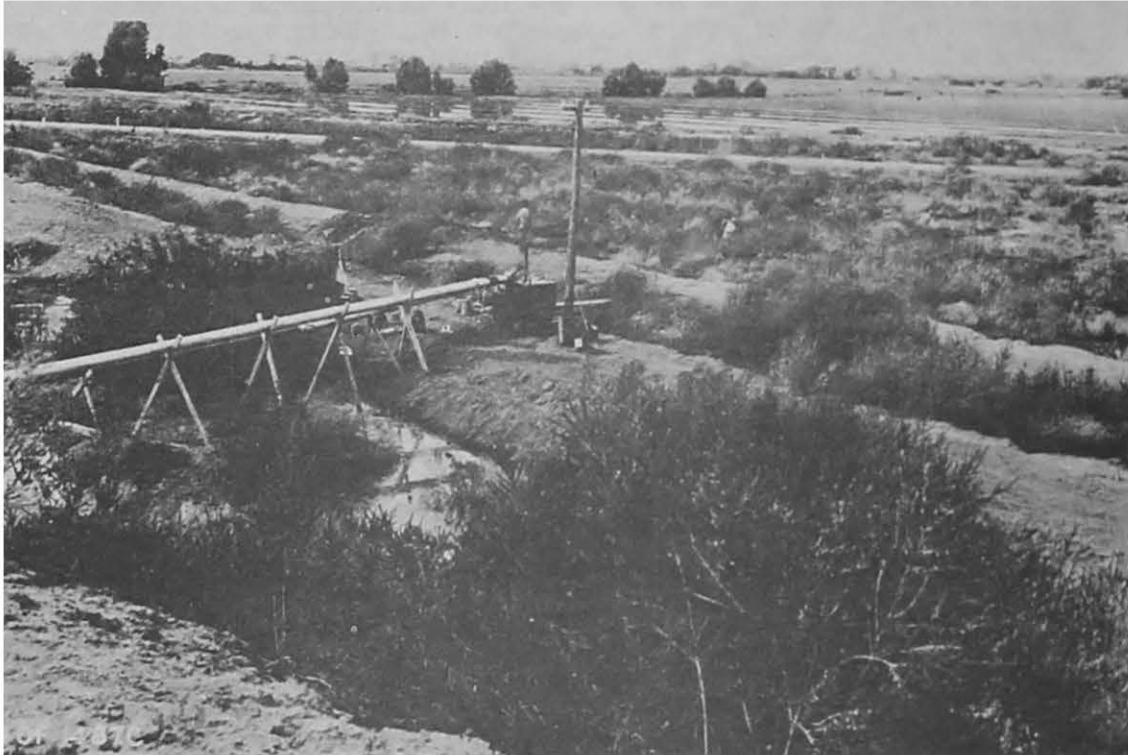
Photograph No. 1

Groundwater over cultivated field due to seepage
from canal 700 feet north of field.

Thousands of miles of irrigation canals in the western states fail to deliver a large proportion of the water turned into them at their intakes because of leakage from unlined sections. This problem was recognized as early as 1907 by Dr. Elwood Mead, later appointed Commissioner of Reclamation, who wrote: (51)* "The water which sinks into the soil from ditches and reservoirs is one of the chief sources of waste in irrigation. In gravelly soils, or where ditches cross gypsum strata, the losses sometimes amount to more than half the total flow. The water which escapes is often worse than wasted. It collects in the lower lands, fills the soil, drowns the roots of trees and plants and brings alkali to the surface," Photograph No. 1.

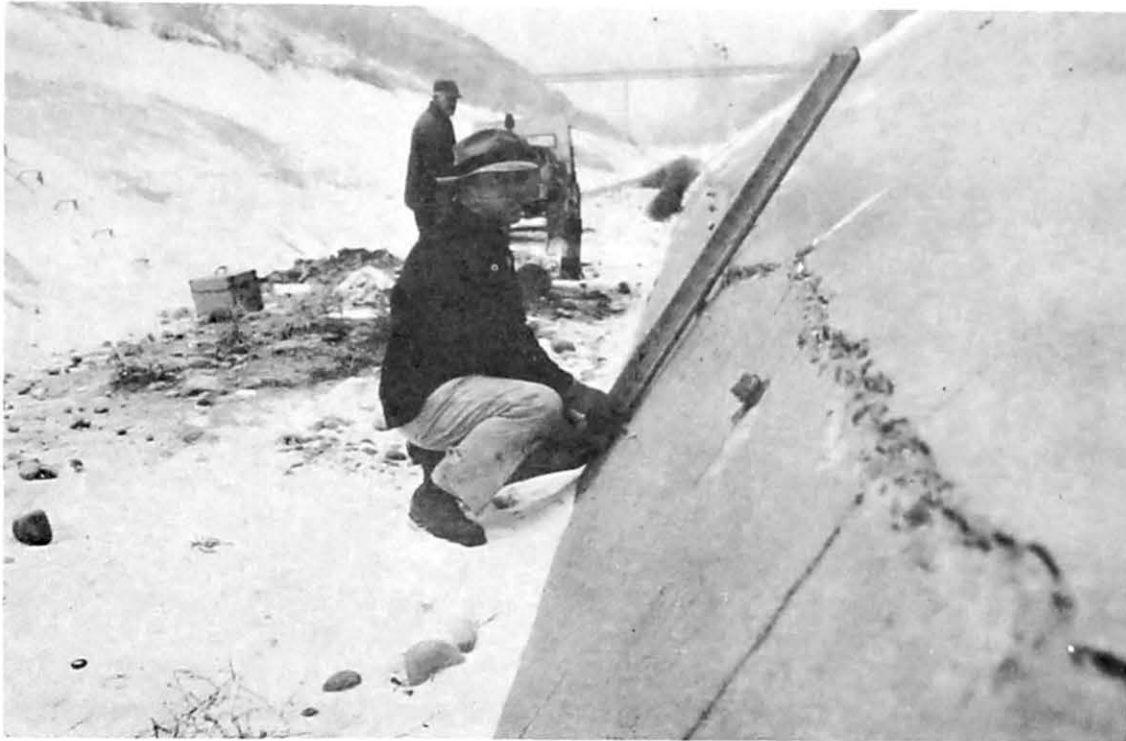
Photograph No. 6

Damage to concrete by frost heaving--Terrace Heights--
Yakima Project, Washington.

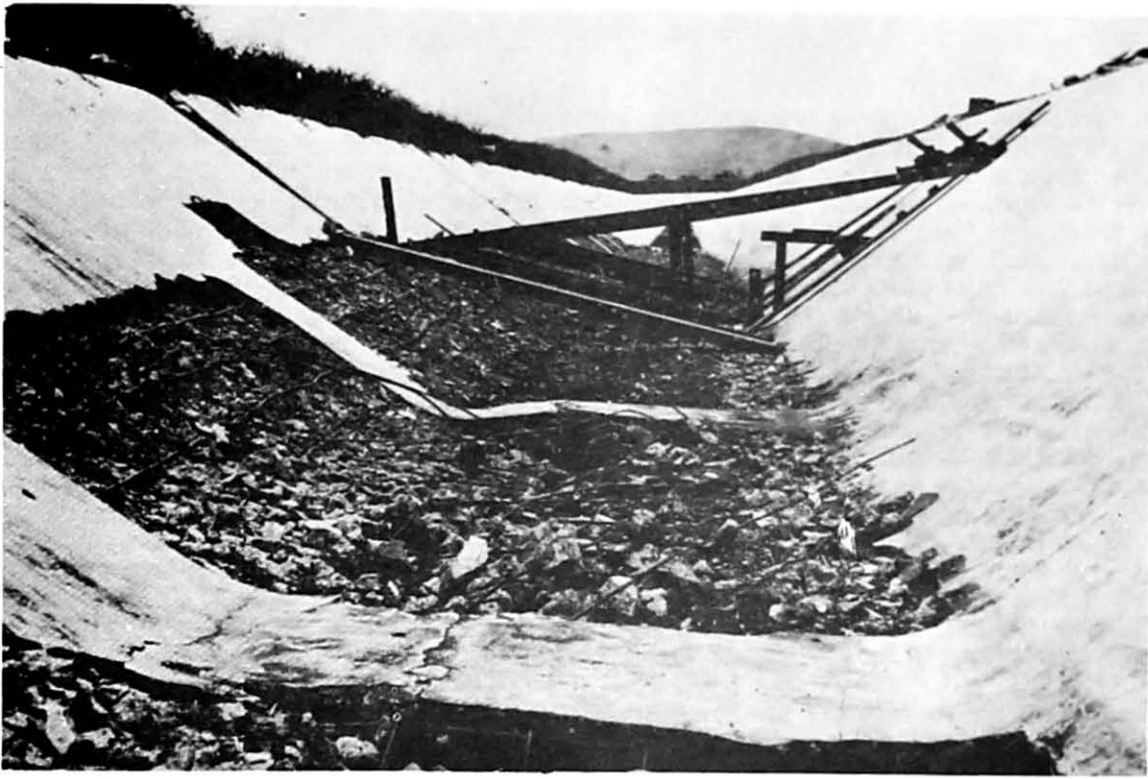
Photograph No. 10

Failure of a concrete lining due to floatation--
Contra Costa Canal, California.

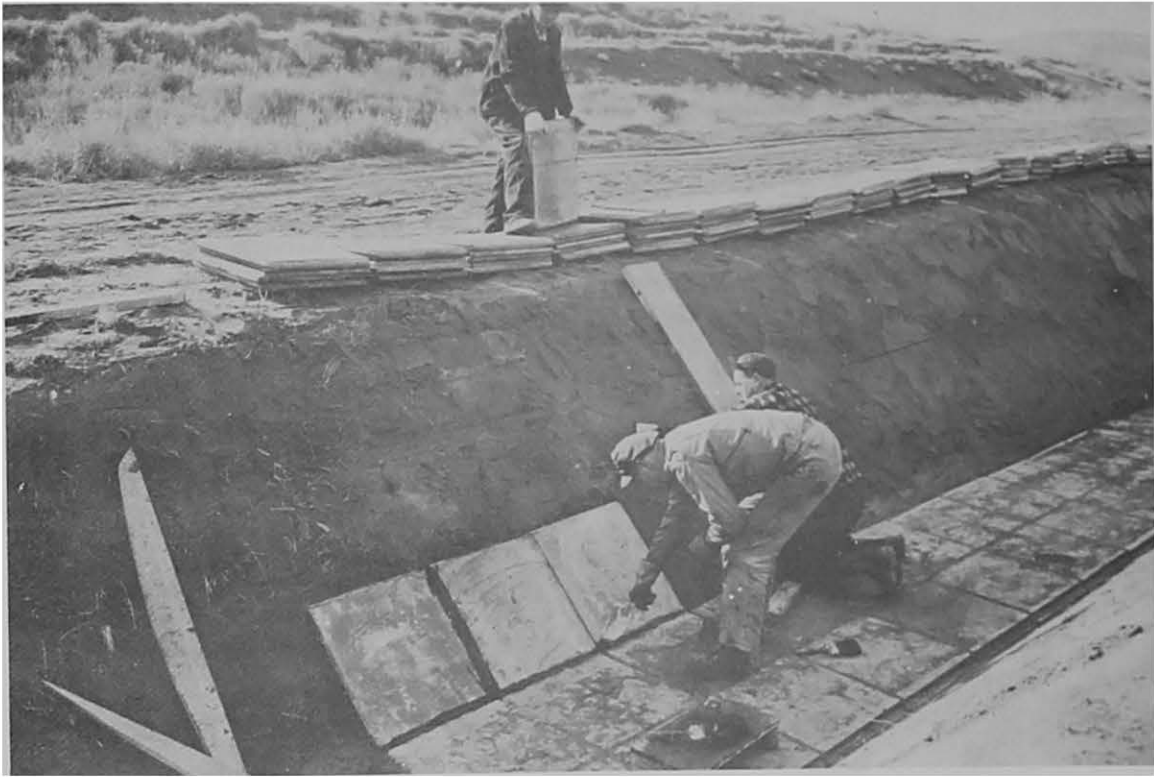
Photograph No. 12

Installing 2-foot square slabs of precast concrete lining--Yakima Project, Washington--1947.

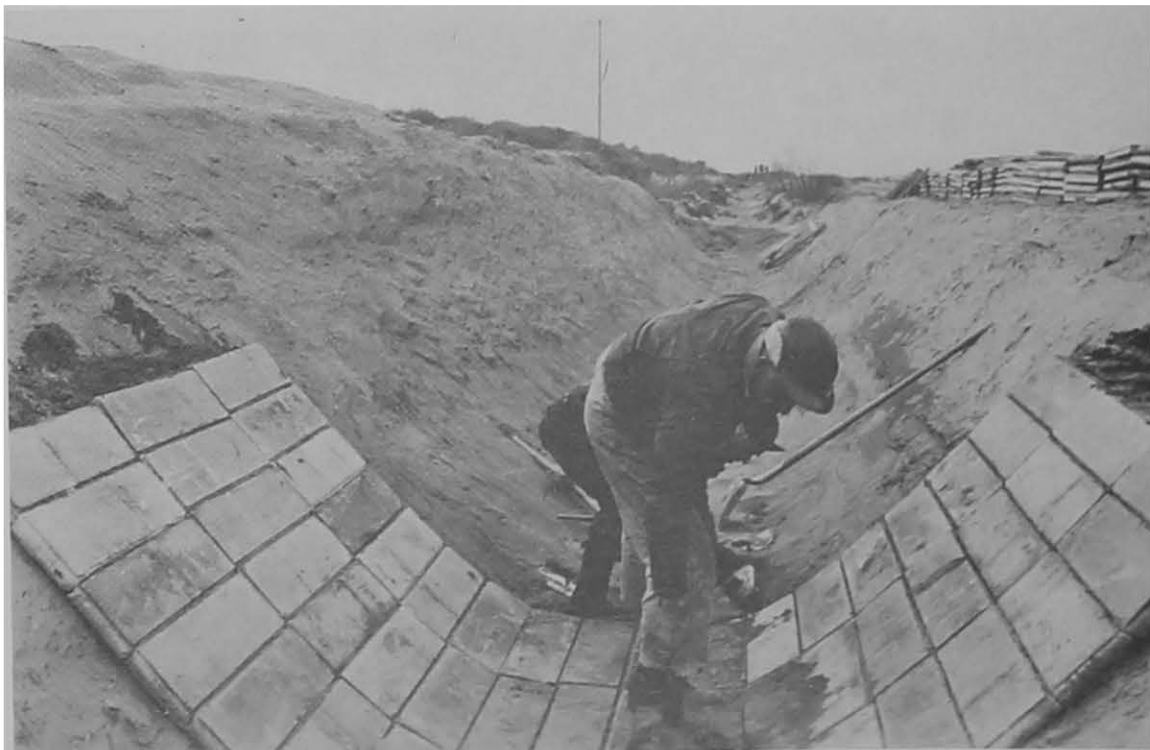
Photograph No. 13

Placing 8-inch by 24-inch precast concrete slabs with tongue and groove joints. Yakima Project, Washington--1947.

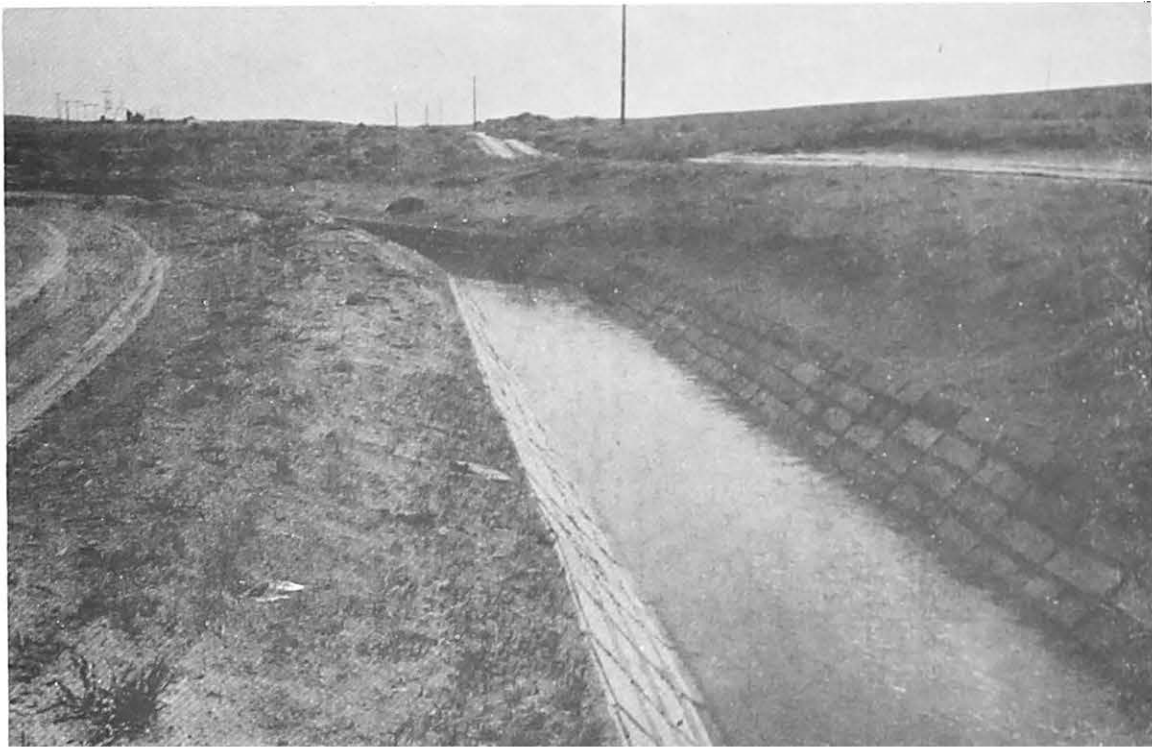
Photograph No. 14

Precast concrete lining installed in 1947--Yakima
Project, Washington.

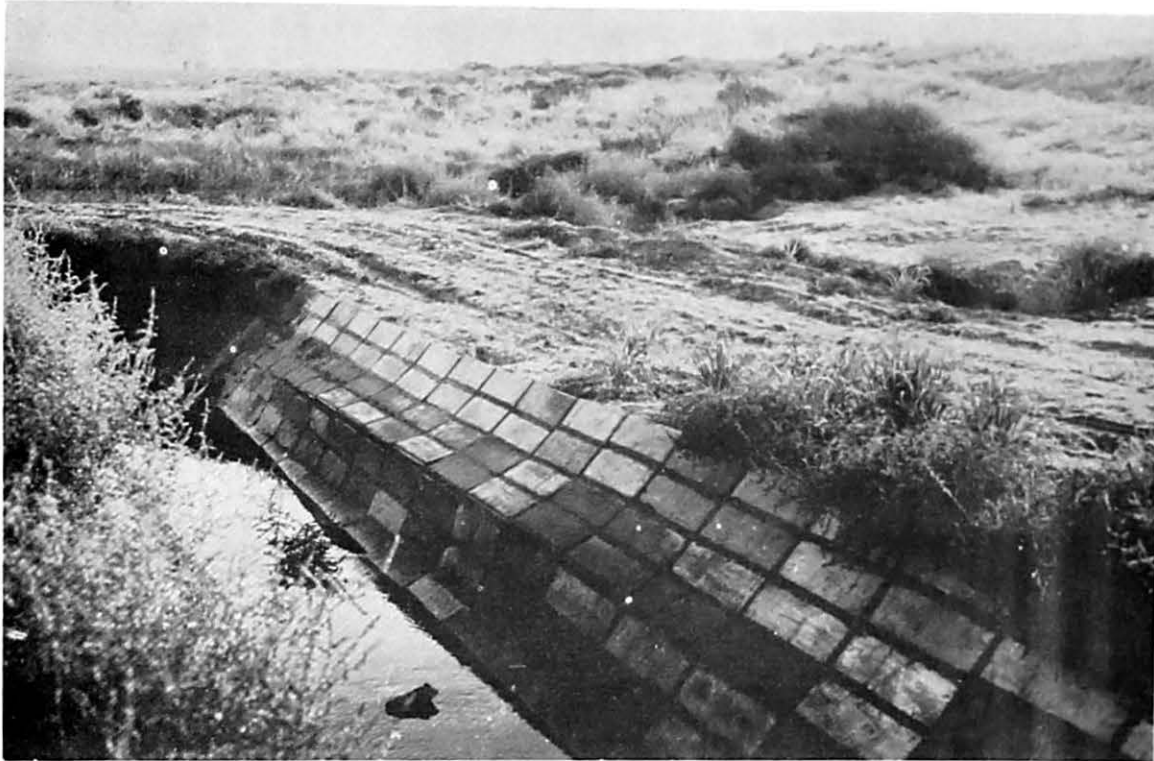
Photograph No. 16

Partial failure of precast concrete lining due to surface water entering behind lining--Yakima Project, Washington.

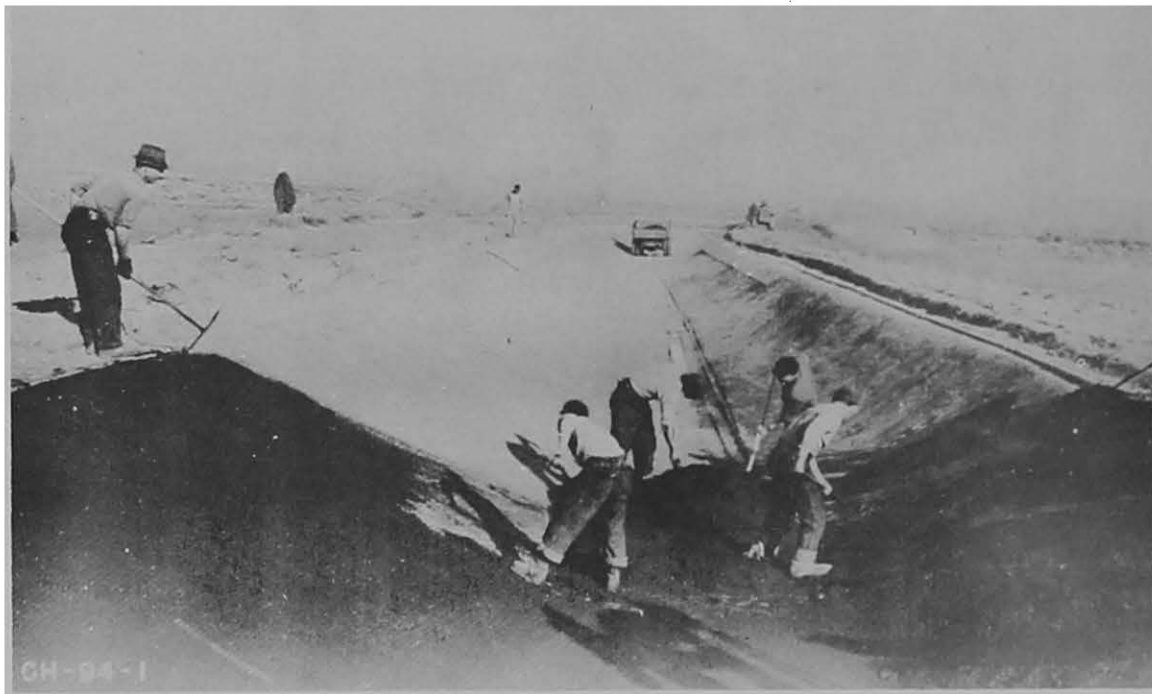
Photograph No. 29

Hand-placed asphaltic concrete lining November 1939--
Snipes Mountain Canal, Washington.

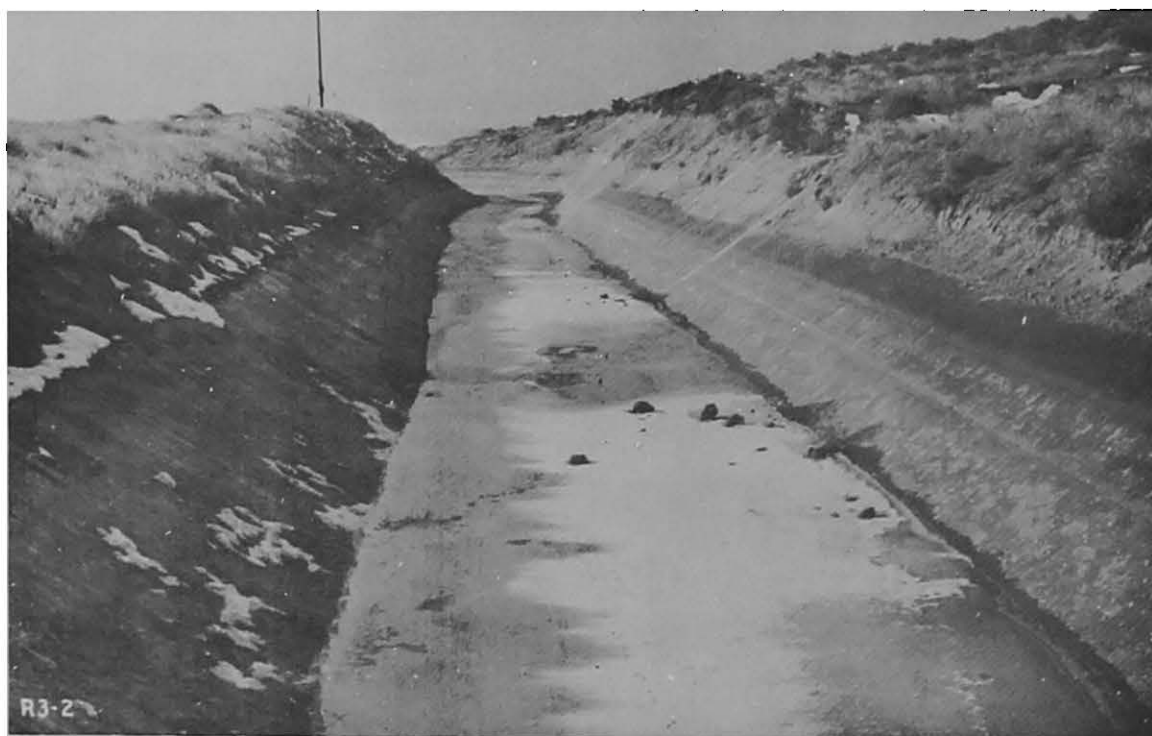
Photograph No. 30

Asphaltic concrete lining in Malheur Canal--placed
November 1944--Owyhee Project, Oregon.

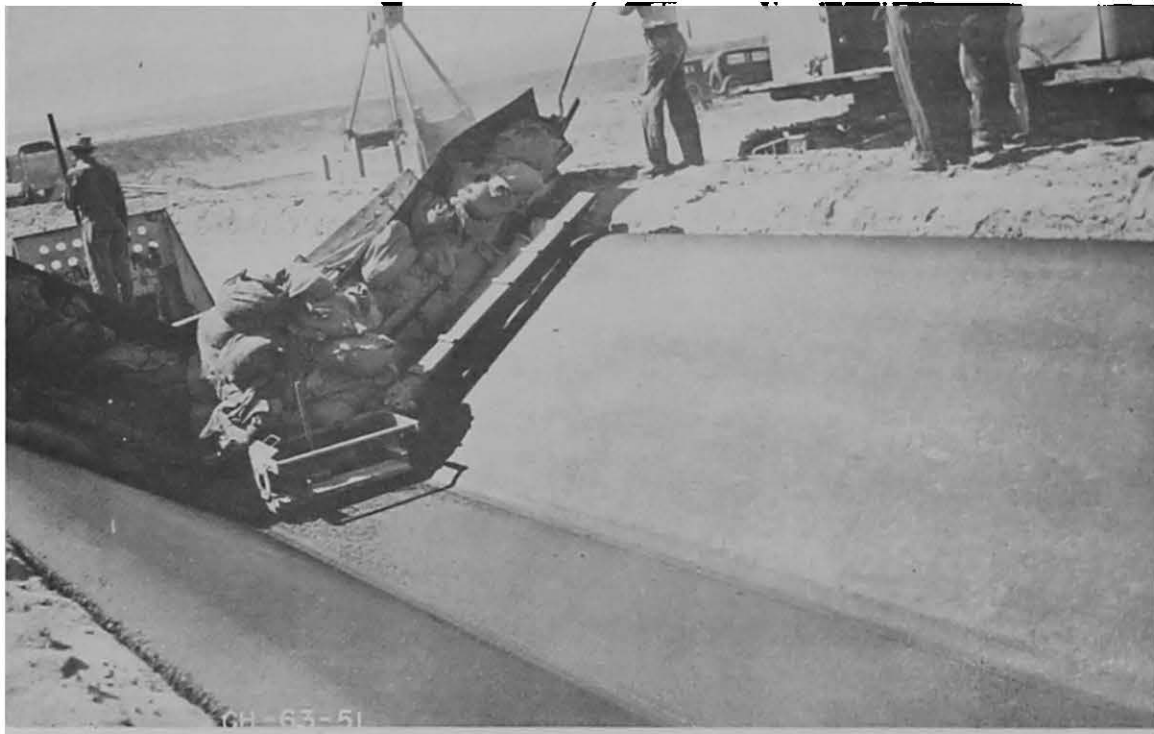
Photograph No. 31

Asphaltic concrete lining being placed in Pasco
Laterals, Washington--June 1947.

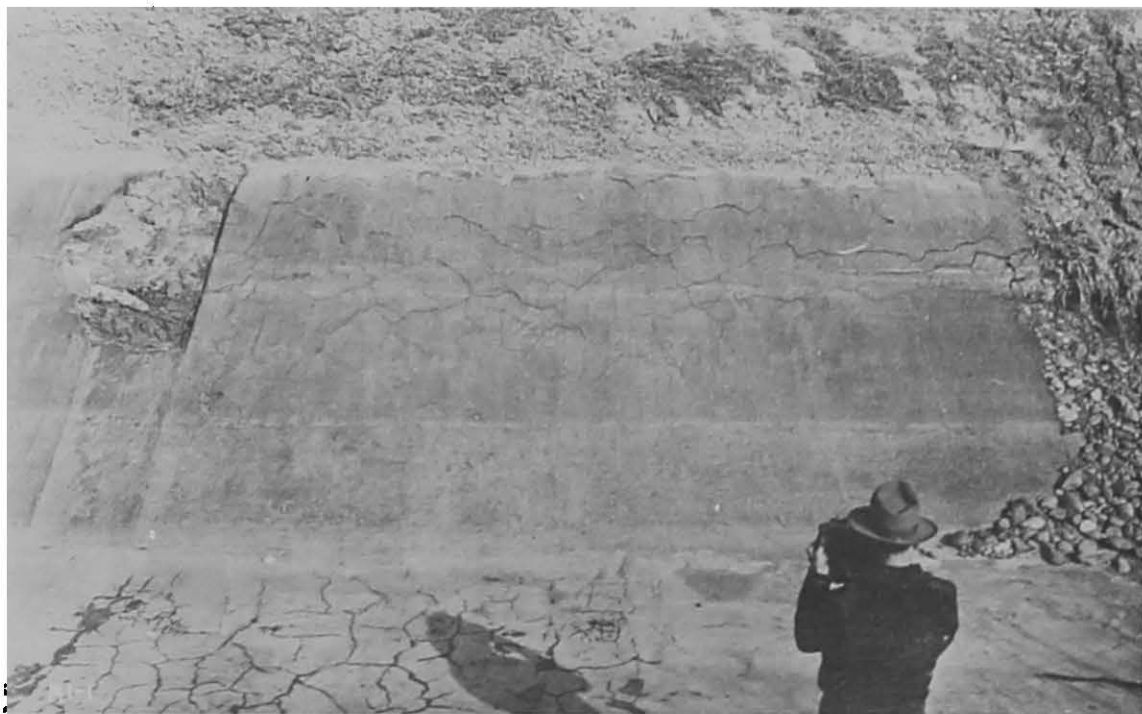
Photograph No. 32

Cold-mix lining (asphalt emulsion and fine sand) in
"D" Line Canal--Boise Project, Idaho. (Note
shrinkage cracks.)

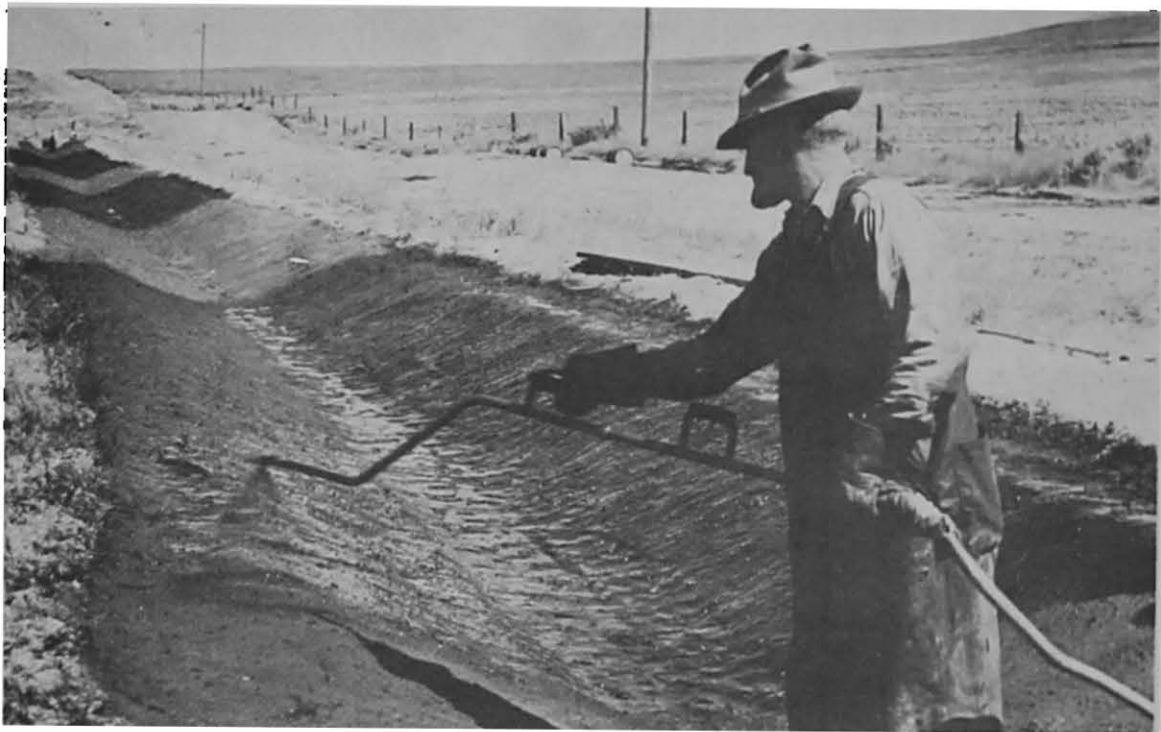
Photograph No. 33

Applying SC priming oil over diesel oil preprimed earth, prime membrane lining--East Turbine Lateral--Yakima Project, Washington.

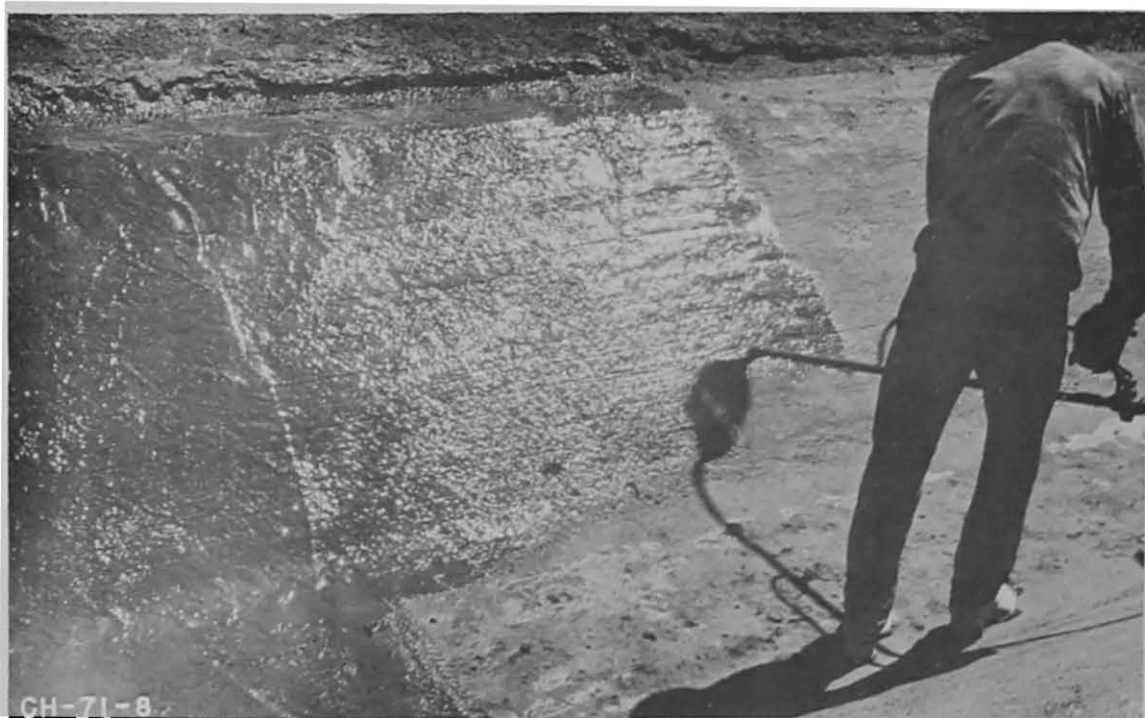
Photograph No. 34

Applying diatomaceous earth-filled asphalt cement membrane over primed soil, experimental area of Pasco Laterals, Washington.

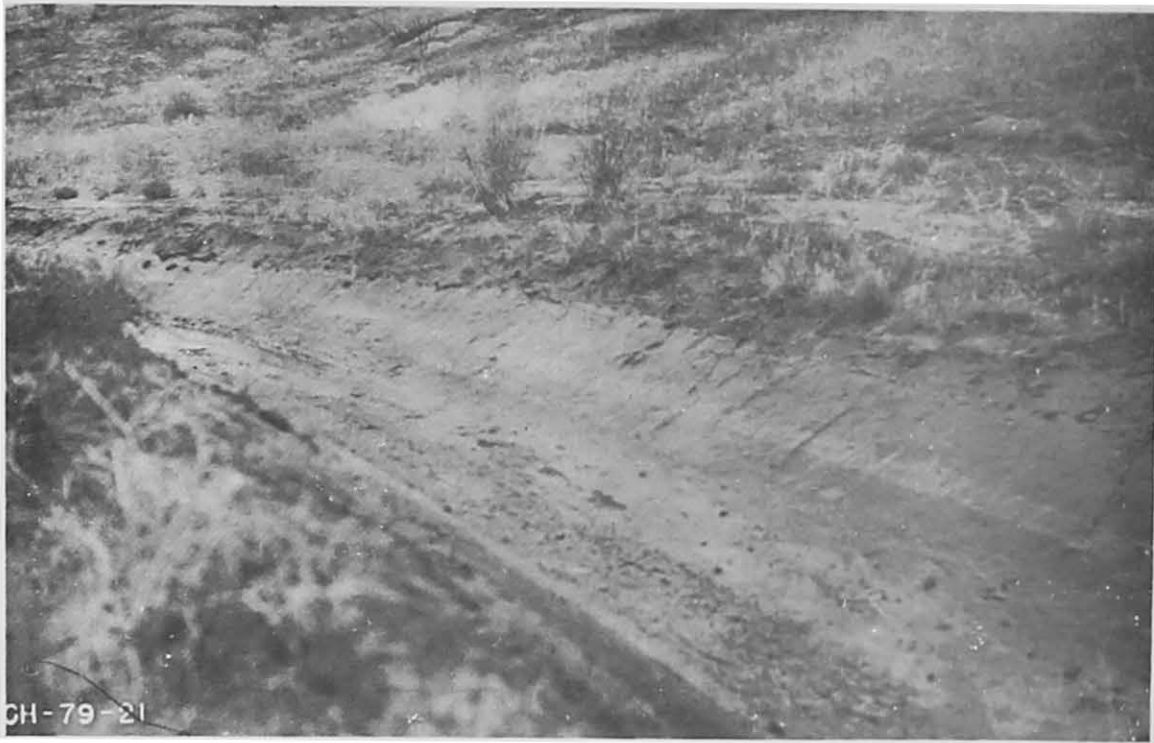
Photograph No. 35

Section of prime-membrane lining in "H" Line Canal--
Boise Project--after six irrigation seasons.

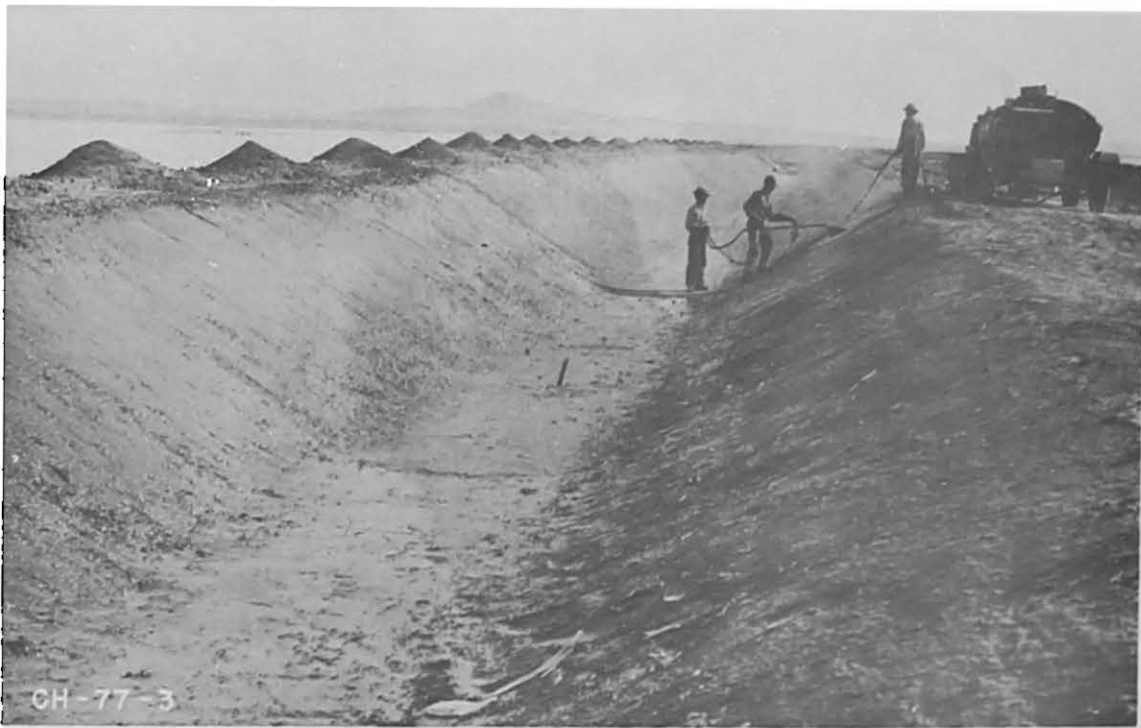
Photograph No. 36

Applying asphaltic membrane to subgrade for buried-
membrane lining--Klamath Project, Oregon--September
1947.

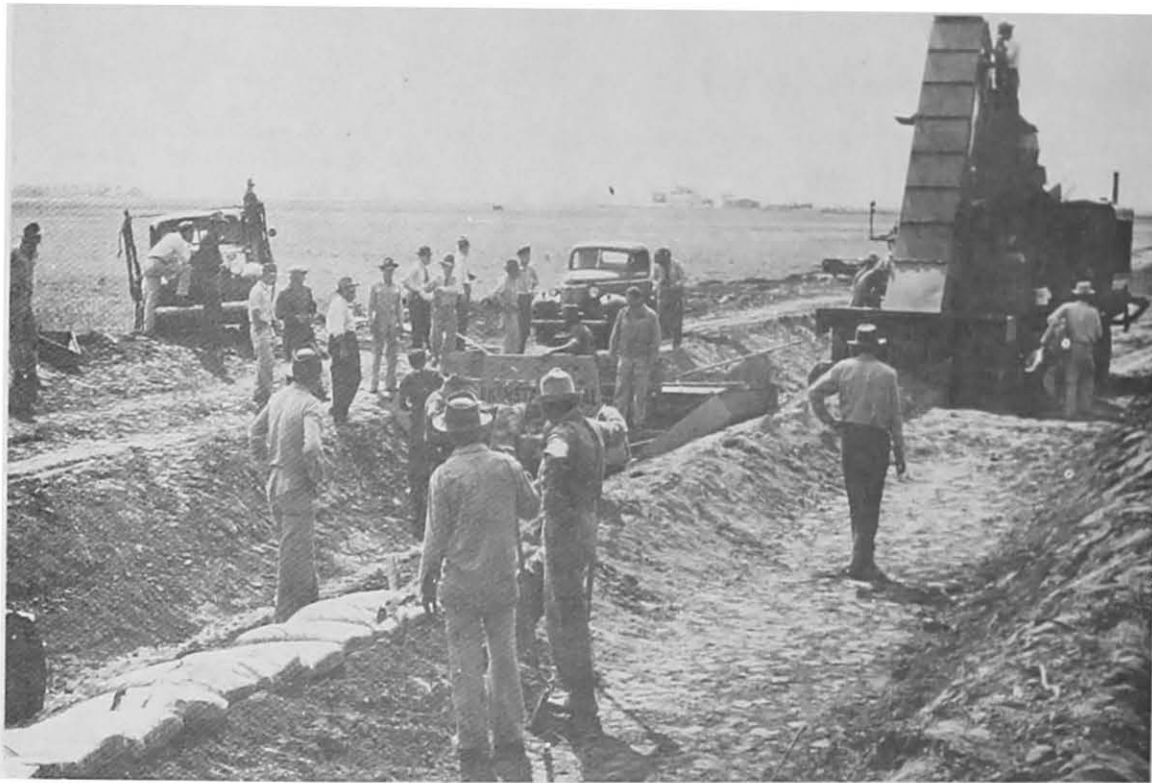
Photograph No. 49

General view of Barber-Greene road mixer and Ekenstam Canal Paver at start of installation of plastic soil-cement lining--W. C. Austin Project. Oklahoma.

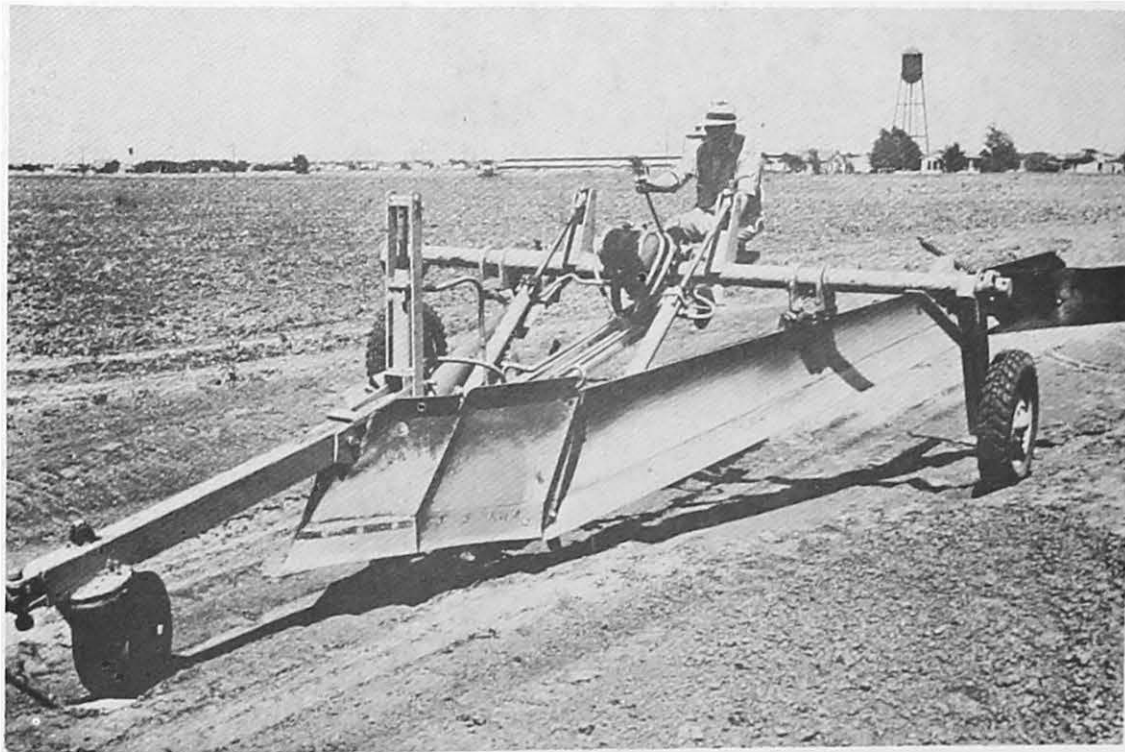
Photograph No. 56
Chattin Ditcher for excavating canals and laterals.

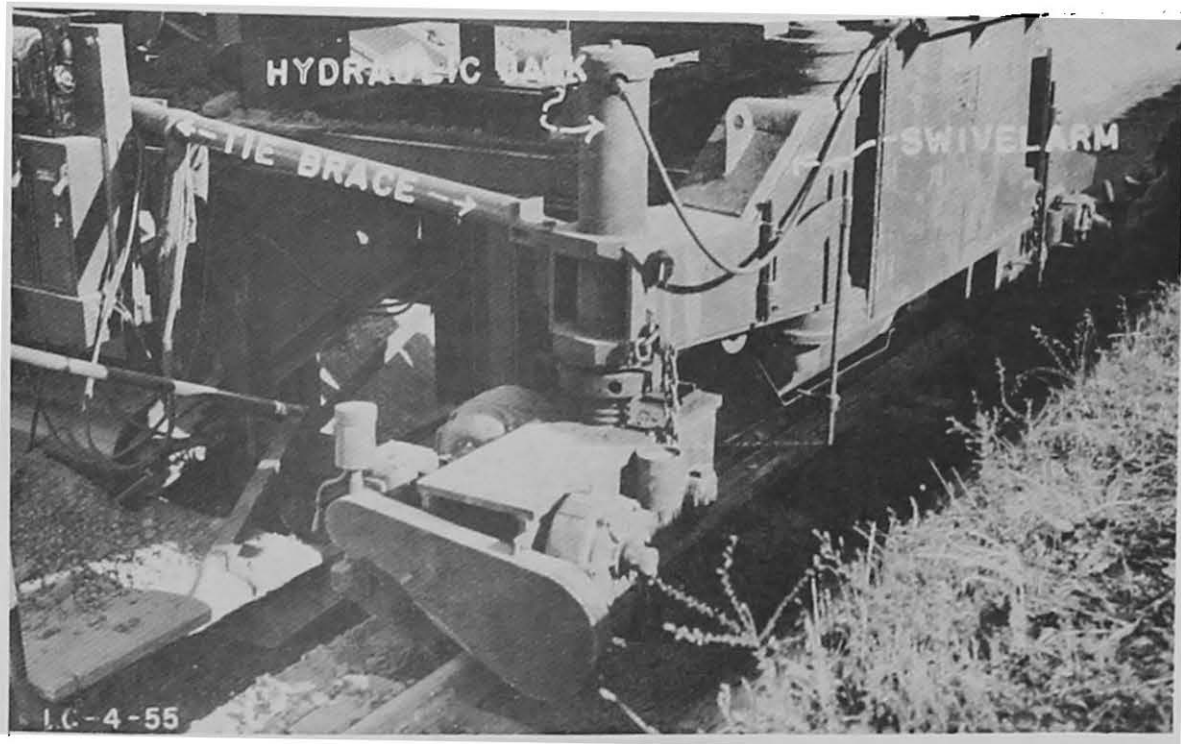
Photograph No. 66

Method of securing adjustment in depth on trimming machine shown in Photograph No. 65. Hydraulic jack permits about 1 foot of adjustment and approximately 10 inches of additional adjustment can be obtained by revolving swivel arm about its horizontal axis--Contra Costa Canal, California.

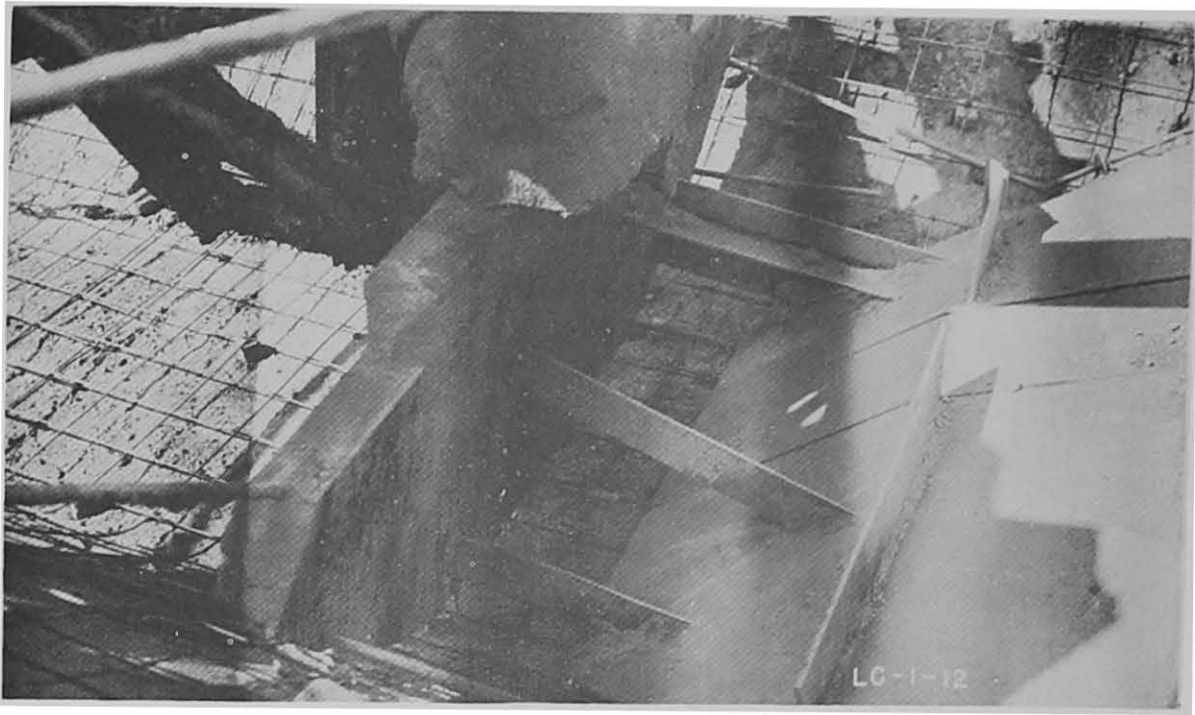
Photograph No. 71

View looking down into concrete compartment of machine shown in Photograph No. 70--Balmorhea Project, Texas.

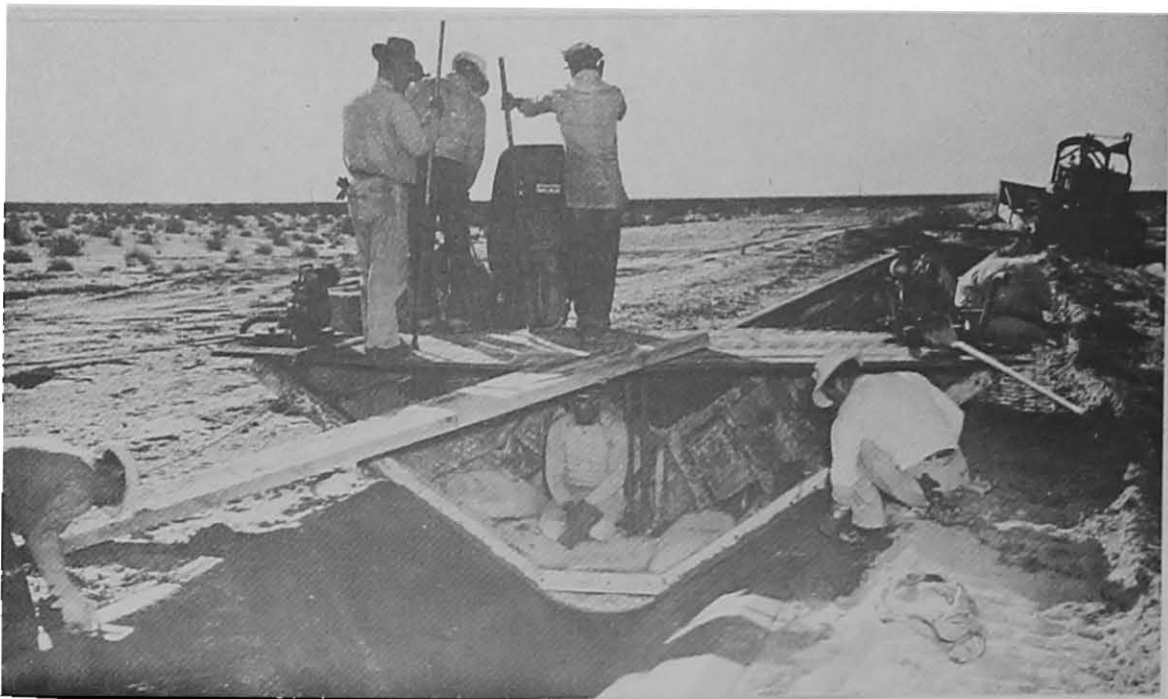
Photograph No. 72

Rear view of slip-form machine for placing unreinforced concrete lining--Forward motion by tractor in background--Gila Project, Arizona.
