TECHNICAL BULLETIN—5

SOIL CONSERVATION SERIES—5

RECLAMATION OF ILL-DRAINED SOILS

at villages Nagansur and Agalgaon in
Sholapur District

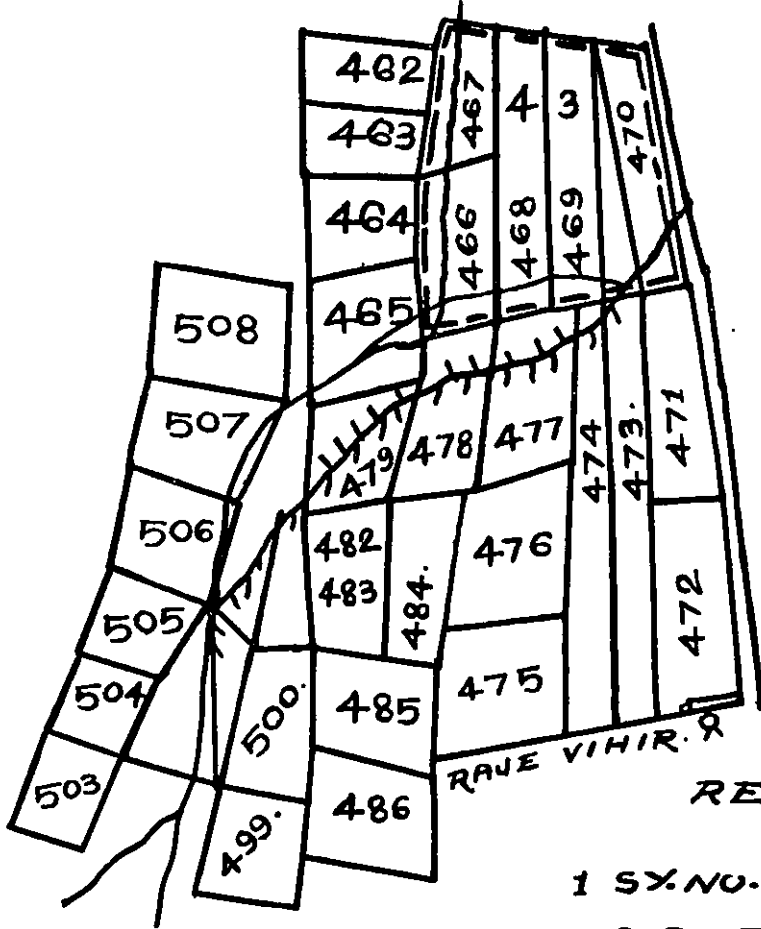
FIG. 1

SCALE
1" = 1320'

REFERENCES.

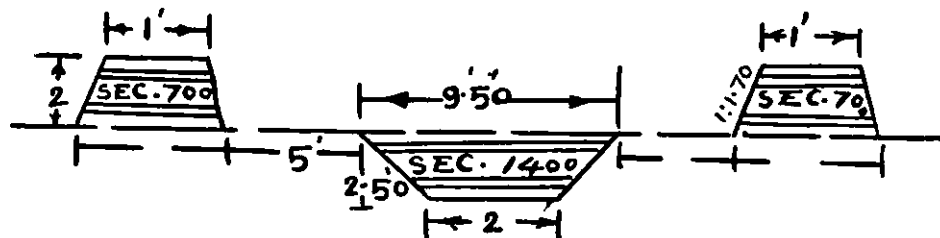
FIG. 11

CLOSED DRAINS

14	—	—	3	10.75	2.50	2.75	1:2	190	1800
15	—	—	6	"	"	"	"	220	1800
16	—	—	8	"	"	"	"	220	1800
17	—	B TO D	—	18	6	3	"	1265	3600
18	—	D TO E	—	"	6	"	"	220	3600
19	—	H TO C	—	13.50	3	"	1:1/2	1265	2400.
20	—

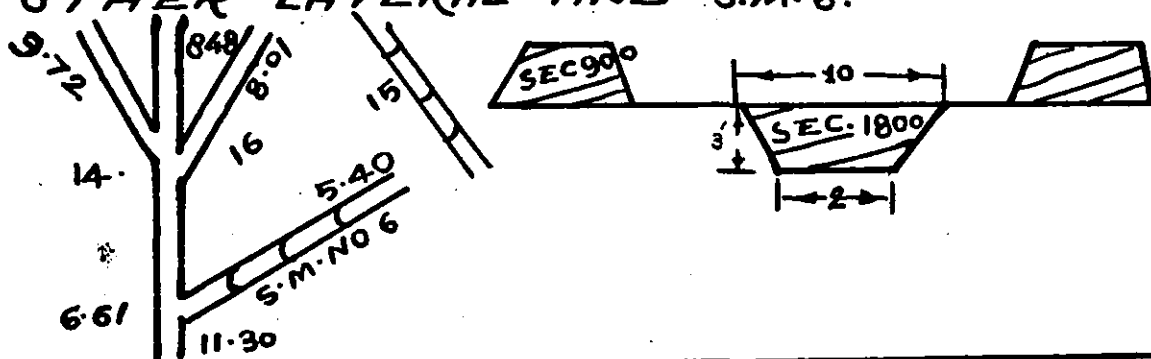
NAGANSUR BL. NO. 3.

SY. NO. 470.

DETAILS OF LATERAL J TO K. AND
OTHER LATERAL AND S.M. 6.

N.	NAME OF DRAIN.	LENG. TH.	SEC. TION	SIDE SLOPE	T	B	H.	GRA. DE.	LEVELS.	
									INLET	OUTLET.
14	LATERAL	135	14'	1:1.50	7	2	3	2%	9.72	9.99
15	"	349	"	"	7	2	3	"	7.45	8.15
16	"	553	"	"	7	2	3	"	8.02	9.03
6	SUB.M.	606	18'	1:1.34	10	2	3	"	5.40	6.61
	J.K. LATERAL	1412	"	"	10	2	3	"	8.48	11.30.

7. In Survey No. 470 at the end, only sand was observed in nalla bed. After opening the laterals from J to K (1,320 feet) and after functioning of drains white salt layer was accumulated over an area of $10' \times 10'$, is a clear indication that sufficient quantity of salts have been leached out by rains.

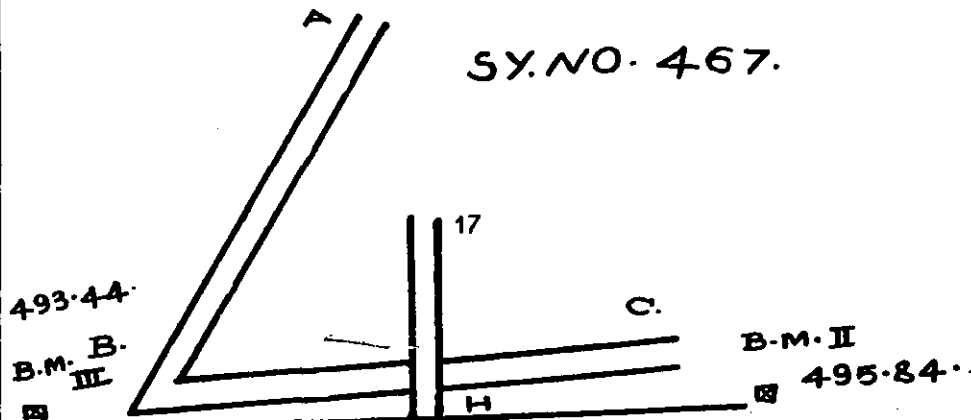
FIG. 12.A

SY. NO. 467.

SR. NO.	SUB MAIN.	SUB LATERAL	LATERAL	T	B.	H.	SIDE SLOPE	LENGTH.	SECT.
1	C TO B.	-	A TO B.	18	6	3	1:2	1155	3600
2	-	-	-	9.50	2	2.50	1:1 1/2	412	1400
3	-	17	-	9.50	2	2.50	"	245	1400.

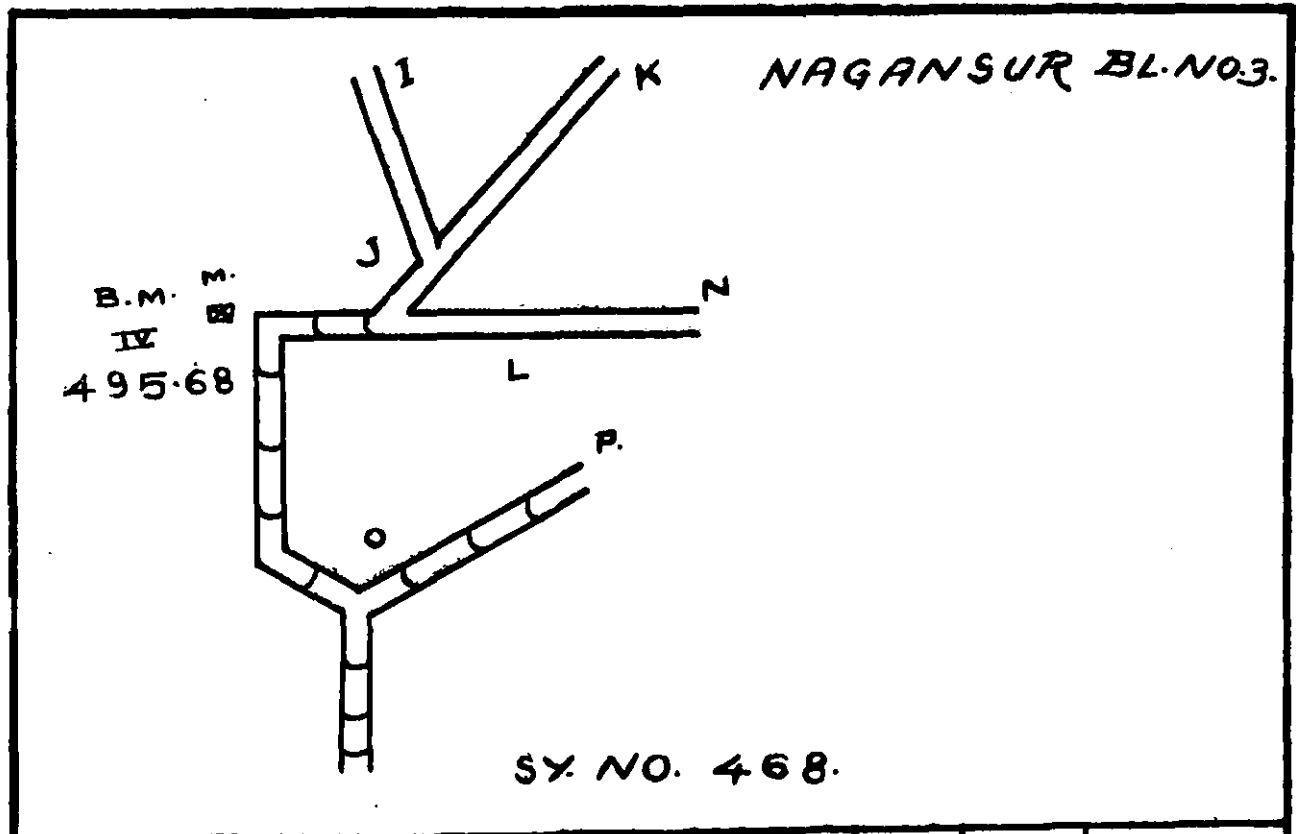
FIG. 12. B.

Sr. No.	SUB MAIN.	SUB LATERAL.	T.	B.	H.	SIDE SLOP E.	LEN. GTH.	LAT. ERAL.	SECTION.
1	-	-	10.75	2.	2.75	1:2	375	I TO U	1800
2	-	-	16.00	4.	3	"	1457	K-LMO	3000
3	-	-	9.50	2.	2.50	1:1 1/2	275	N TO L	1400
4	P-O	-	10.75.	2.50	2.75	1:2	195.	-	1800

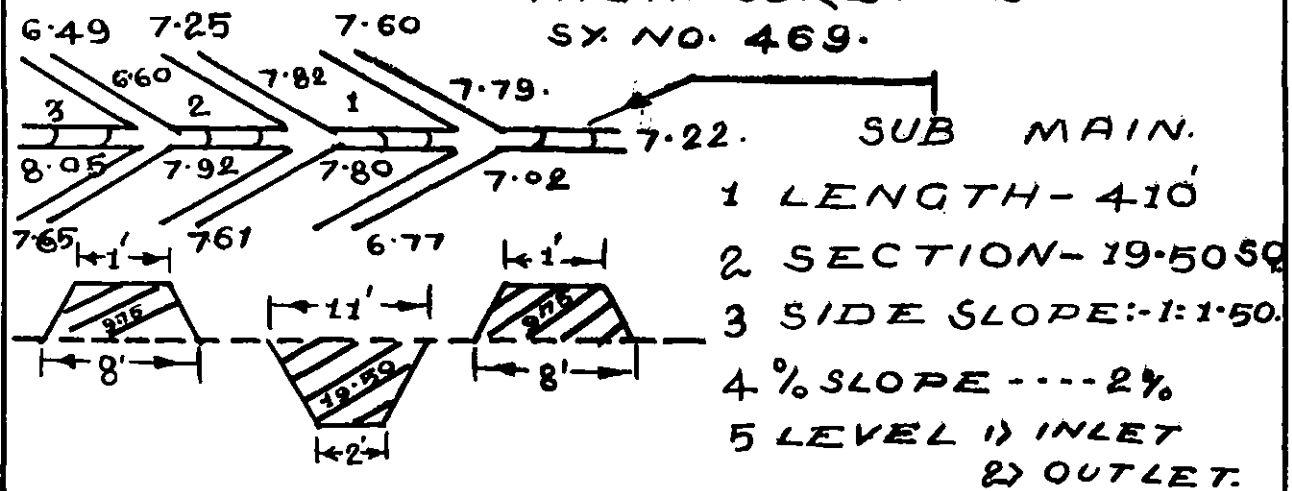
FIG 13. A

NAGANSUR BL. NO. 3.
SY. NO. 469.

SR. NO.	LENGTH	SECTIO. - N.	SIDE SLOPE.	BED % SLOPE.	LEVELS.	
					INLET	OUTLET
1	96'	14 00	1:1.50	2%	7.60	7.79.
2	95'	DO	DO	"	7.25	7.52.
3	105	DO	DO	"	6.49	6.60.
4	138 1/2	DO	DO	"	6.77	7.02.
5	139'	DO	DO	"	7.61	7.80
6	127'	DO	DO	"	7.65	7.92.

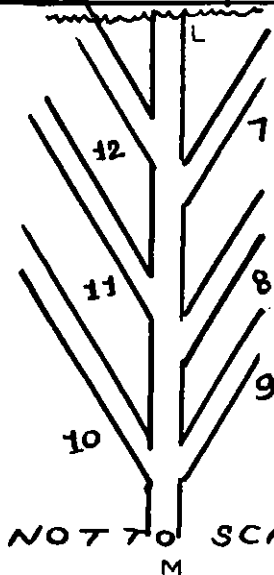
NAGANSUR BL. NO. 3
 SY. NO 469.
 SUB MAIN 2

- 1 LENGTH ----- 282'
- 2 SECTION 18.00 SQ.
- 3 SIDESLOPE 1:1.34.
- 4 BED SLOPE 2%
- 5 LEVELS INLET 6.35.
 AT, LATERAL } OUTLET 7.22
 L TO, M. } 435.

In sub-main 2 and the main 1, layers of sand were observed below 1' and 1½ feet. Due to the sandy layers proper shape could not be given to the drains. Lime cankers (CaCo₃) with thickness of half an inch below 4 feet, in drains A to B within a length of 300' were observed.

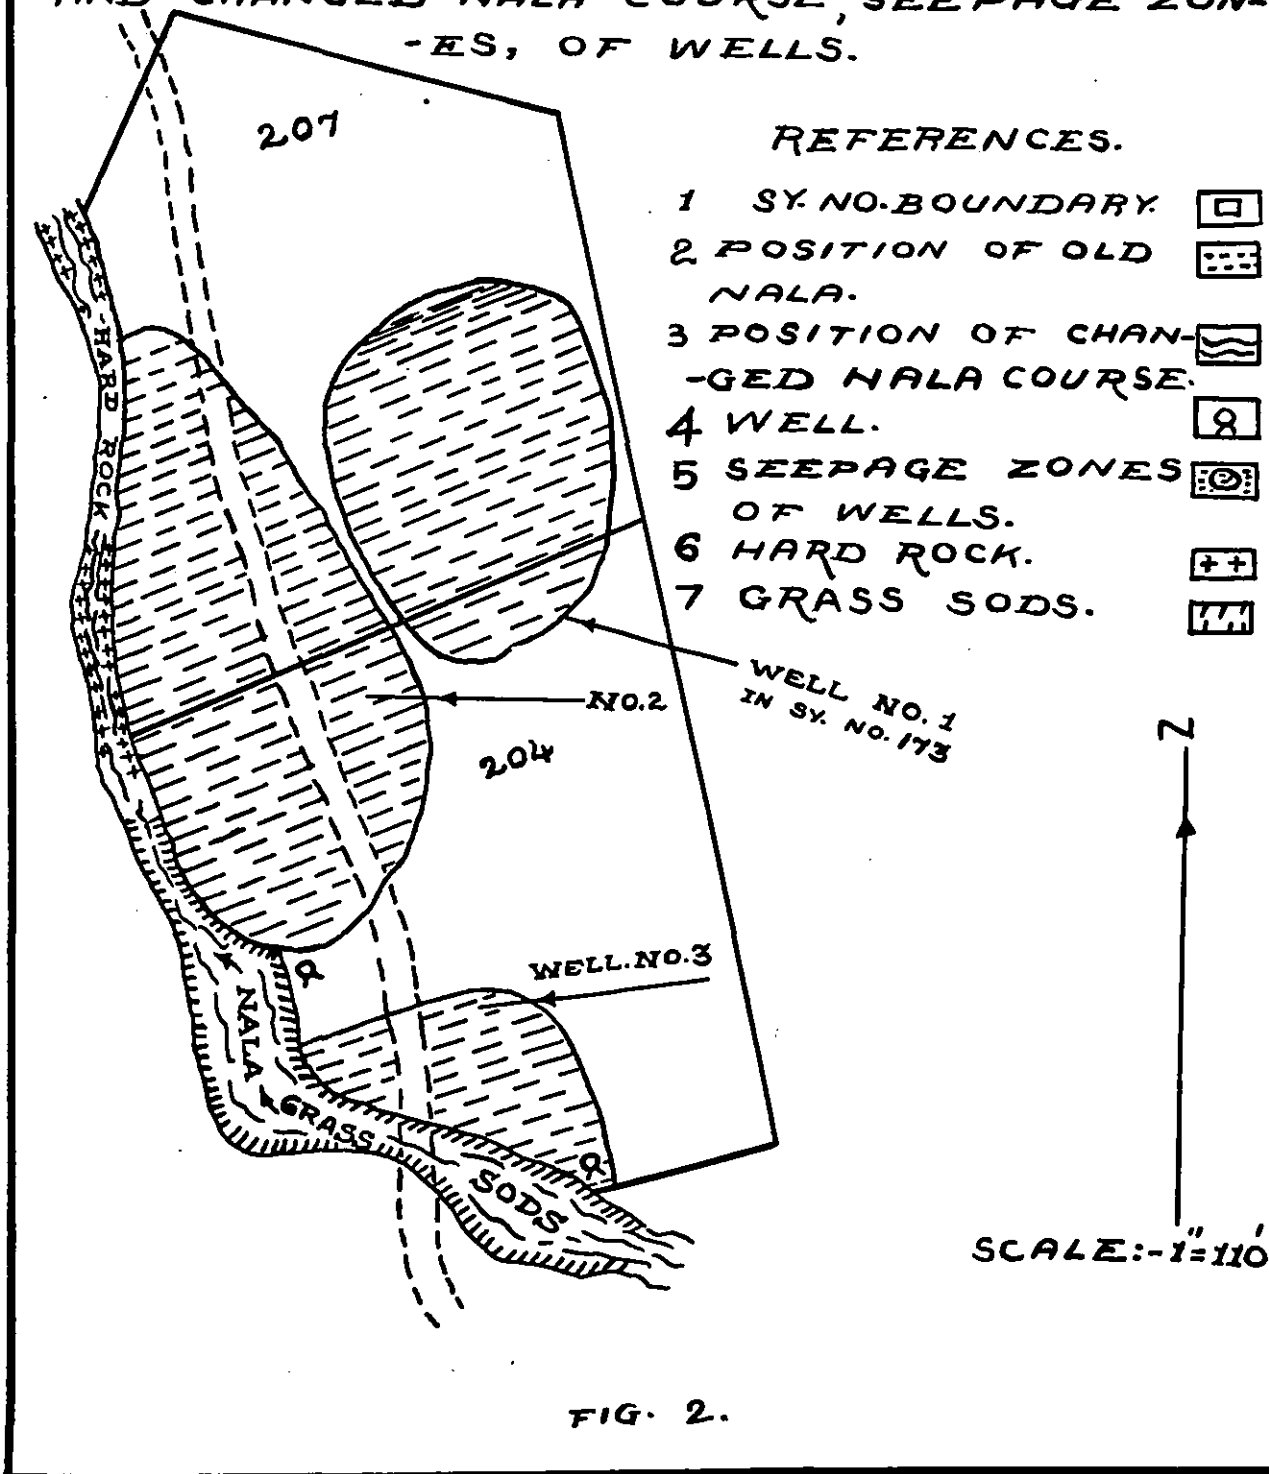
TALUKA:-BARSHI DIST:-SHOLAPUR.

PART PLAN SHOWING POSITIONS OF OLD AND CHANGED NALA COURSE, SEEPAGE ZONES, OF WELLS.

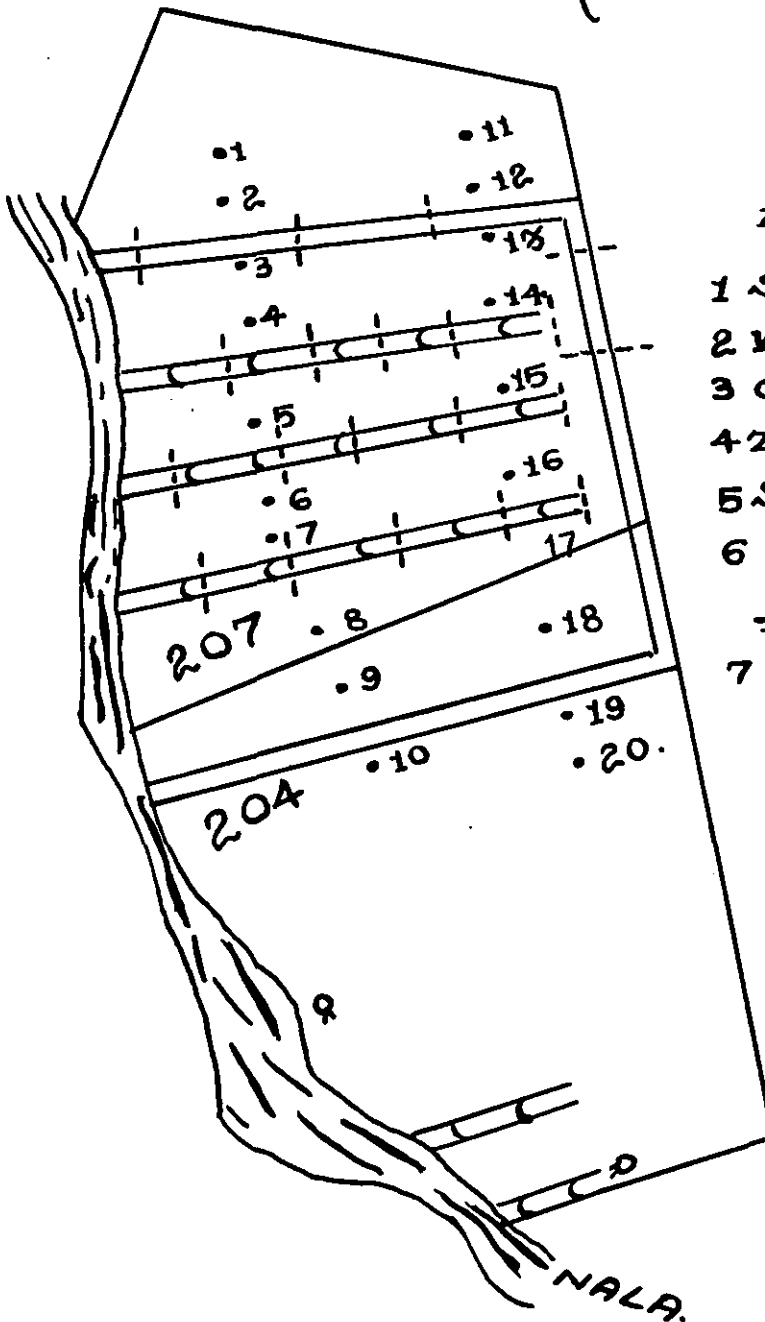
FIG-7

PART PLAN SHOWING ALIGNMENTS
OF DRAINS SOIL-PITS PIEZOMET-
ER TUBES.

ILL-DRAINED PROJECT AT.
AGALGAON BL.NO.23.
TALUKA :- BARSHI. DIST:-SHOLAPUR.

- REFERENCES
- 1 SY.NO. BOUNDARY.
 - 2 WELL -----
 - 3 OPEN DRAIN-----
 - 4 TILE DRAIN-----
 - 5 SOIL PIT.-----
 - 6 PIEZOMETE.-----
 - 7 NALA -----

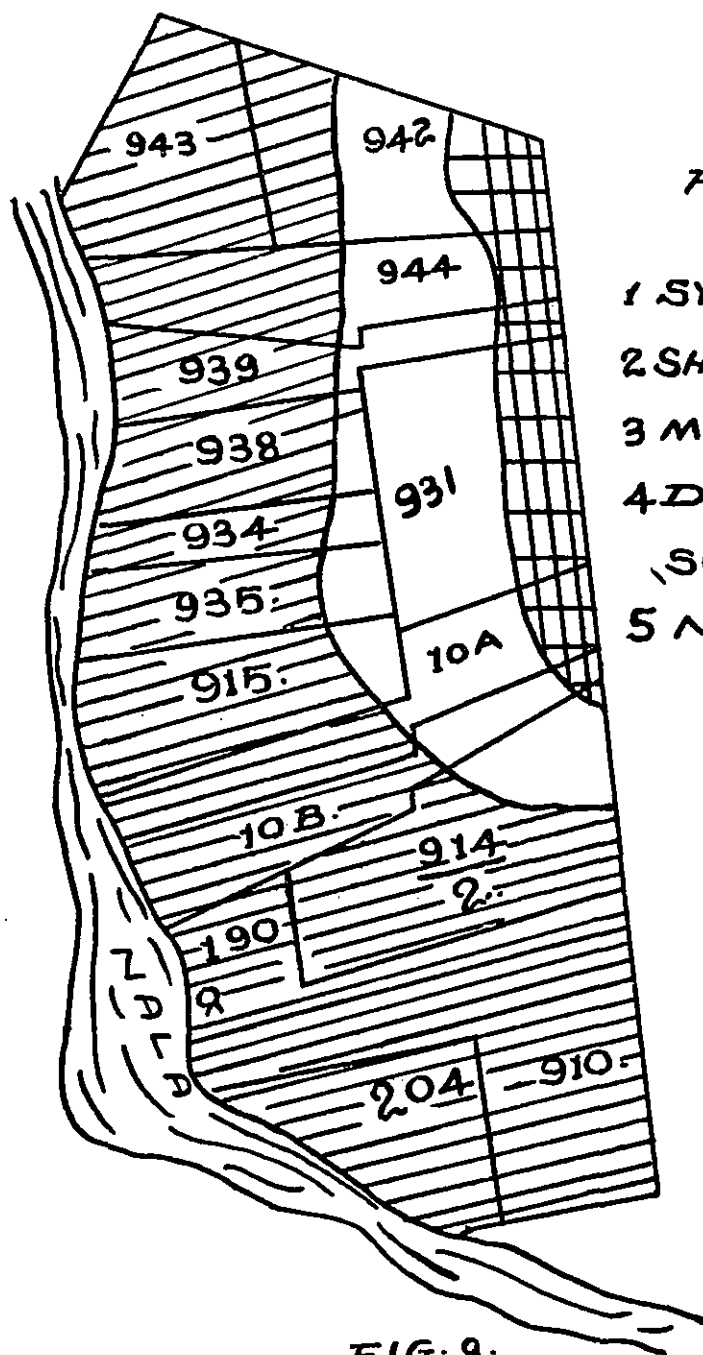
FIG. 8.

PART PLAN OF SOIL TYPES.

SCALE:-1"=110'
AREA=5531 ACRES

- 1 SY.NO-BOUNDARY
- 2 SHALLOW SOIL
- 3 MEDIUM SOIL
- 4 DEEP BLACK SOIL
- 5 NALA

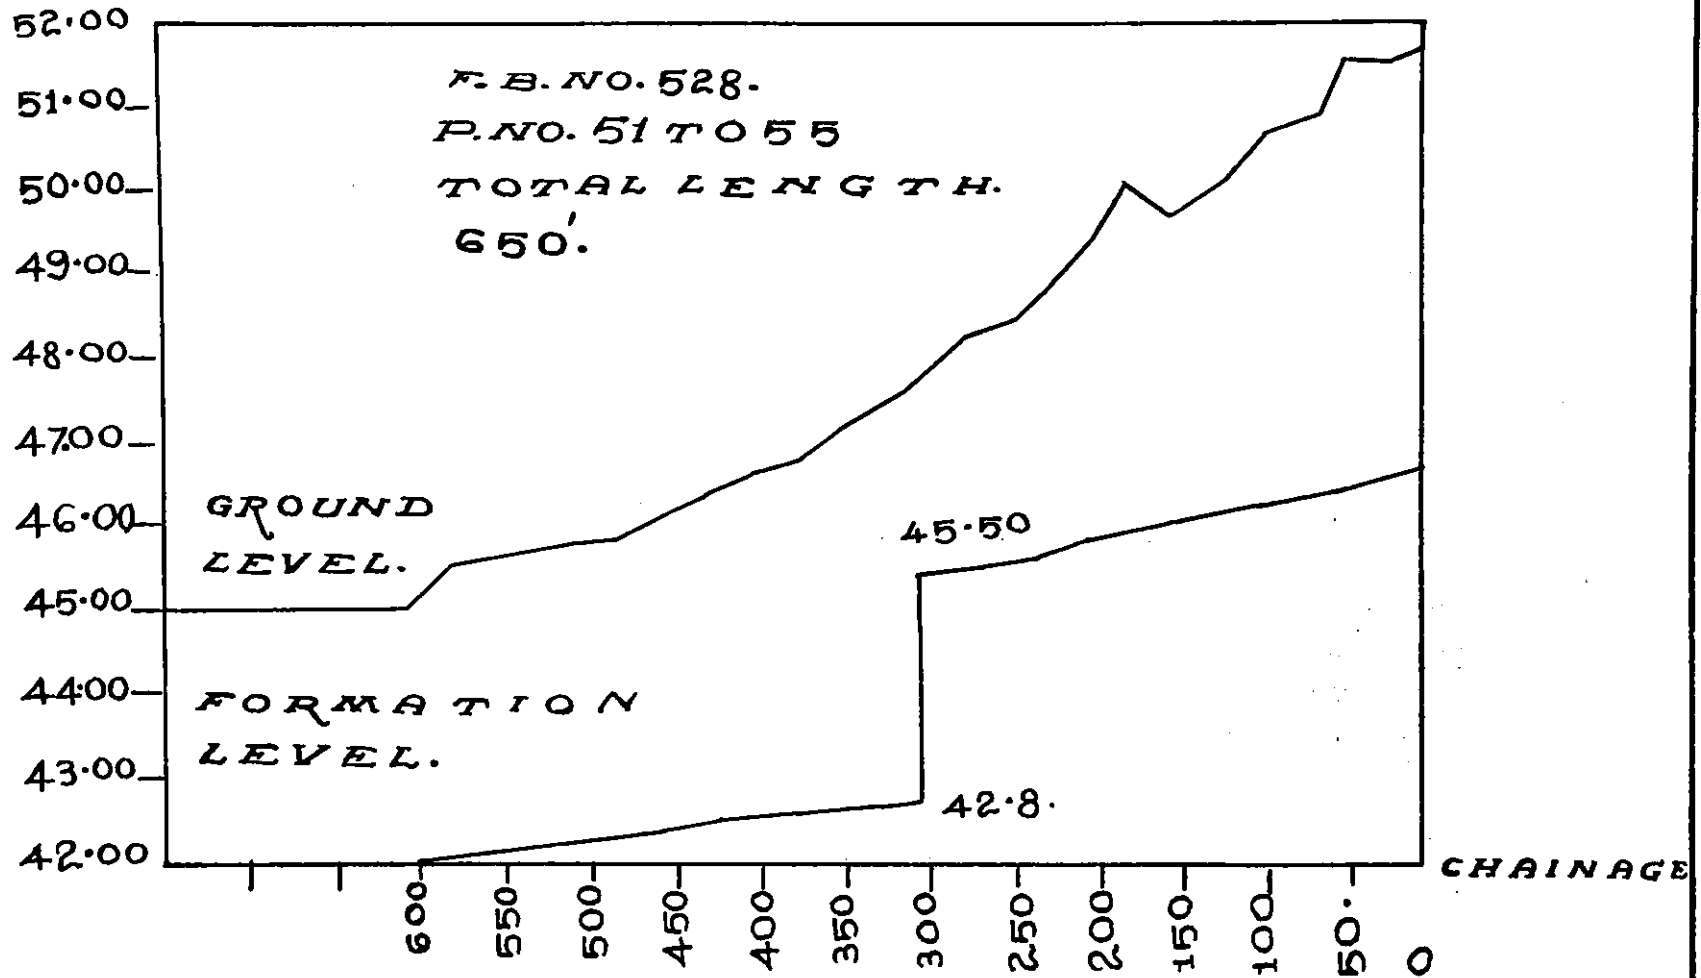
FIG. NO. 9.

AGALGAON BL. NO. 23.
DRAIN NO. 3.

SCALE :- 1" = 2'
HORIZONTAL = 1" = 100'

1. Within two hours, the nalla was flooded due to water received from outside catchment with an average depth of two feet. The flow was continuous.
2. Tile drain No. 5 and open drains Nos. 3, 4 and 8 were observed flowing for the first time on the 19th August 1965.
3. Tile drains Nos. 1, 2, 6 and 7 were found flowing on the 24th August 1965.

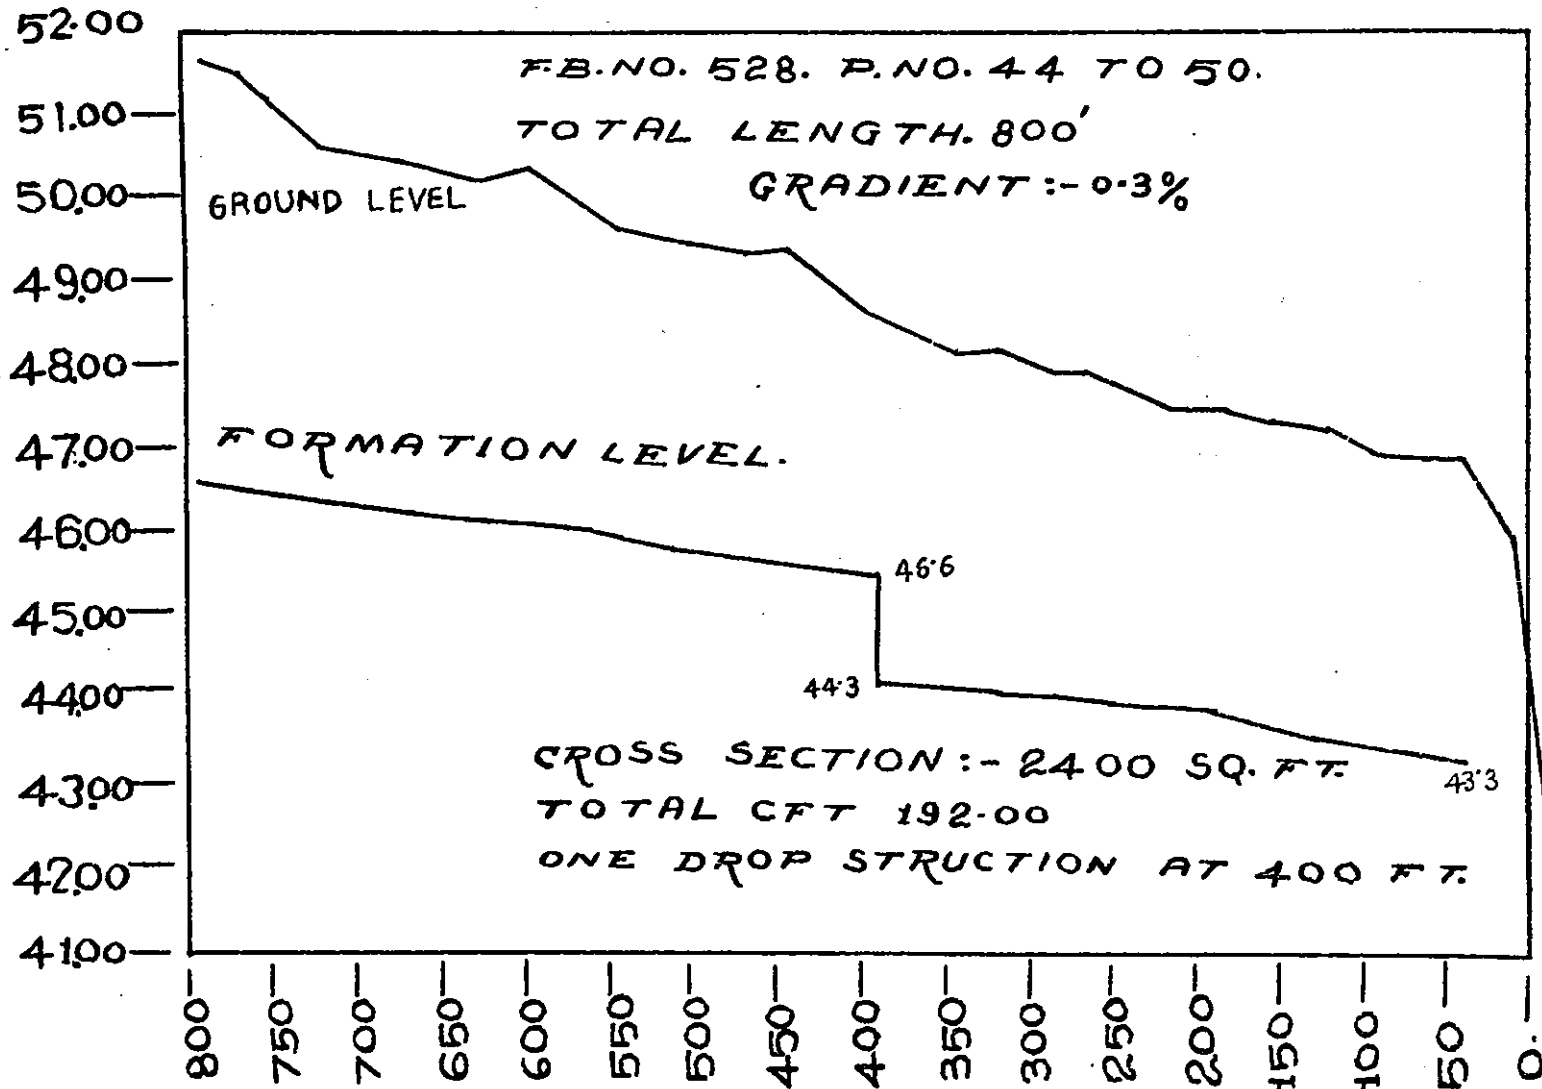
FIG. 10

AGALGAON BL NO. 23.
DRAIN NO. 4.

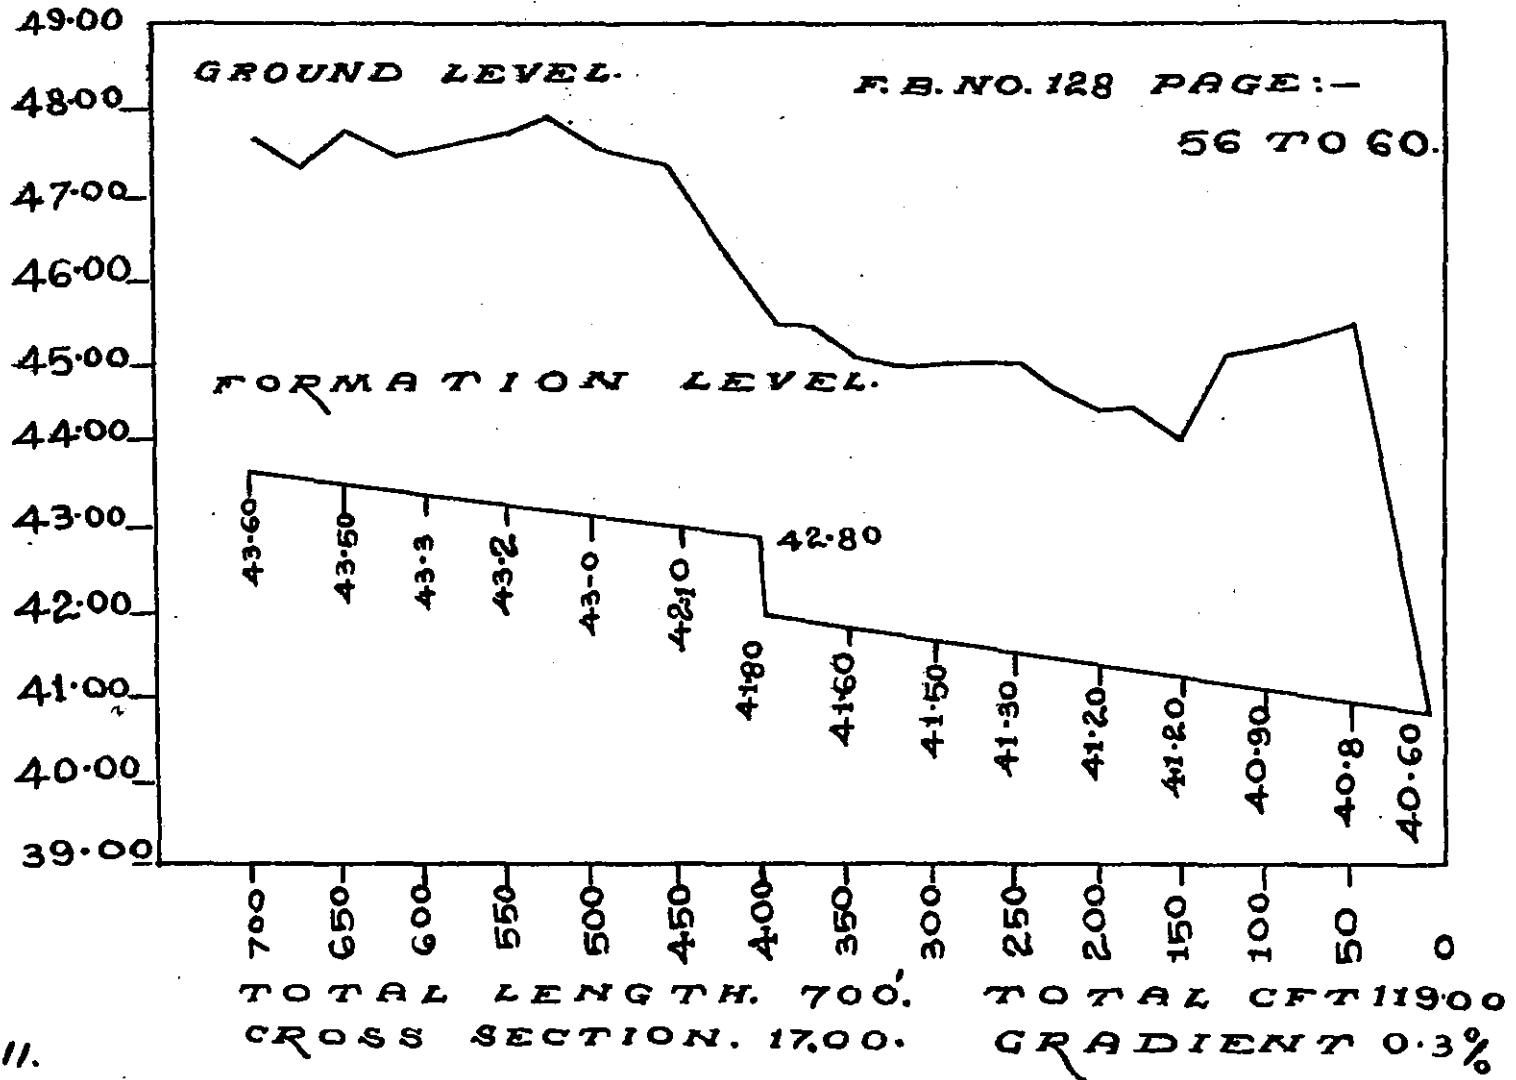
FIG. II.

A GALGAON BL. NO. 23. DRAIN NO. 5.

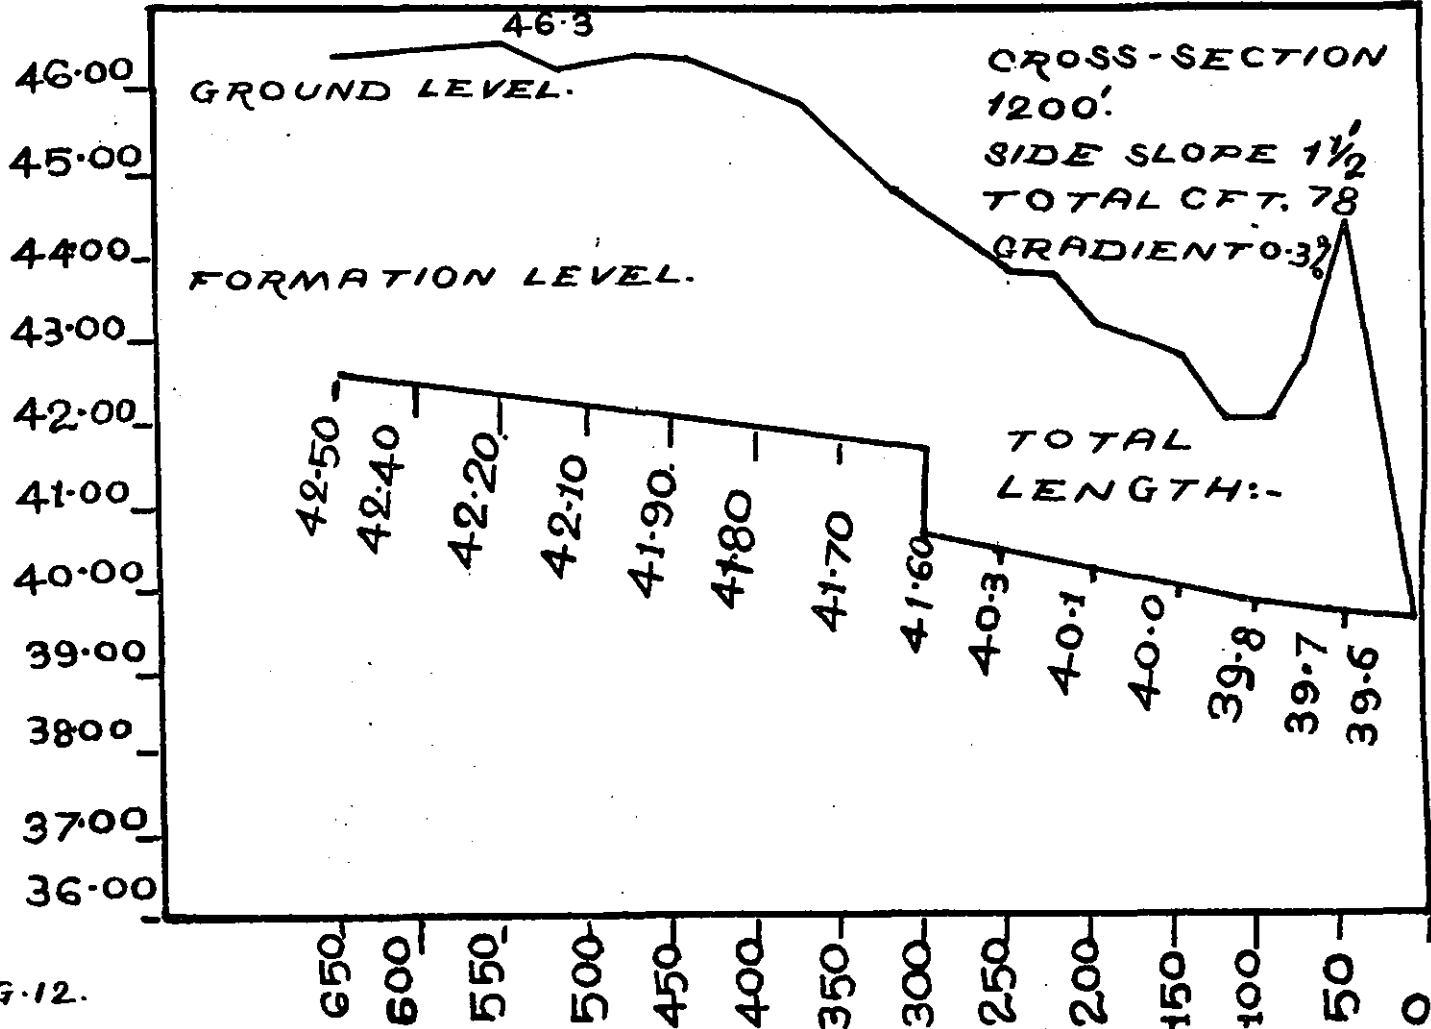
FIG. 12.

AGALGAON BL. NO. 23 DRAIN NO. 6

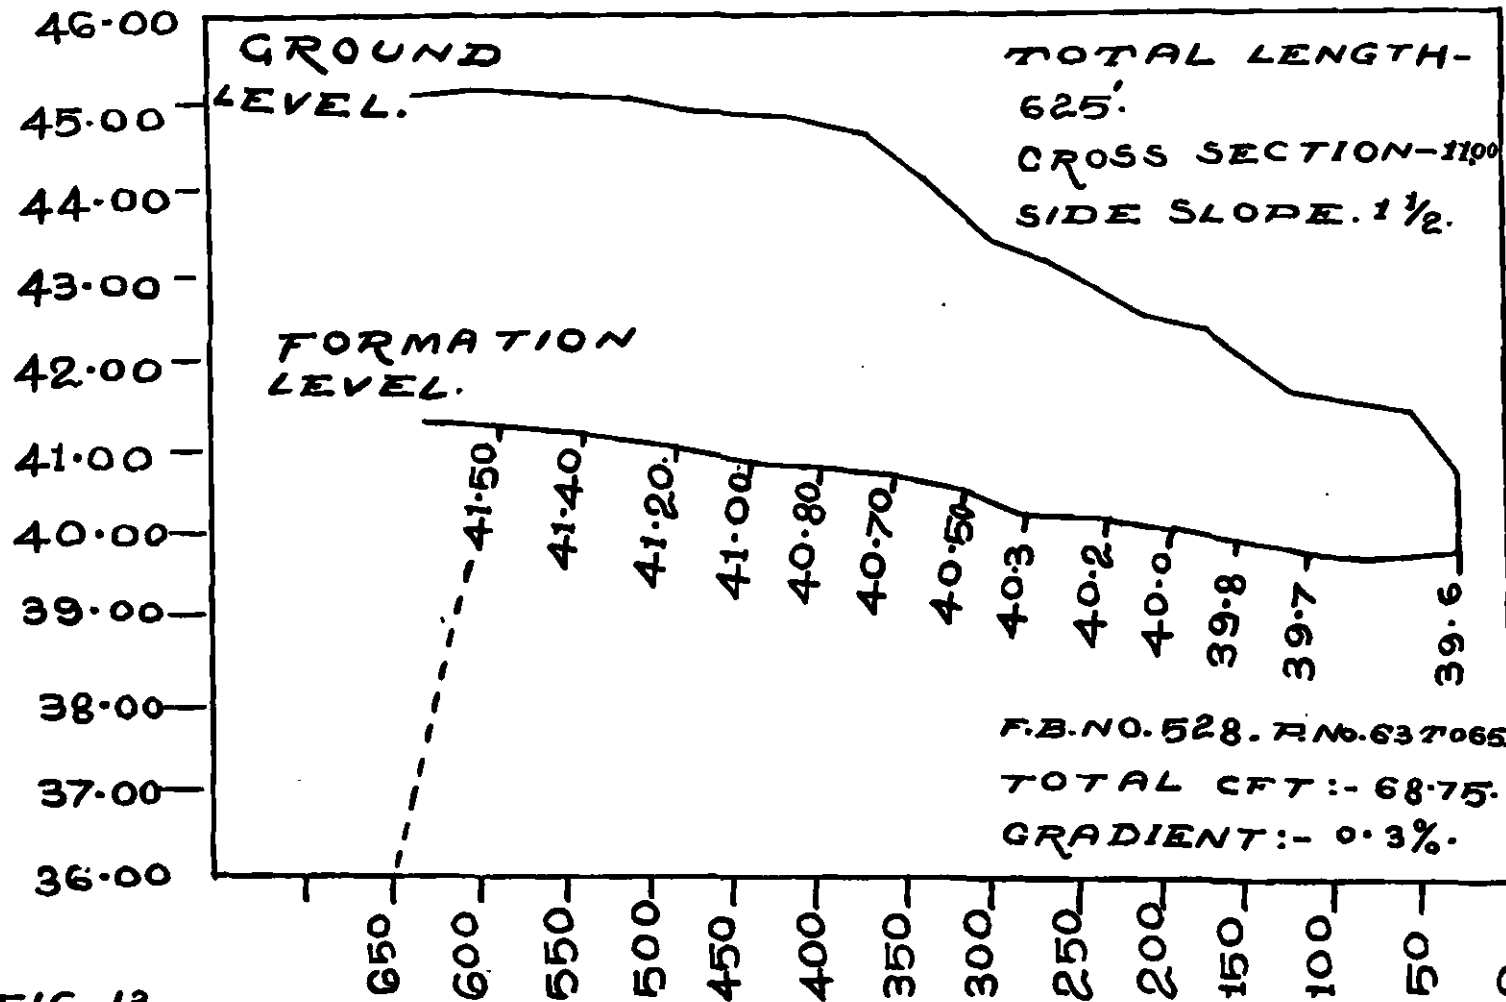
FIG. 13

AGALGAON BL. NO. 23
DRAIN NO. 7

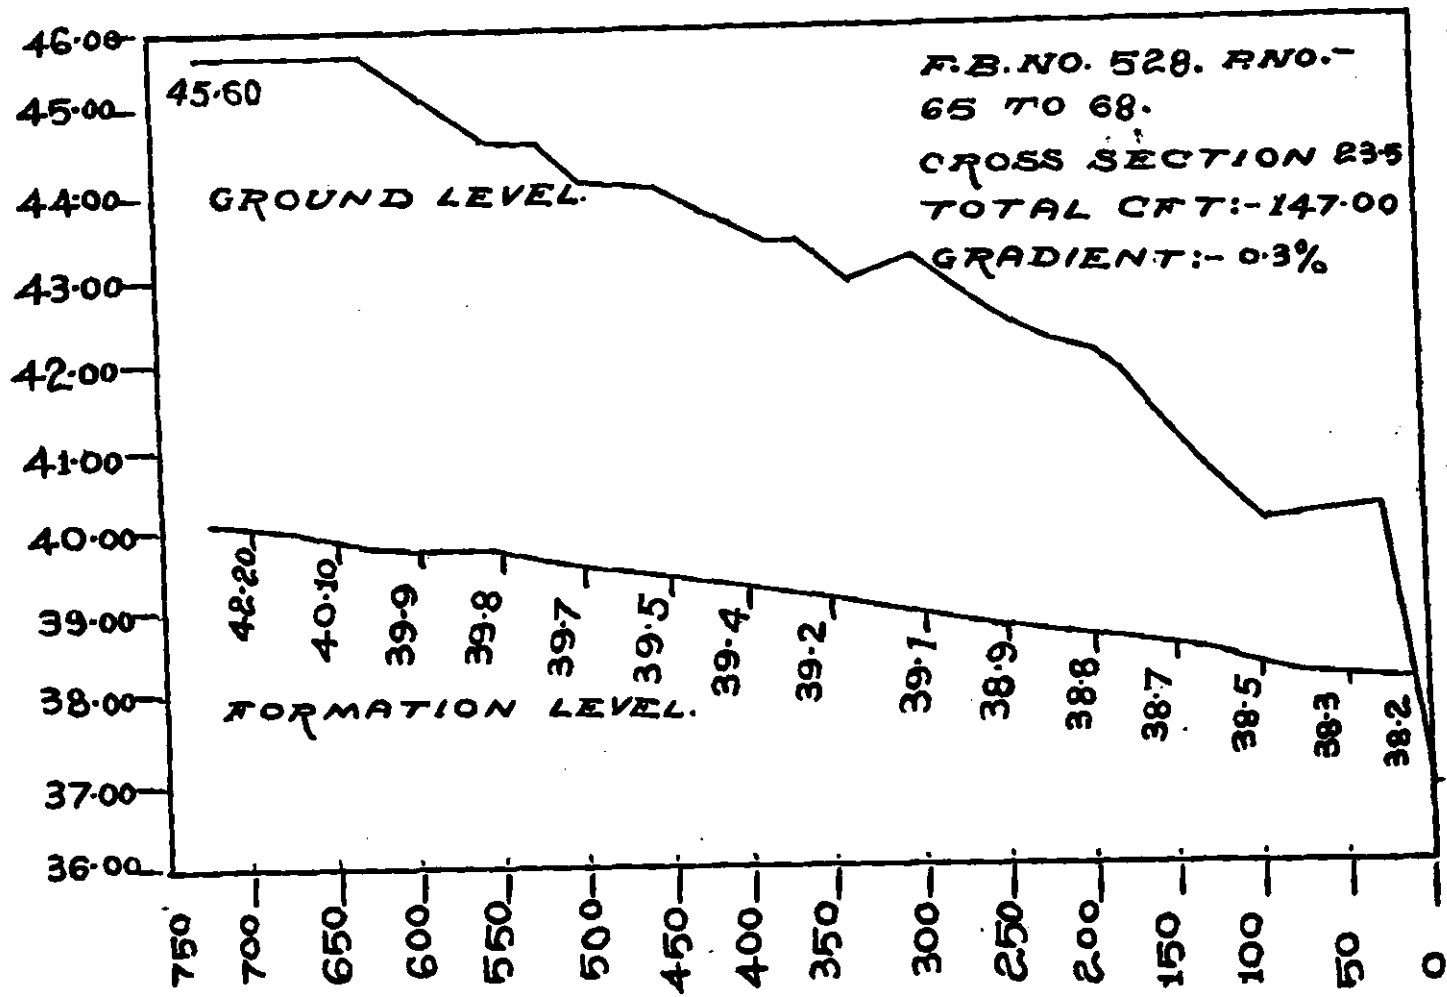
FIG. 14.

AGALGAON BL. NO. 23
DRAIN NO. 8
